## AN EXPERIMENTAL STUDY OF CRACK PROPAGATION IN STIFFENED OVER-HEIGHT COMPACT TENSION (SOCT) SPECIMENS

**Abstract:** *In this paper, three Stiffened Over-height Compact Tension (SOCT) specimens were tested to investigate the damage mechanism when a crack encounters a stringer in Quasi-Isotropic (QI) laminates, where the stringer is simulated by a strip representative of a stringer foot. SOCT specimens consist of a 4 mm thick skin sandwiched by a 2 mm stringer on each side of the skin at the rear of the specimen, the stringers were co-cured to the skin. It was found that severe skin-stringer debonding occurred while no stringer breakage was observed. It is believed that as the crack propagates in the skin and causes skin-stringer debonding, load is transferred to the stringers. Skin fracture did not induce crack propagation in the stringer, but rather large areas of skin-stringer debonding.*

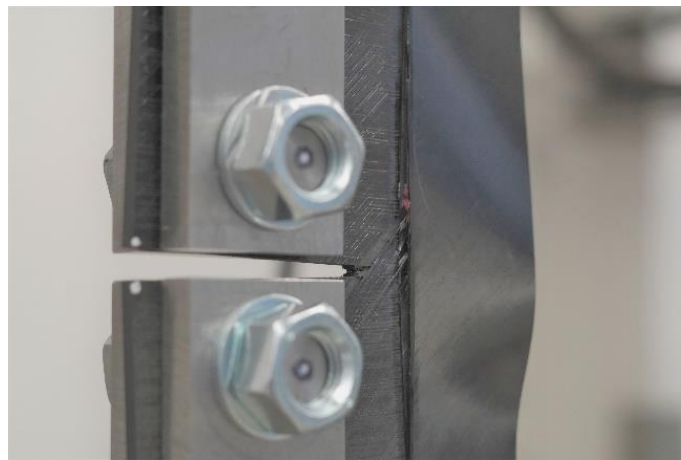
*a) Test 1 after compressive failure showing large area of skin-stringer debonding without stringer failure.*

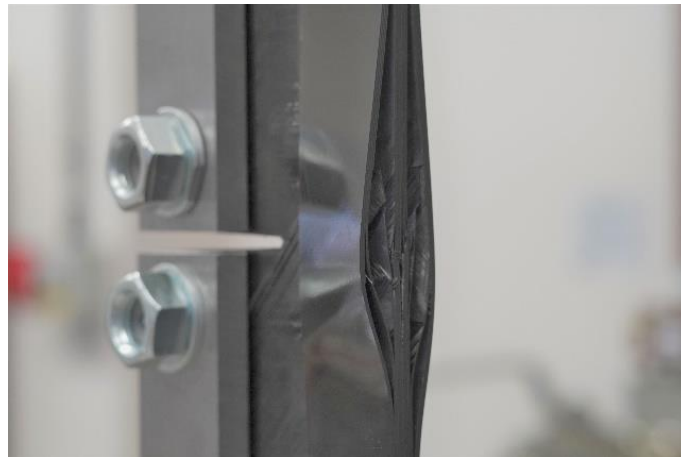
*b) Test 1 specimen showing compressive failure at the rear without stringer failure. Stringers at the rear of the specimen have bulged out due to compression, no stringer cracking observed.*

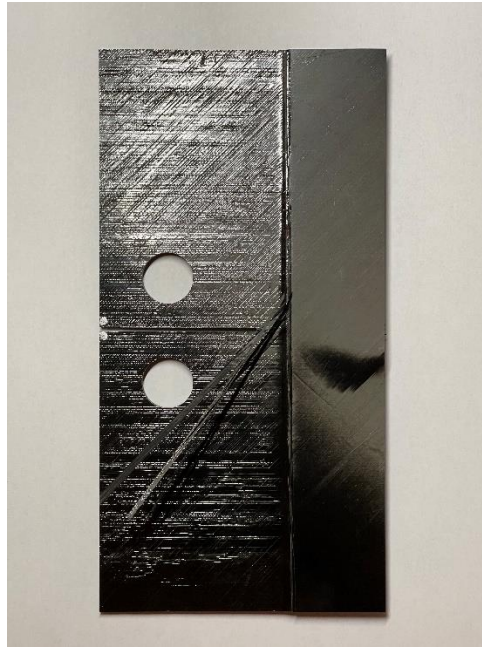
Figure 4. Test 2 specimen showing no stringer damage after compressive failure at the rear. Triangular black area on the stringer is the stringer bulging out as compressive failure in the skin underneath it has created a thicker damage zone in the skin.

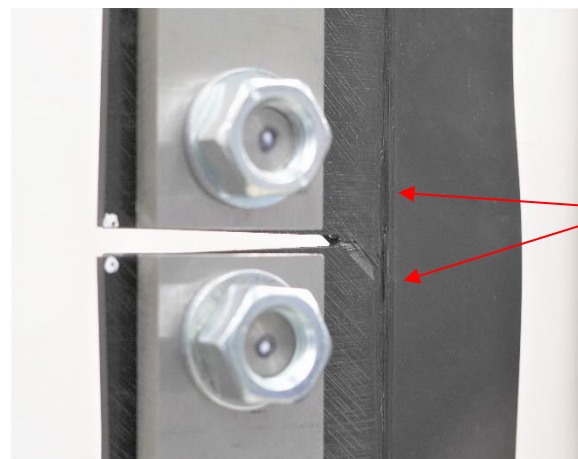
Dark vertical gap between skin and stringer indicating debonding.

a) Test 3 specimen showing skin surface splitting and skin-stringer debonding.

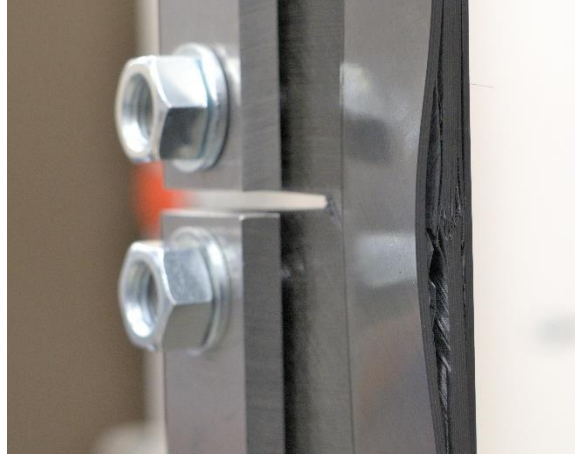
*b) Test 3 specimen showing skin compressive failure at the rear and skin-stringer debonding.*
