Mechanical characterisation of adobe samples from the state of Morelos, Mexico

Paper (reviewed on 24th of April 2023) – 4995 words, 10 tables, 9 figures.

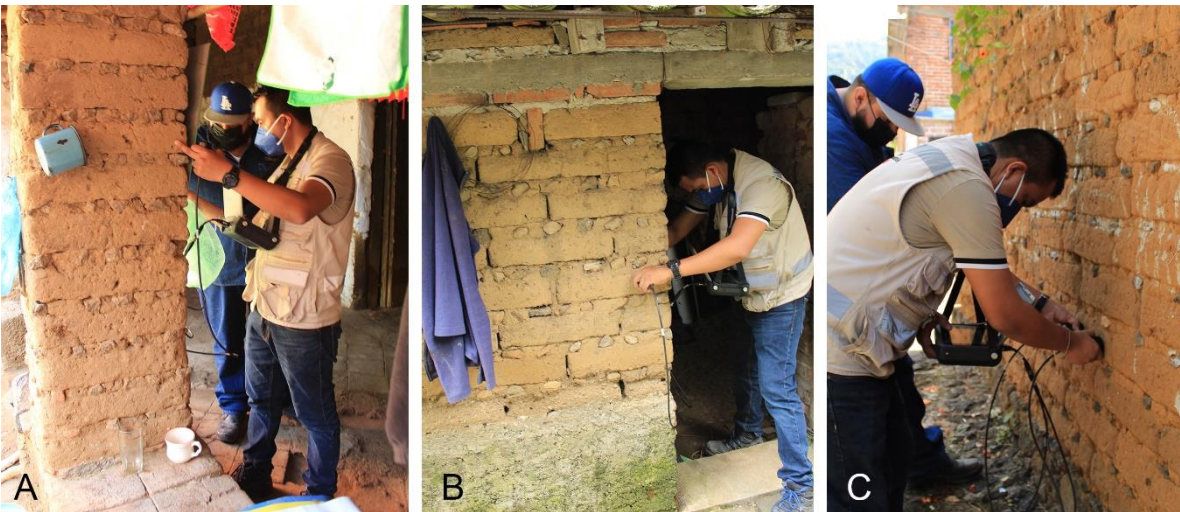
Figure 1. Examples of direct ultrasonic wave propagation measurements in a column (A) and a wall (B) and an indirect measurement in the external face of a façade wall (C)

A series of tests to determine the velocity of ultrasonic wave propagation were performed in situ, totalling 117 successful measurements on 39 different samples (i.e., each sample was measured three times to obtain a mean value) in 13 different buildings. The possibility of performing direct and indirect tests was heavily constrained by the facilities provided by the owners of the buildings. Despite the ideal procedure being to test both internal and external materials (given the sensitivity of adobe towards weathering), in most cases, owners only allowed the team to work from the exterior of the buildings (Figure 1), mainly due to public safety concerns. The number of measurements of each type is presented in Table 1. The nomenclature adopted expresses the type of measurement and the number of mortar joints traversed by the elastic wave.

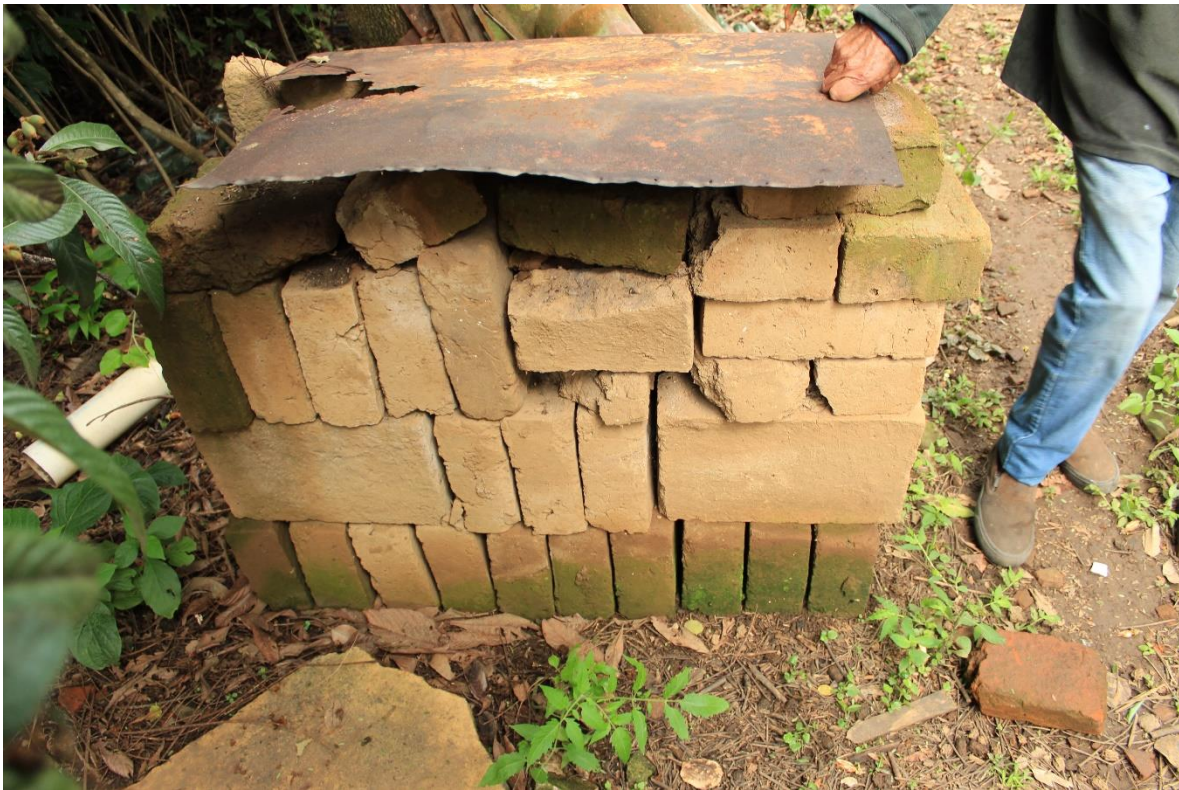
Figure 2. Pile of blocks from which the samples for the experiments in this study were obtained. Note that these pieces were stored in outdoor conditions.

The pieces that appeared to be in the best condition were selected from those offered. The largest piece, substantially bigger than the rest, was divided into pieces (samples A, B and C) in order to perform the preliminary calibration tests. The remaining samples (I, II, III and IV) were kept in their original conditions. The description of all the samples is summarised in Table 2.

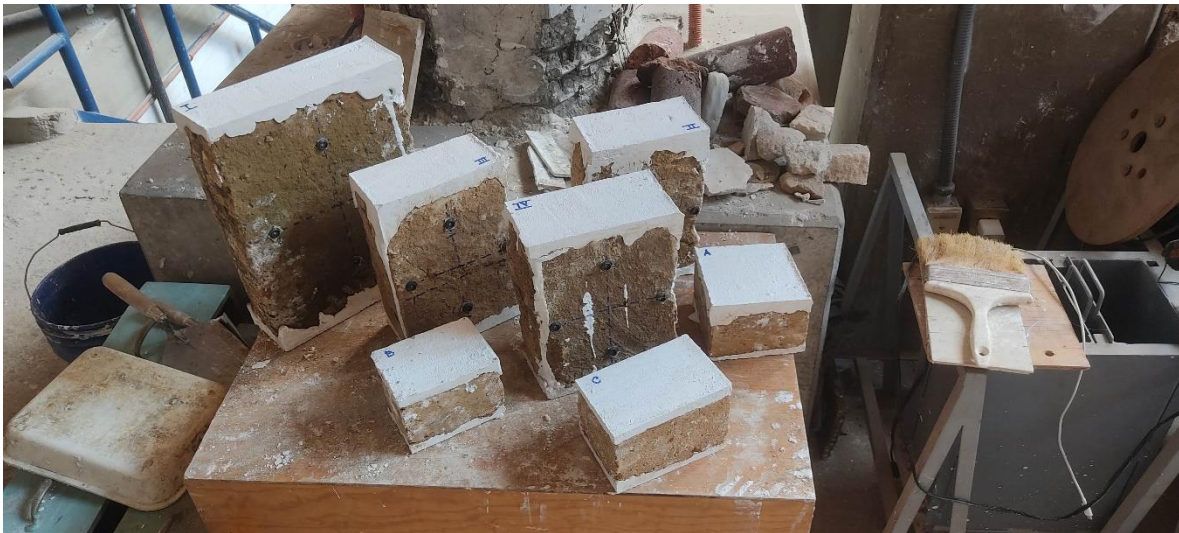
136
137 Figure 3. Set of samples after preparation with gypsum.

132 48h before testing, all the adobe samples were prepared by adding a layer of gypsum to create
133 a more regular contact surface between the adobe units and the machine (Figure 3). This ensured
134 the elimination of any possible stress concentration points and ensured that the specimens were
135 tested for pure compressive strength.

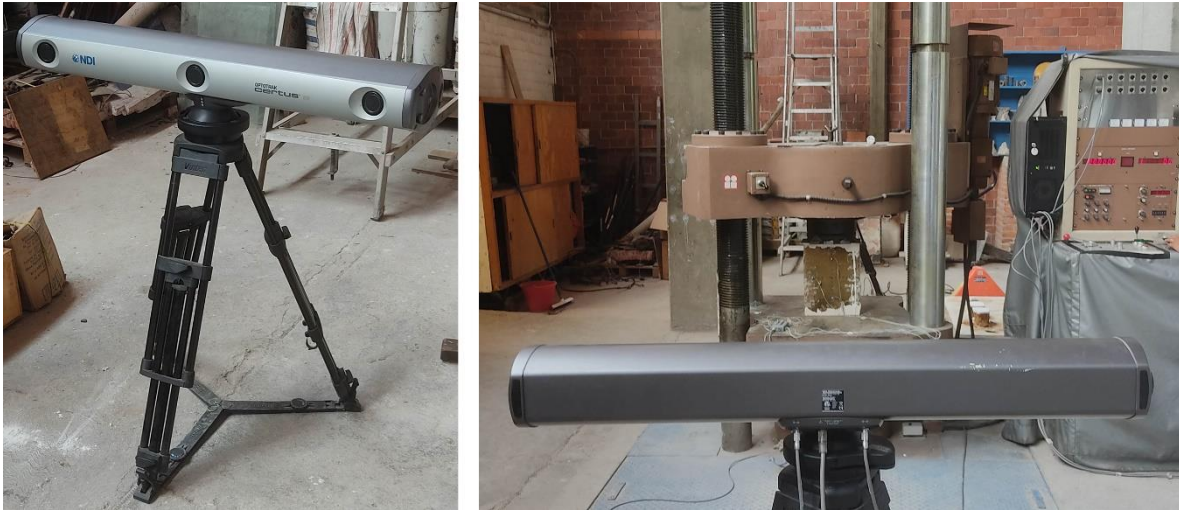
Figure 4. View of the OptoTrack devices.

The conduction of the unconfined compressive strength was aided by two OptoTrack Certus HD Position Sensor devices and infrared LED arrays to measure strain on the surface of the specimens in the two main directions on both sides of each specimen. The sensor was composed of three cameras that tracked the displacements of a set of infrared LEDs in the X, Y and Z axis with a resolution of 0.01 mm. These devices can be set to follow multiple surfaces using a common spatial coordinate reference (Figure 4).

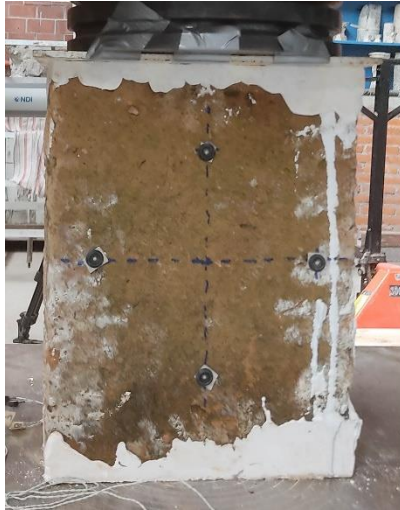
Figure 5. Schematisation of the infrared LEDs array.

Four LEDs were installed in each face of the specimens, arranged in a cross concentric with the geometrical centre of the specimen. This configuration provided two extensometers in the XX and YY axes, as shown in Figure 5. The original length of the extensometers for Specimen I was approximately 200 mm, while those for Specimens II, III, and IV were 150 mm. The initial length of the arrays, as measured by the cameras, is reported in Table 3. During the experiment, the use of both devices allowed for real-time measurements of both faces of the specimens at a frequency of 0.1s. This sampling rate was selected to improve synchronisation with the outputs of the universal testing machine.

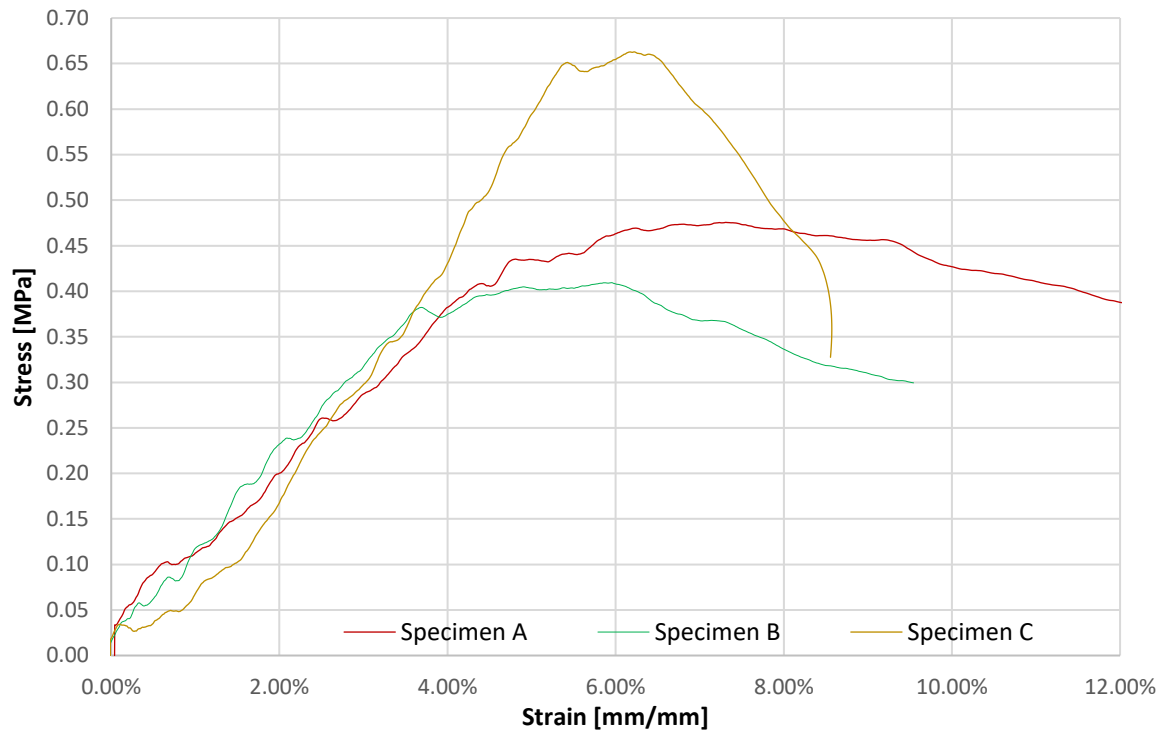
Figure 8. Strain/stress curves for specimens A, B and C.

The behaviour of all the specimens was quite similar in the elastic range, although specimen C reached a significantly higher compressive strength (Figure 8). The behaviour observed after the limit of the elastic region must not be interpreted as a plastic region of the curve but as a softening-alike phenomenon associated with the loss of material. It was observed that the failure mode was similar for all samples, with the detachment of the external layers of the specimens resulting in a sudden loss of section (see Figure 9). This phenomenon was somehow expected since the external layers of the samples are less constrained than the core.

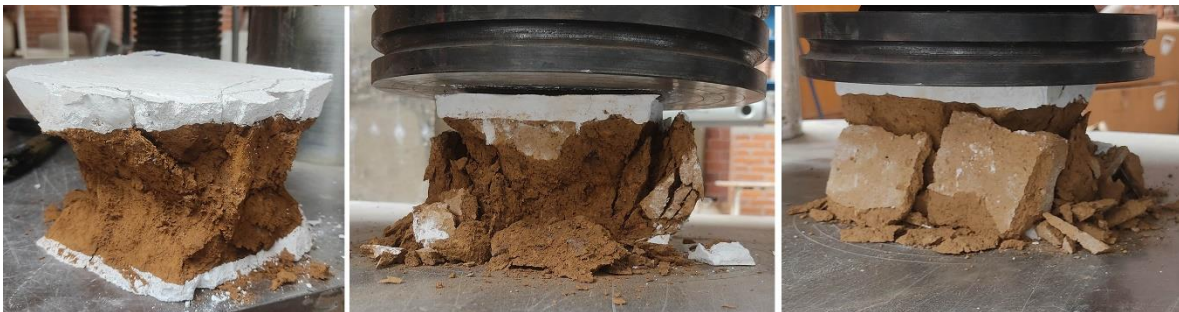
Figure 9. Examples of the failure mode of samples A, B and C, with the detachment of the external layers of material.

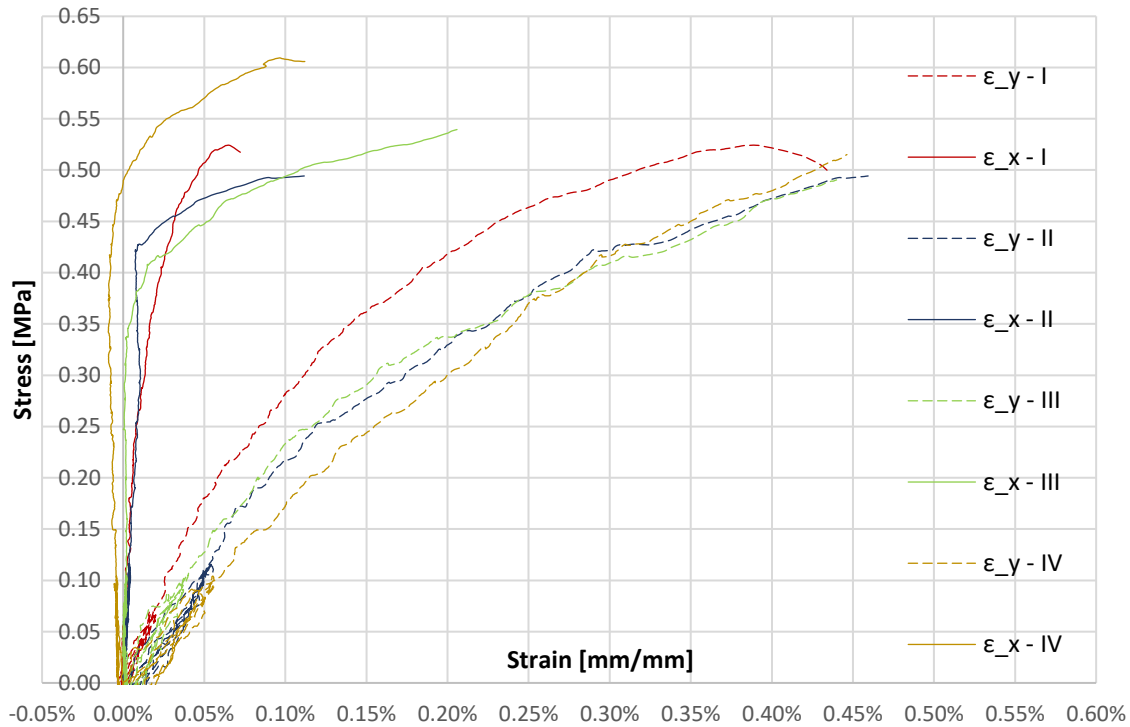
Figure 10. Stress/strain curves for specimens I, II, III and IV.

The experiments on specimens I, II, III and IV were conducted with the support of OptoTrack-based strain gauges. The evaluation of strains in the X and Y directions allowed for the estimation of the Poisson's ratio for each specimen. Overall, the strain behaviour of all specimens was consistent and similar, although the differences in the reached maximum stress. The stress/strain curves, displayed in Figure 10, show similar progressive deformations for all samples. The maximum stresses, strains and mean Poisson's ratio are reported in Table 7.

The hysteretic curves obtained during the load/unload cycles show that, despite a certain variability in the elastic behaviour, there is a consistent elastic recovery. This can be understood as a sign of the good condition of the specimens.
