Residential Building Models for Seismic Risk Assessment at the Historic Downtown of Mexico City

F. Salazar, L. Gerardo^a and Tiago Miguel Ferreira^{b*}

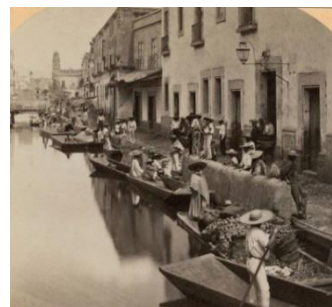
Figure 2. (a) Delineation of the study area. Source: Jiménez Vaca (2014) and digitalized by the authors; (b) Study Area of *La Merced* Neighbourhood in AutoCAD/Google Earth. Source: FCH edited by the authors; (c) Former Ditch of *La Viga* that today passes through an underground pipe at *Alhóndiga* Street. Source: Kilburn Brothers.

The delineation of the study area within *La Merced* was defined through the position of some relevant monuments located at polar boundaries (i.e. north-south, east-west), and it is characterized by the former water system of ditches documented historical studies of the 18th century (Jiménez Vaca 2014). Figure 2 shows the former urban space which displays the monuments that account for the delimitation of the case study, thus leading the concentration of ancient houses over the urban landscape with the channel aquifer network (Jiménez Vaca 2014).

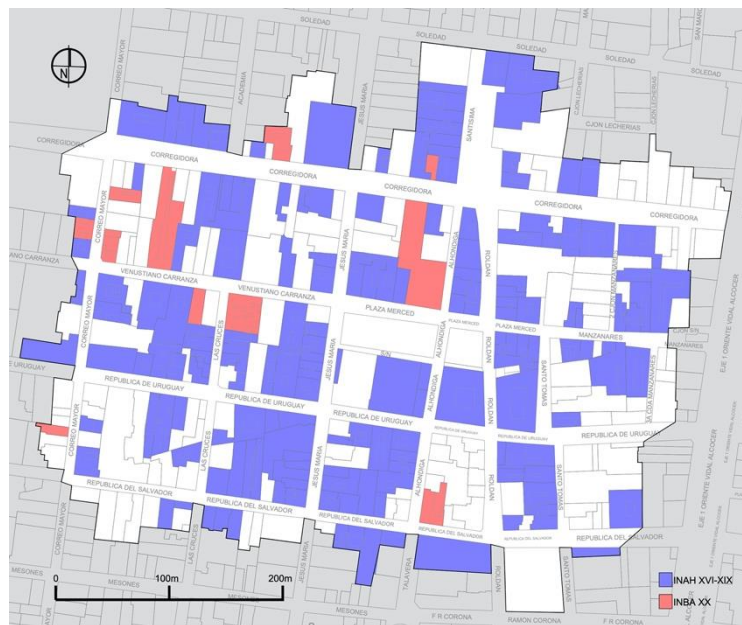
Figure 3. Study area boundaries of *La Merced* (180 national monuments) indicating the heritage local classification (i.e. INAH or INBA). Source: INAH, ACH edited by the authors.

The area includes 180 buildings integrated into the national monuments catalogue (see Figure 3). However, the edifications with no residential link were discarded from the final classification such as monumental architecture (i.e. churches, temples, convents, among others) or buildings dedicated to industrial activities (i.e. manufacturing and distribution of products). The final selection involves 166 buildings which are listed by two cultural authorities: National Institute of Anthropology and History (INAH) and the National Institute of Beauty Arts (INBA)⁴. One-hundred fifty-two constructions belong to INAH buildings list (i.e. built before the 20th century, i.e. historical value) and eleven buildings correspond to the INBA catalogue (i.e. at the beginning of 20th century, i.e. artistic value). In some cases, the historical period is not well-defined due to the urban transformations by listing nineteen buildings in both (i.e. before and after the 20th century).

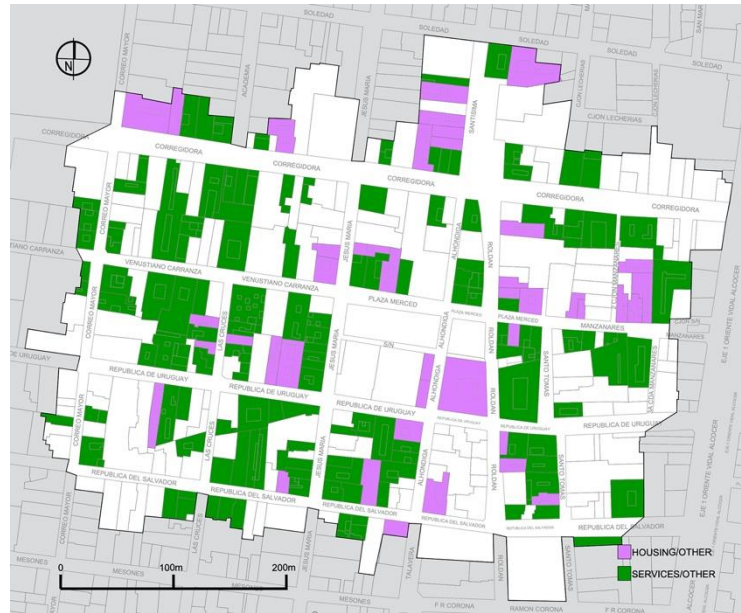
Figure 4. Study area boundaries of *La Merced*, where 166 buildings are zoned by housing or services/commercial land use. Source: INAH, ACH edited by the authors.

Despite this, few inhabitants have continued to reside and develop the usual commercial activities (CENVI 2005). Based on the relation of Esquivel Hernández (Esquivel Hernández 2016), the population ratio per dwelling is 3.4 inhabitants, and based on the examination of number dwellings and stores (Rojas Loa 2012), the local inhabitants and users in working hours in La Merced is about 2291. In some cases, property registry of the city centre indicated the occupation of two houses which belong to the same structure, such as the building located at the 16th of *Manzanares* Street. Figure 4 depicts the current urban distribution of residential and commercial zoning at La Merced, where 105 units are houses with other land use, namely dedicated to other public services, whereas 61 constructions correspond to service commercial areas.

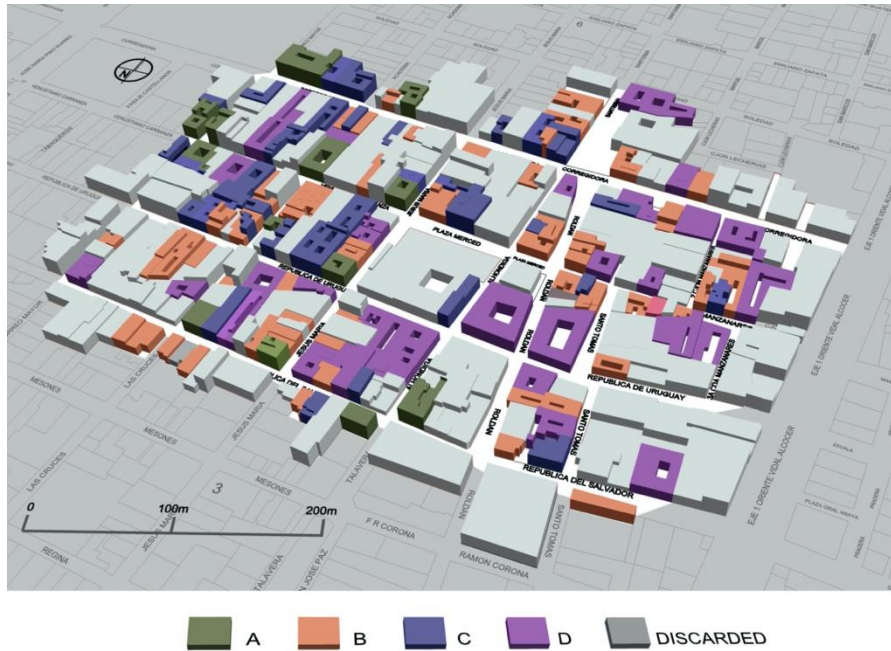
Figure 6. Geometrical Typology.

Figure 6 depicts the distribution of the 3D geometrical building model mapping related to the selected cases within the study area of *La Merced* that accounts for the results further depicted in Table 1, with 14 buildings of type A, 68 of type B, 43 of type C, and 41 of type D.

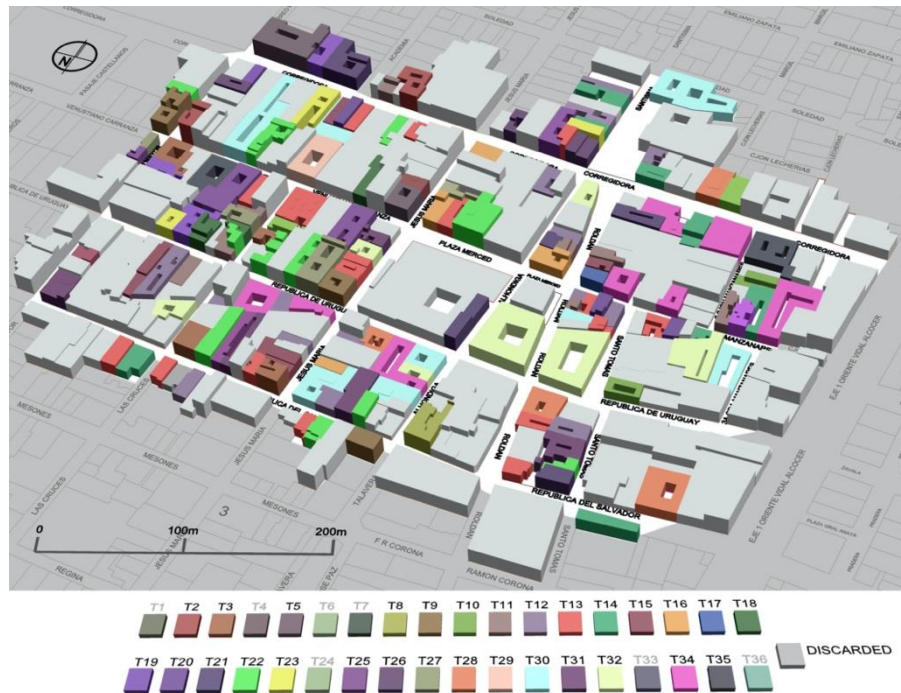
Figure 10. Distribution of the building typologies.

Finally, Figure 10 illustrates the distribution of the building typologies over the study area. The great diversity of material and shapes denotes the complexity of the typological classification.
