Heritage in the Crossfire: Developing novel field-based methods for assessing ballistic impact driven deterioration of heritage stone

A thesis submitted in partial fulfilment of the requirements of the University of the West of England, Bristol for the degree of Doctor of Philosophy

Faculty of the Environment and Technology, University of the West of England, Bristol

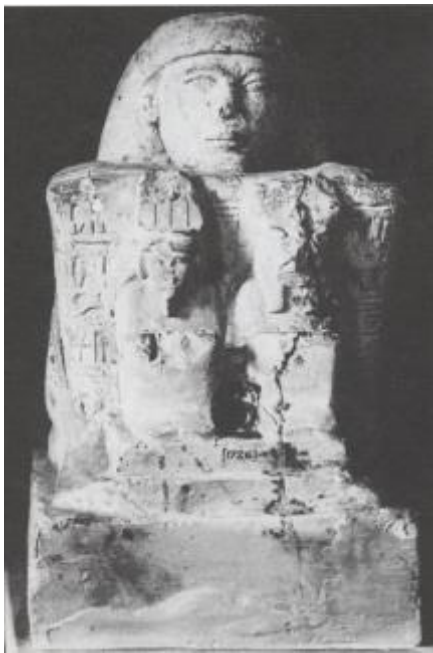
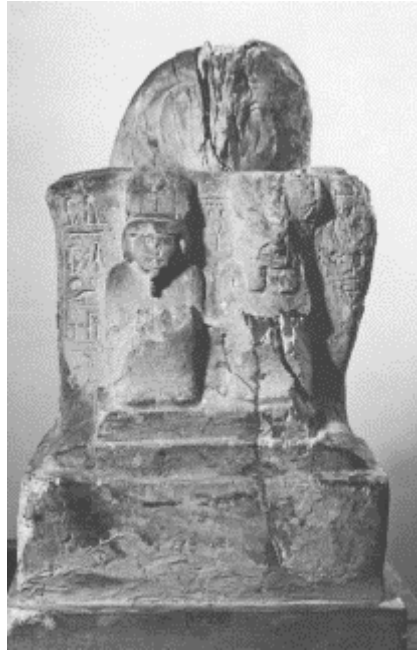
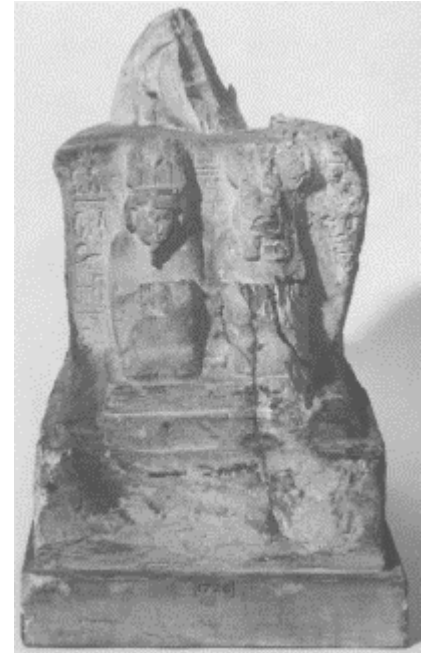
Figure 1.15: Images showing the decay of a salt-contaminated Egyptian sculpture over time
(Adapted from Bradley and Middleton, 1988)

1920

1940

1983

Haloclasty is a common weathering process in arid regions because there are many natural sources of salt contamination in these areas, including the natural deposits inside rocks highlighted earlier. Other sources include sodium bicarbonate from the evaporation of saline lakes. Such deposits have been observed in East Africa and are known to increase the Ph of water (Christensen, 2003 Singer and Stoffers, 1980). Alkali aqueous sodium bicarbonate can increase the solubility of rock minerals such as quartz (Crundwell, 2017), and is known to be a factor in rock weathering and breakdown in the rift valley (Goudie and Cooke 1983). Such an availability of natural salts is a serious risk to heritage monuments in arid regions, as described by Bradley and Middleton (1988). Deteriorated Egyptian sculptures in the collection of the British Museum were analysed for salt content and compared with un-deteriorated sculptures. The seriously decayed sculptures exhibited far higher concentrations of soluble salts, and the decay caused by these salts was graphically illustrated with images of the sculptures over time (Figure 1.15).

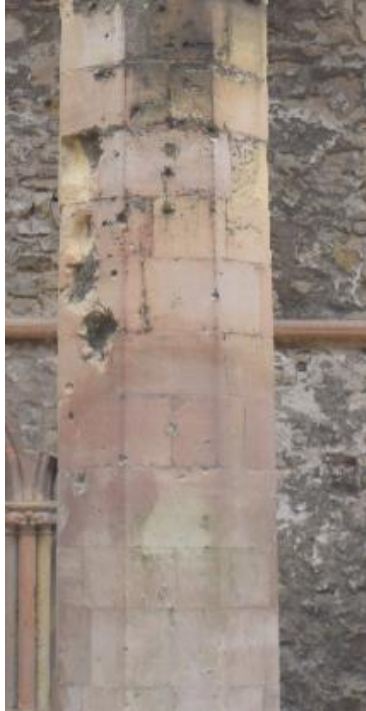
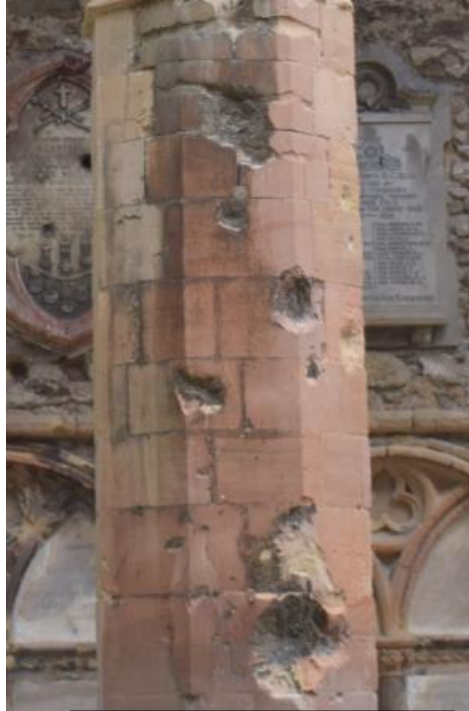
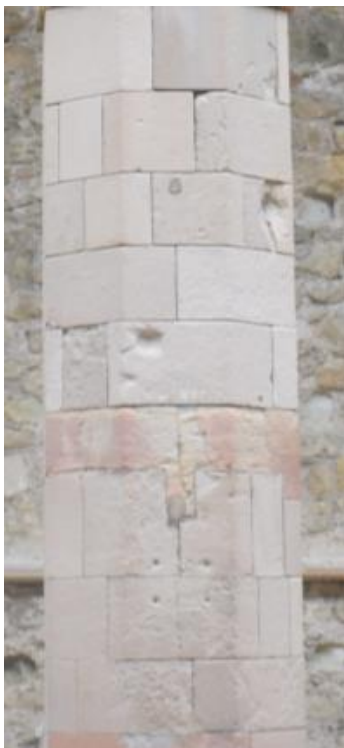
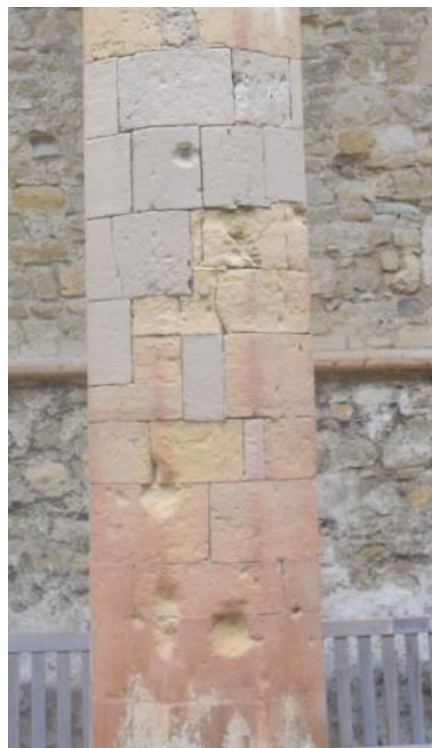
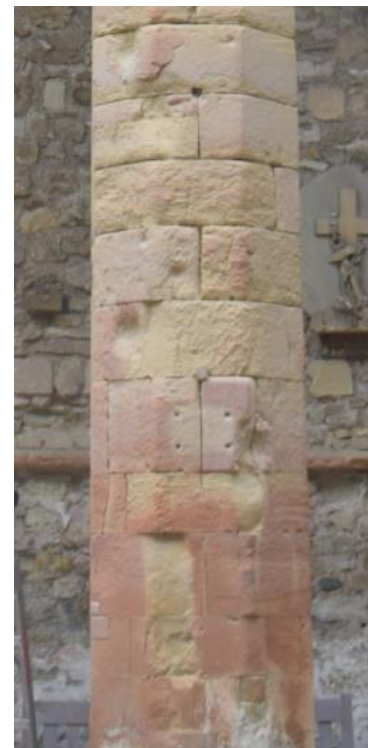
Figure 3.31: Images showing the different weathering formations dependant on face orientation.

North facing, black discolouration present in impact craters

South Facing, No black discolouration present in impact craters:

This disparity in the presence of weathering crusts in craters is possibly attributable to the lack of sunlight drying the north facing impact craters through evaporation of moisture. This is supported by the hypothesis for the formation of black gypsum crusts put forward by Rodriguez-Navarro and Sebastian (1996): A lack of solar heating and corresponding drying will allow the accumulation of greater moisture levels on North facing surfaces, which will then hydrate sulphur ions present on the columns due to air pollution and saline groundwater rise. This creates sulphuric acid, which then oxidizes to produce black gypsum crusts. These weathering agents will then precipitate as discoloured weathering crusts (Mol *et al*, 2017). Török (2007) notes that bubble or “framboidal” weathering crusts of black gypsum often form on stone surfaces under cover due to a lack of exposure to remove them. Macaluso and Sauro (1996) also record bubbling/blistering weathering formations associated with gypsum. Based on these observations, it seems likely that the black framboidal weathering crusts at the RGC are caused by precipitation of gypsum. The general scaling and flaking of the stone surfaces at the RGC are also highly consistent with the images of gypsum weathering presented by Farkas *et al* (2018) (figure 3.32). Gypsum weathering crusts are commonly associated with limestone buildings and could be due to atmospheric pollution, or to gypsum containing building materials present at the site, such as mortars (Kloppmann *et al*, 2011). Sulphates contained in sea-spray from the nearby coast at the RGC site will also contribute to the formation of these gypsum crusts (Montana *et al*, 2008). This is a notable observation because it demonstrates the interplay between ballistic impact and weathering processes. The impact craters act to allow the accumulation of weathering agents on north facing columns, causing the growth of gypsum efflorescence and leading to obvious damage to the aesthetic value of these regions of the church. This is clear evidence that ballistic impacts can exacerbate some aspects of weathering processes.

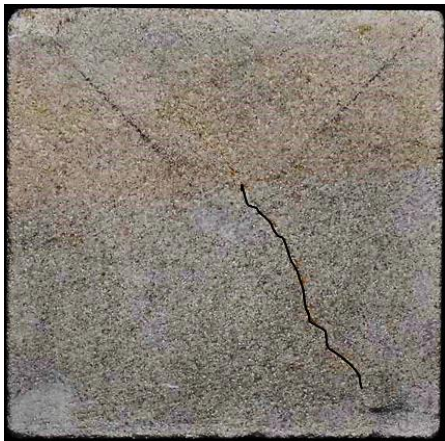
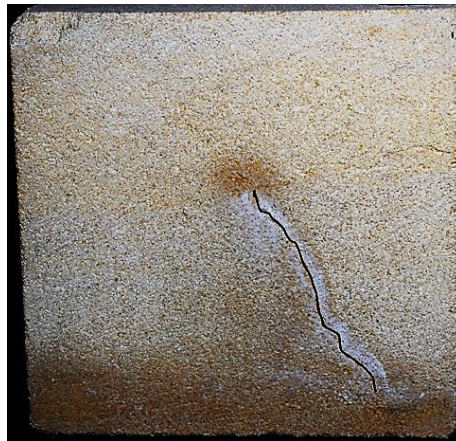
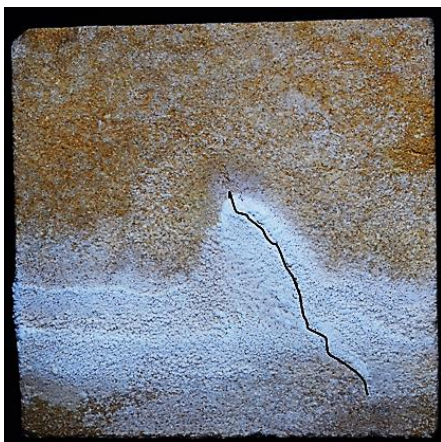
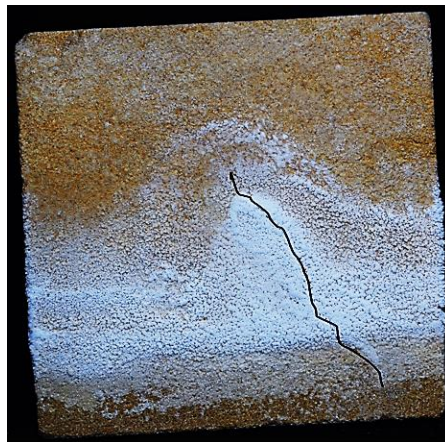
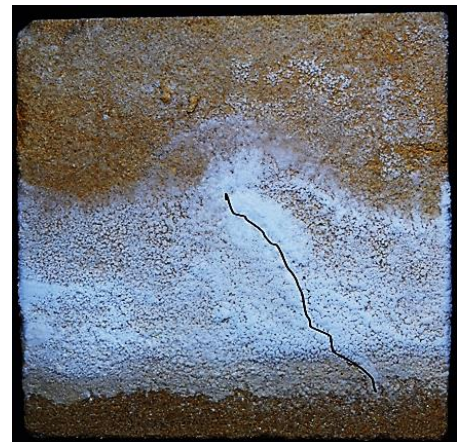
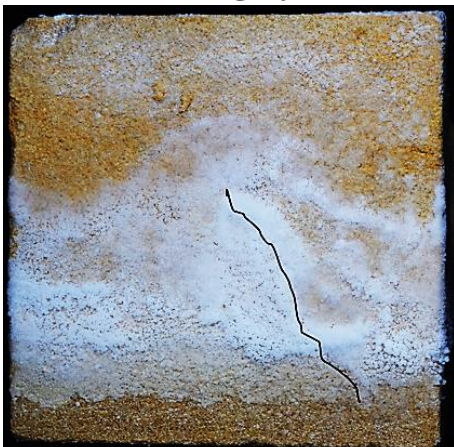
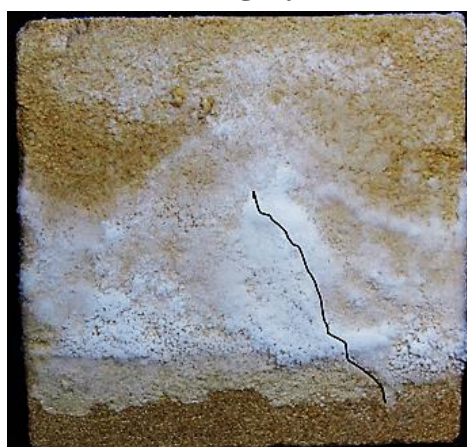
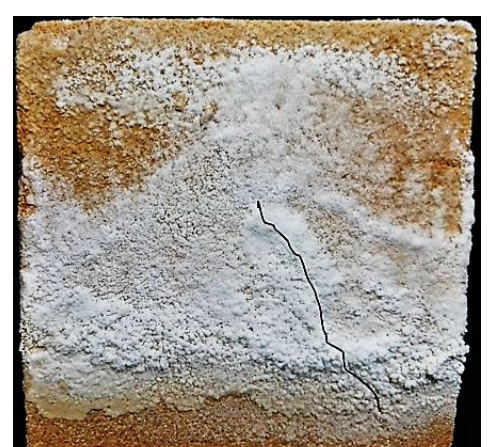
Figure 4.11: Progress of the weathering front and the growth of salt efflorescence on sample 1 side 4. Note that efflorescence can be clearly seen to occur preferentially along the fracture running from the centre to the bottom left of the block (highlighted in black), indicating greater penetration of saline solution into this fracture.

Inspection of the samples after weathering showed that the weathering regime had caused the accumulation of significant salt efflorescence. A notable trend is the obvious exploitation of fractures by the saline solution through the preferential accumulation of salt efflorescence along surface fractures (figure 4.11, overleaf). This lends support to the theory discussed throughout section 1.6 that fractures caused by ballistic impact are likely to exacerbate weathering processes through increased ingress of moisture and dissolved salts.

Figure 4.12 shows that after eight weathering cycles the efflorescence has spread from the base of side 4 to the top of the block, preferentially exploiting the large fracture. This demonstrates that capillary rise of saline solution along ballistic impact fractures facilitates rapid accumulations of salt efflorescence, which in a heritage context could deteriorate surface features such as carved detail or painted rock art. Furthermore, the widespread occurrence of efflorescence on the samples suggests that the weathering regimes designed for this study are a viable method of simulating haloclasty processes observed in arid environments. This is an important finding, because it shows that the weathering simulation methodology is effective and can be carried forward into the future experiments of this project.

with sample 2. This would result in greater precipitation of salt crystals in surface pores for sample 1, as seen in figure 4.18. Efflorescence exploiting fracture networks in sample 1 is also visible in the accumulation of salt crystals along fractures seen in figure 4.11. The model of NaCl depositions exploiting pre-existing fracture networks is also described in work by Warke, Smith and Lehane (2011).

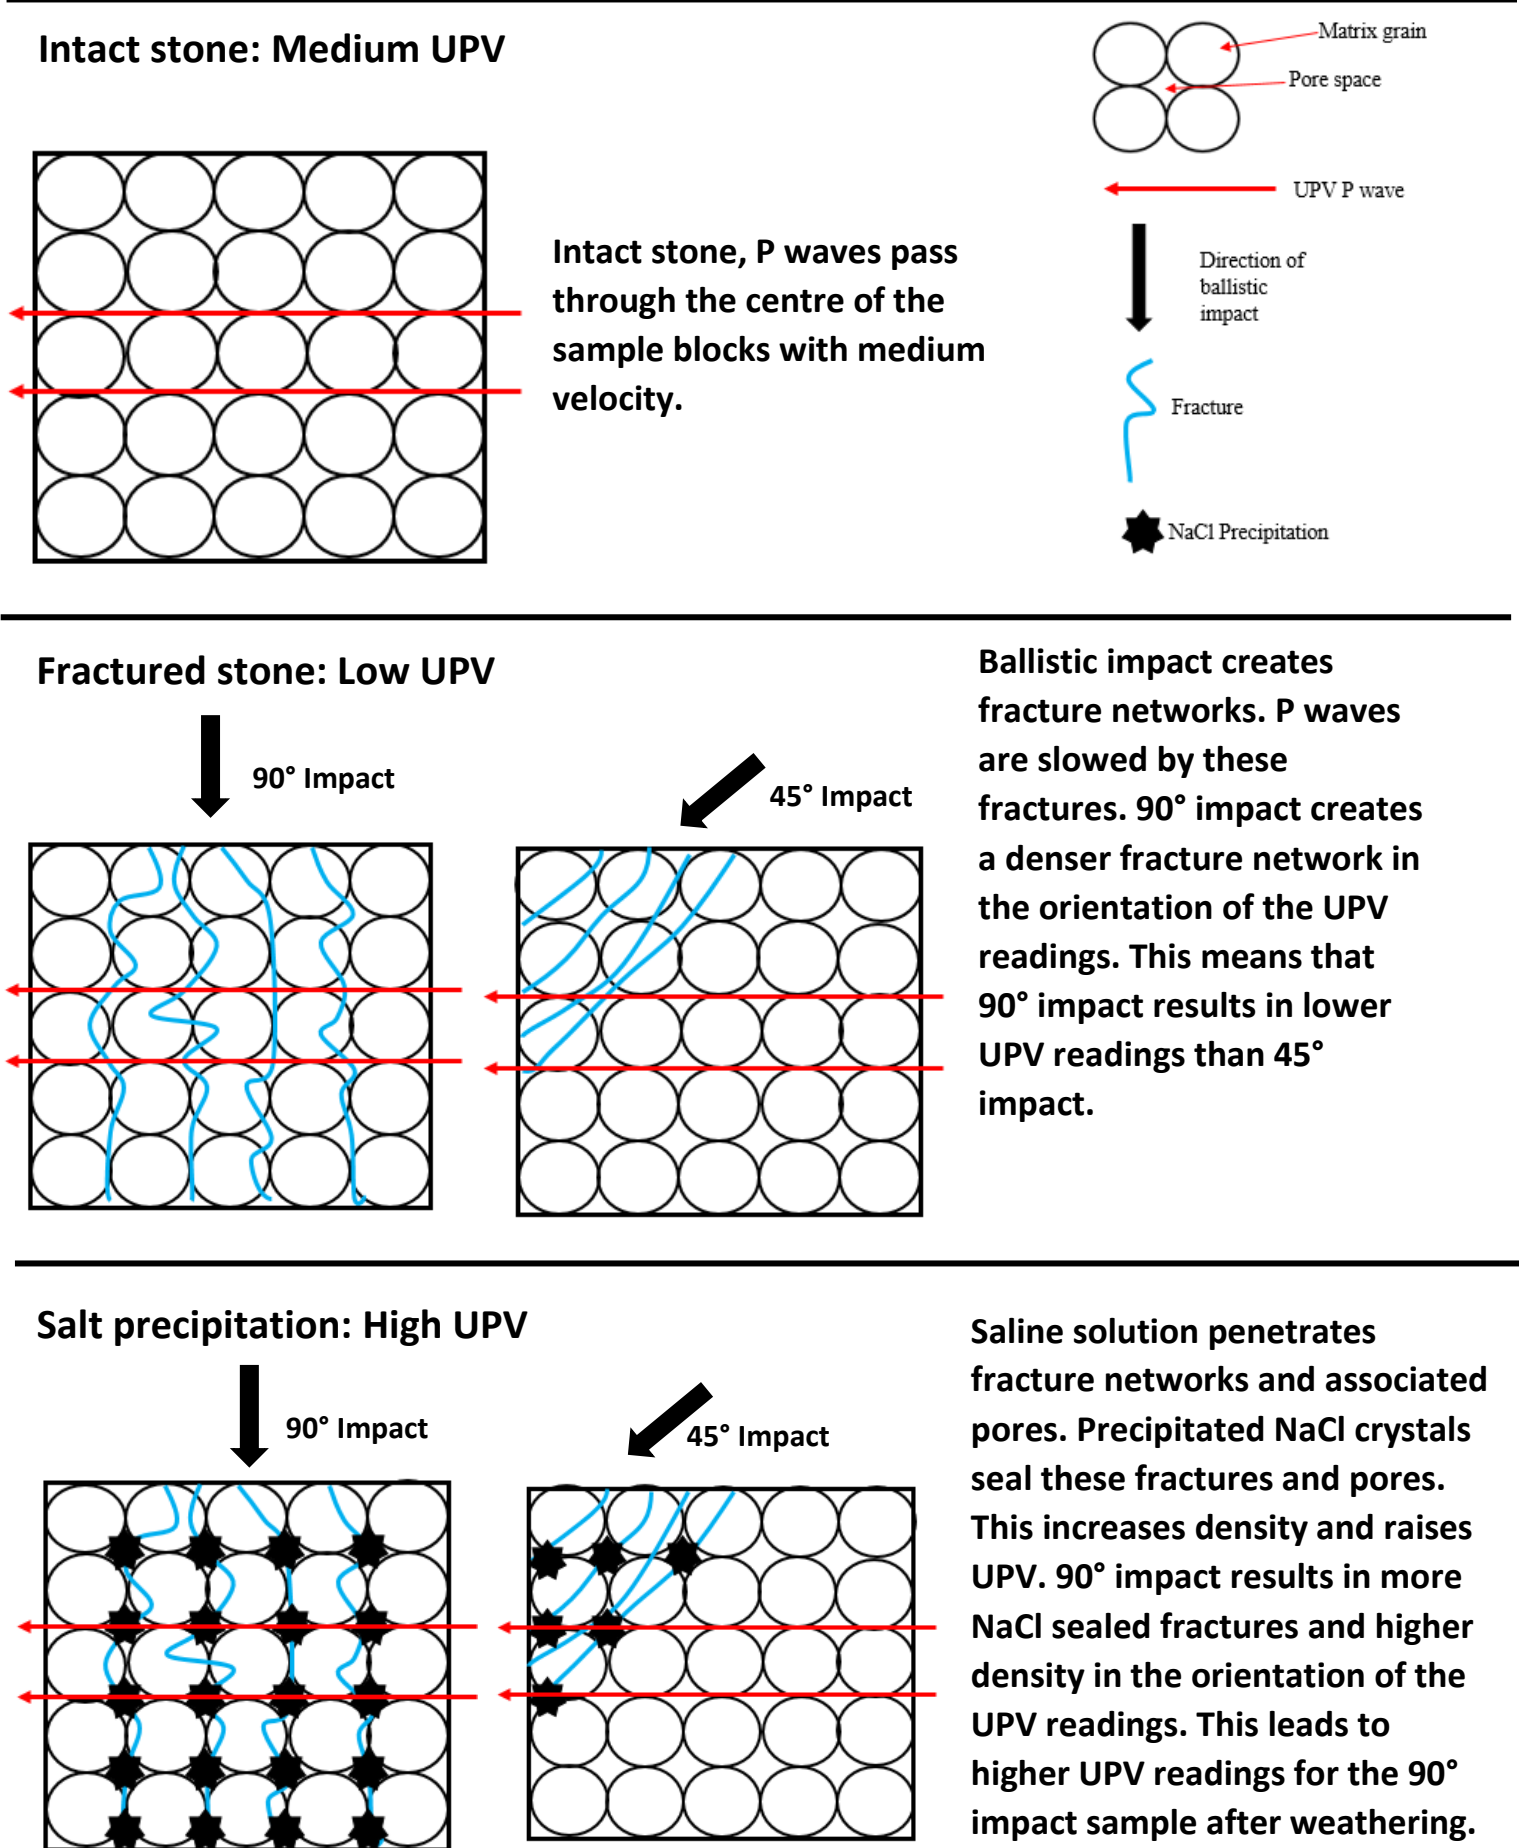
This figure, supported by the UPV results presented above, outlines the causal mechanism by which 90° ballistic impact creates a denser internal fracture network. This greater fracture density is responsible for faster uptake of saline solution observed through mass monitoring measurements, as discussed in section 4.4.4. It is worth noting that in a field setting, that an increase in UPV readings for weathered heritage stone above a known control value (i.e. for freshly quarried samples of a lithology known to be used in heritage buildings) could be used to infer a fracture network infilled with salt crystals. Contextual information would be necessary to assess whether this infilled fracture network was caused by ballistic impact, i.e. by recording the presence or absence of visible impact craters.

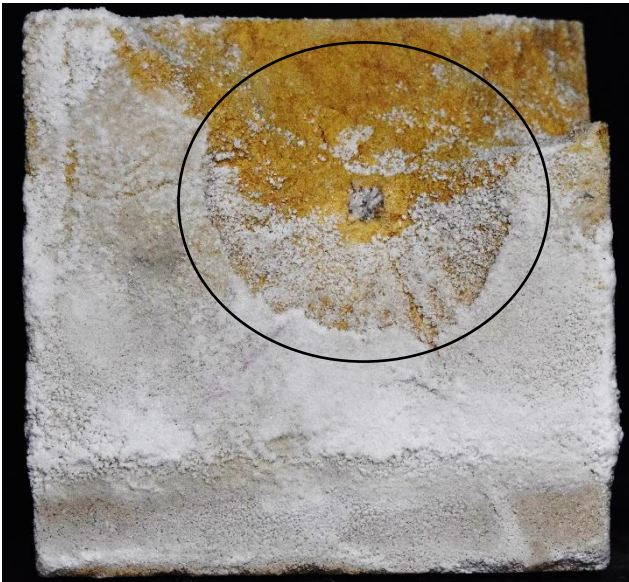
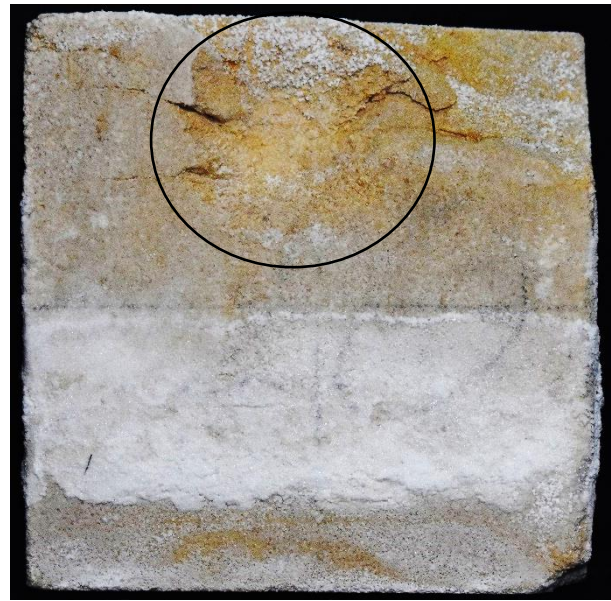
Figure 4.28: Images showing the greater level of salt efflorescence (white areas) in the impact crater (black circle) of sample 1 than sample 2. This is indicative of greater haloclasty in the impact area of sample 1, caused by a denser fracture network facilitating higher mobility of saline solution.

The hypothesis that the impact crater of sample 1 experiences more weakening due to haloclasty is supported by the level of salt efflorescence exhibited in the impact craters of the two samples (figure 4.28). More efflorescence is present in the impact crater of sample 1 indicating that saline solution is more able to access this crater and cause mechanical degradation.

In addition to the greater salt efflorescence coverage in sample 1's impact crater shown in figure 4.28 an increased level of haloclasty weathering in the impact crater of sample 1 is also evidenced by data from permeability analysis, as will be explored in the following section.

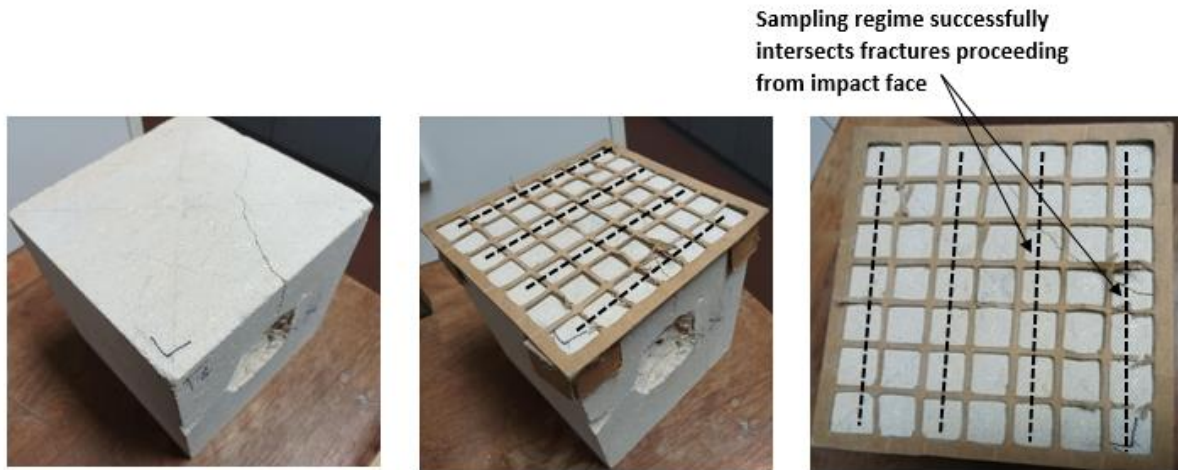
Figure 5.12: *The permeability sampling regime on non-impact sides, showing the 28 cells sampled and how they successfully intercept and detect fractures initiated on the impact face from the impact crater.*

Control measurements were taken using the methods outlined in section 4.1.1.2. Results from chapters 2,3,4 and 5 consistently show that increases in permeability are caused primarily by visible ballistic damage such as disaggregation and visible surface fracture networks, and also that surface fracture networks are initiated at the impact crater and propagate to non-impact surfaces from the impact face. If this hypothesis could be proven, it would allow faster assessment of the effect of ballistic damage on impacted stones' permeability by allowing survey to focus on the surfaces where impact occurred, and fracturing is most intense. Furthermore, Sections 2.6 and 3.4.5 highlighted the need to find a method of collecting permeability data that was rapid enough to be used in the field, but still produced data sets with a sufficient number of data points to give meaningful results. Therefore, the permeability survey needed to balance testing the hypothesis that surface fracture on non-impact faces is initiated at the impact face, and expedited data collection. To achieve this, after shooting, all 49 cells of the impact face were measured for permeability. On non-impact sides, permeability measurements were taken from the columns and rows of cells that would intersect any surface fractures proceeding from the impact face. This sampling regime gave 189 permeability measurements per sample, whilst still ensuring that any increases in permeability due to surface fracturing propagating from the impact face were identified and facilitating faster data collection. This permeability sampling regime is shown in figure 5.12:

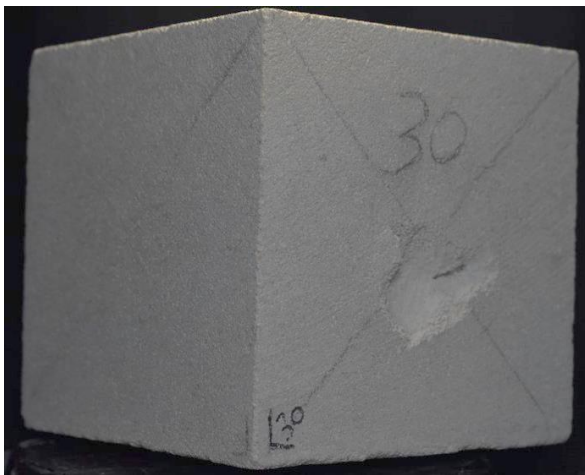
Figure 5.21: *Images showing that 5.56x45mm projectile impact at 45° excavate a longer, deeper crater across the sample than 7.69 x 39mm ammunition, damaging a wider area. Note the lead smearing (dark area) in the impact crater at the centre of the impact crater in the 7.62 x 39mm impact crater*

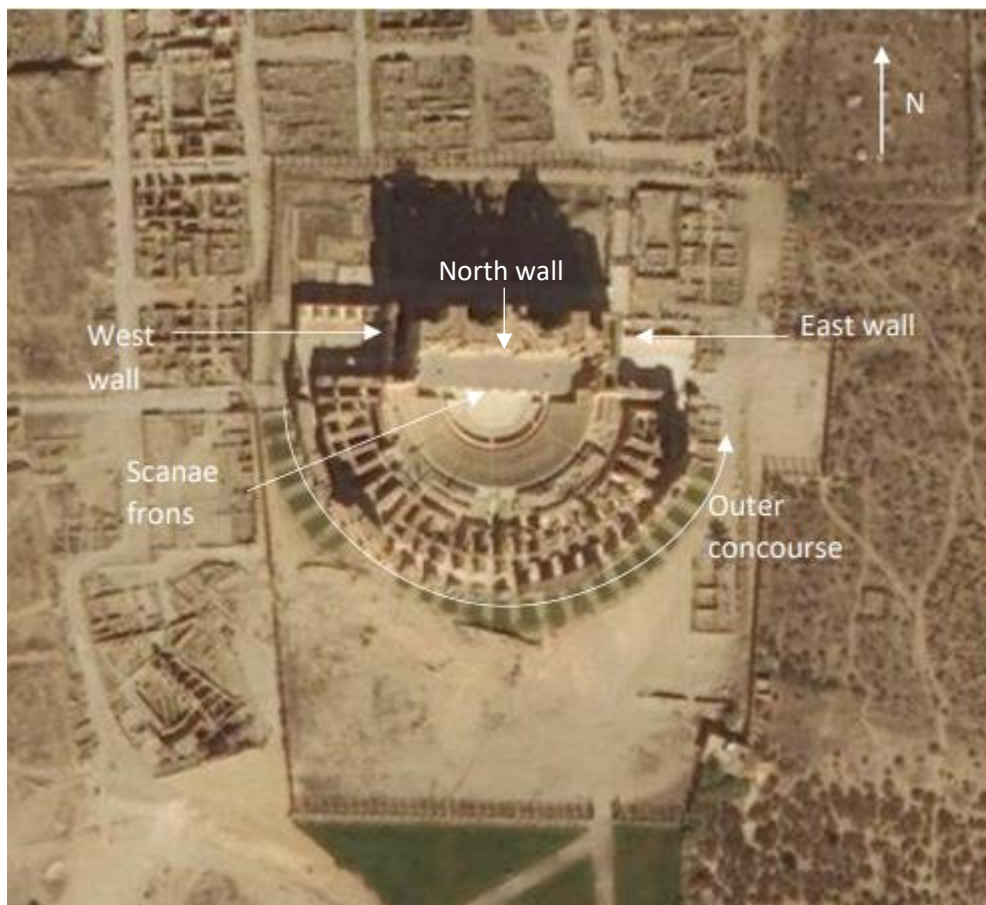
Figure 7.2: *The names used to designate regions of the amphitheatre where ballistic impact clusters were identified. (Adapted from www.bing.com/maps)*

Using images captured by a drone with a pre-programmed flight path, a 3D model of the amphitheatre was created by Patrica Voke, a member of the Sabratha Heritage Protection programme. Using this model, different areas of the amphitheatre were assigned group names, to allow for quick referencing of the location of impact clusters:

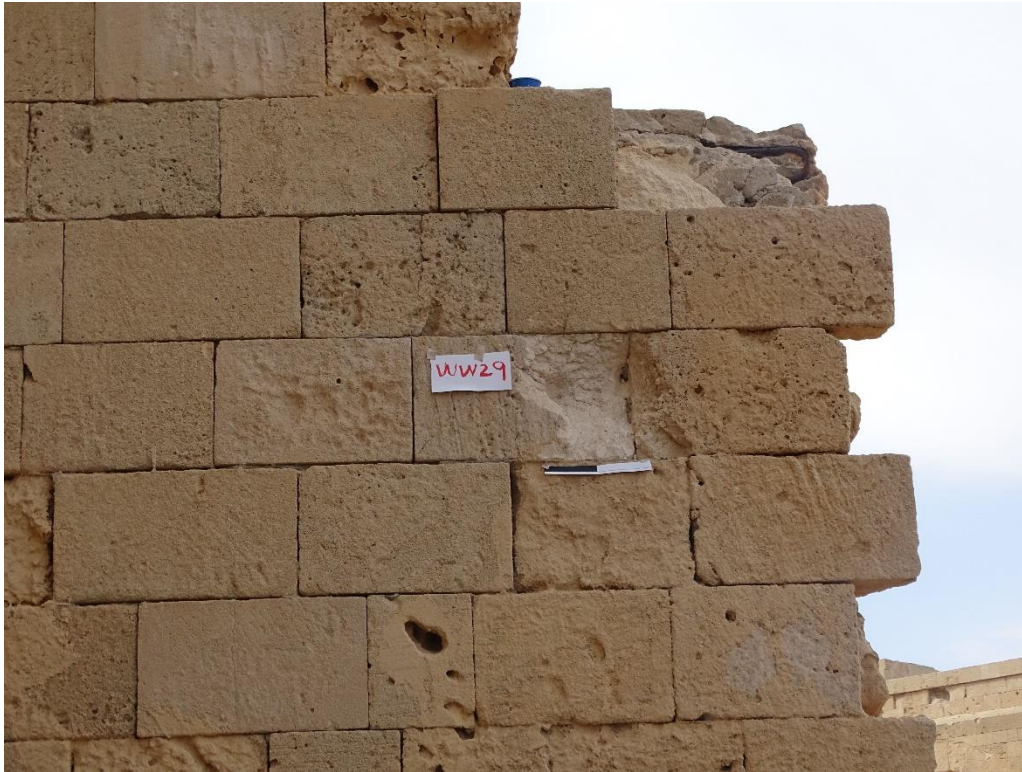
Figure 7.6: *A clear example of a ballistic impact crater present on the amphitheatre site (impact point WW_29) alongside obvious alveolar weathering of the stone surface arising from salt crystallisation processes. This image demonstrates why ballistic impacts are likely to exacerbate existing structural degradation.*

The monuments at Sabratha are primarily constructed from Gargaresh calcarenite, a bioclastic quaternary limestone with low compressive strength (5.6) Mpa, high carbonate content (>90%) and moderate to high porosity (9-17%). (El-Shahat, Minas, Khomiara, 2014, Abdalauh, 2011). Large pores in excess of 0.1mm allow rapid entry of water into the rock, and thus present a risk of weathering deterioration even prior to the introduction of ballistic fracture networks. In addition to the risks associated with the properties of the stone itself, investigations of weathering processes at the site have revealed blackening of stone surfaces associated with biofilm colonisation, whilst the primary cause of weathering deterioration has been identified as mechanical degradation occurring from crystallization of salts from saline sea-spray (figure 7.6) (*Ibid.*). High absolute temperatures at the site, as well as wide temperature fluctuations are likely to exacerbate salt weathering by aiding capillary rise and causing repeated precipitations of salt crystals (Abdalauh, 2011).

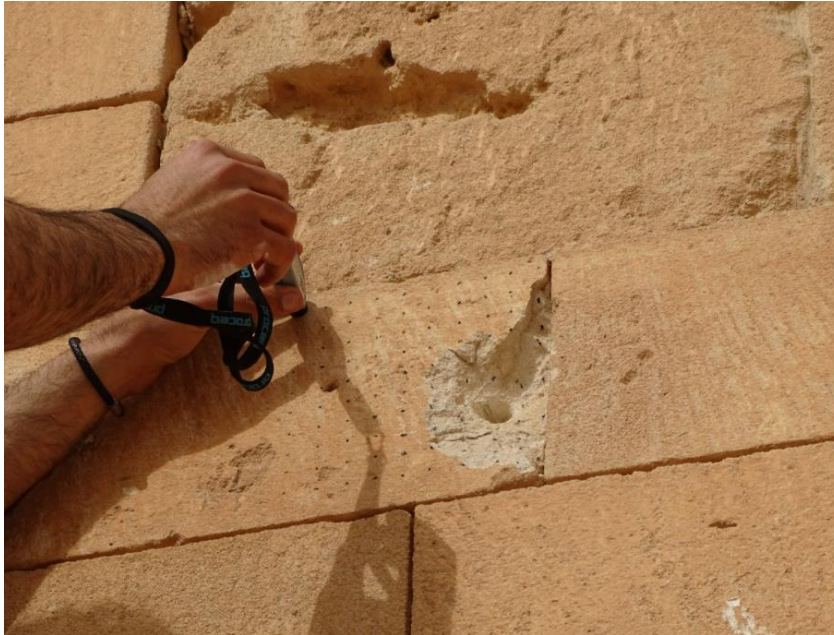
Figure 7.8: A pencil sampling grid on the amphitheatre wall and data Equotip data collection in progress.

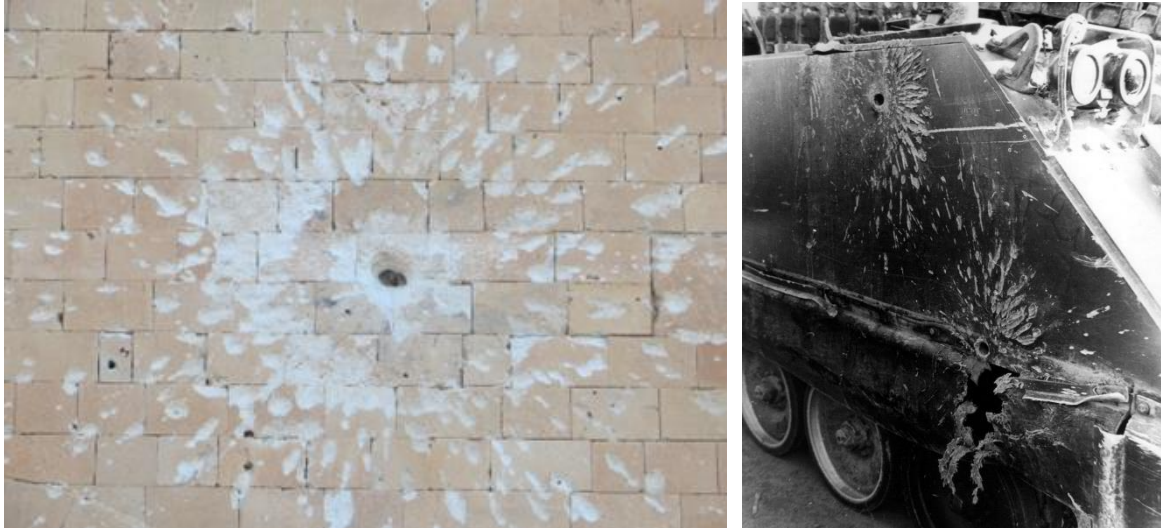
Figure 7.10: A comparison between the RPG impact on the East wall of the amphitheatre (A) (B) and HEAT warhead impact into an armoured vehicle from the Vietnam war. Adapted from Bryla and Starry, 1979.

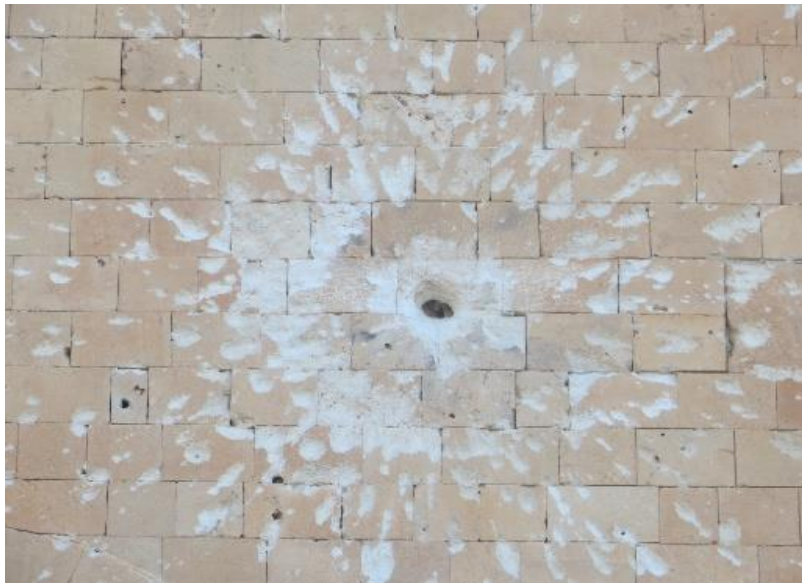
Figure 7.18: Radial scarring around the RPG Hit perpendicular to the central hole indicating the direction of travel of the RPG.

Also of interest is that the RPG Impact (EW_02) sees a lesser strength reduction than many other areas (-6.8%). This is thought to be because the radial scarring seen around the RPG hit is perpendicular to the wall surface and the direction of the RPG travel. This would mean that the shrapnel that caused that scarring “scraped” along the wall at an oblique angle, causing less of the kinetic energy of the shrapnel to be delivered to the wall, and thus resulting in a smaller reduction in hardness and corresponding weakening. This supports the findings of chapter 5 that angled impact results in less weakening than direct impact. However, the central block of the RPG hit has clearly been completely penetrated (figure 7.17), and although surrounding areas may have not been significantly weakened, this block is likely to be at risk of exacerbated further deterioration and structural weakening due to the large amount of material that has been removed/destroyed. Furthermore, the RPG hit has arguably caused the greatest spread of aesthetic deterioration at the site, as the radial scarring around the impact covers a large area (figure 7.7, figure 7.18).

The hardness readings allow us to identify that the western and eastern wall of the structure have been most weakened by the small arms fire, whilst the impacts on the outer concourse and scaenae frons have caused comparatively little weakening (figure 7.19). The hardness loss on the western wall is particularly pronounced, probably due to the presence of impact craters in plaster material used in restoration work. Therefore, future interventions may wish to target the western and eastern walls as a priority, especially as the RPG impact to the eastern wall has caused massive damage to the central block and widespread aesthetic damage, although outlying areas of the RPG impact seem to have experienced relatively little weakening (figure 7.15, figure 7.18).

Impact	lithology/material and wave impedance?	Efflorescence Visible at impact site?	Known sources of weathering salts at site (e.g. coastal)?	Impact Angle?	Projectile Construction?
WW_23	Plaster (relatively low wave impedance)	No	Yes	Normal	Unknown
EW_02	Stone (relatively high wave impedance)	No	Yes	Oblique (shrapnel ricocheting along target surface, see figure 7.18)	Unknown

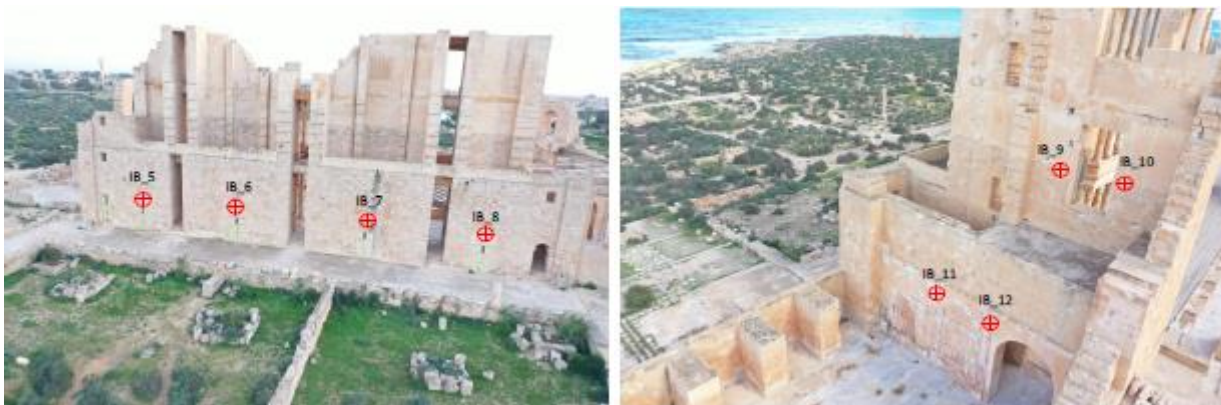
Figure 7.21: *Locations of temperature sensors (North Wall) IB 5 and IB 10 (West wall).*

Conversely, sensor IB 10 which was on a thin portion of the western wall, and therefore the east facing portion of this wall experiences direct sunlight until 12:00, at which point the west facing portion of the wall experiences direct insolation (figure 7.22). Given that this thin section of wall is likely to be exposed to sunlight throughout the day it is likely to see the greatest heating, this is supported by the Ibutton temperature data, which shows that IB 10 placed on this section of wall experiences the highest temperature variation.

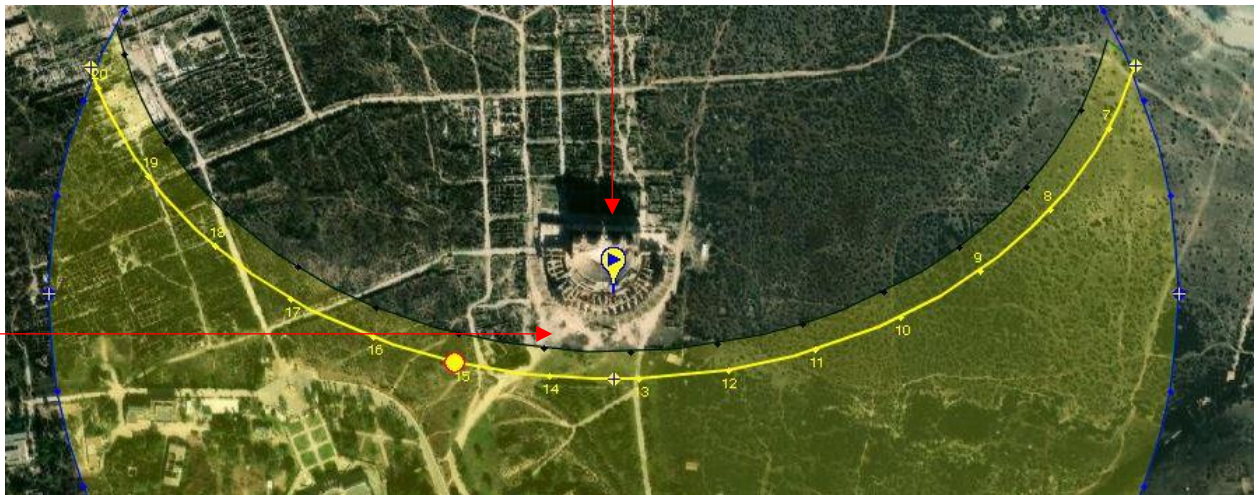
Figure 7.22: Plot of the sun's course relative to the centre of the Sabratha amphitheatre on 27/07/2021 with location of sensors. Adapted from sunearthtools.com.

North facing location of IB 5
in shadow zone- low
temperature variation

West facing
location of IB
10, constant
west wall on
both sides of
thin wall, high
temperature
variation.

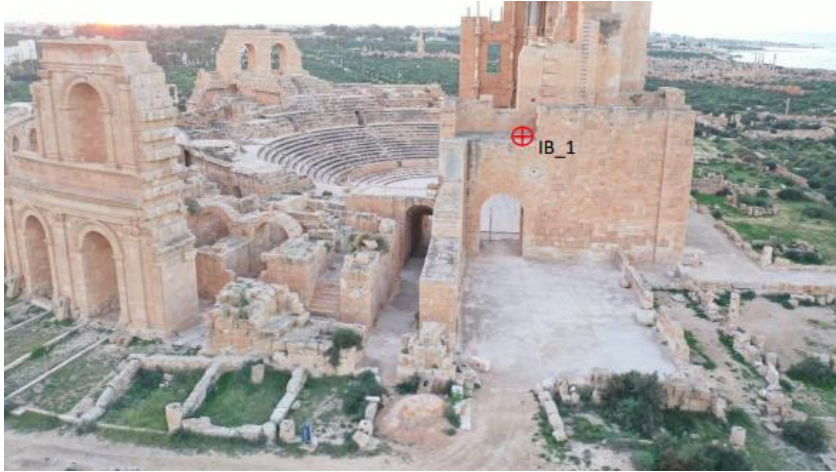
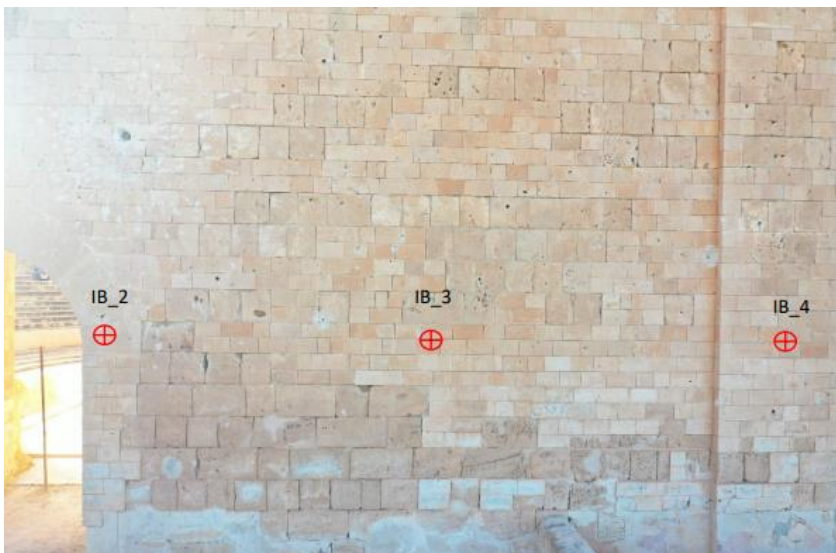
East wall:

Appendix B: Locations of Ibutton temperature sensors around the Sabratha amphitheatre site
