The impact of vibration on comfort and bodily stress while cycling

John Parkin, Professor of Transport Engineering, University of the West of England Eugénie Sainte Cluque, Student, London South Bank University

This paper reports preliminary work to understand the nature of vibrations from riding a bicycle and how these may impact on human comfort and bodily stress.

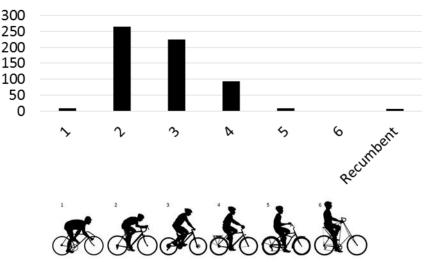
Figure 2 Riding position

The majority of respondents report adopting riding position 2 or 3, and both of these positions place greater force in supporting body weight through the hands and arms than do the higher numbered riding positions. Table 3 shows the materials of the bicycles ridden by the respondents and the type, if any, of suspension.

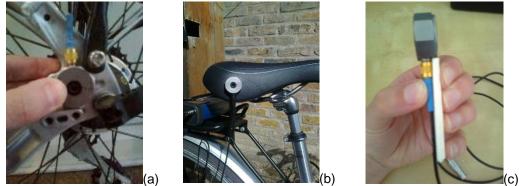
Figure 4 Fixing to frame at rear axle (a), to saddle (b) and wooden lathe supporting the cable (c)

The sensitivity of the accelerometer is designed for measuring vibration in buildings, which is of low amplitude. Consequently, the highest peaks of amplitude were in 'overload'. The positioning and fastening of the accelerometer to be secure and to keep true to the reference z-axis was also an issue because the connection of the frame to the back wheel did not have a platform large enough for the meter, and the seat post is at an angle of between 22° and 25°. The position at the saddle had to ensure that the meter was not in contact with the rider. Figure 4 shows the fixing positions at the rear axle and on the saddle, together with the wooden lathe that secured the cable so that it did not interfere with readings.

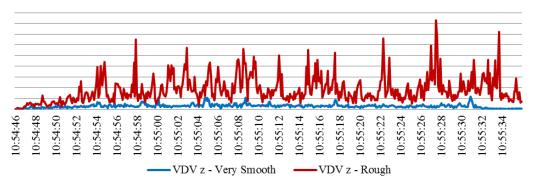
Figure 5 VDV of 100ms integrations over a 50 second measurement at seat post for Bicycle One with suspension seat post for very smooth and rough roads

Figure 5 is the time history plot of 100 millisecond integrations of VDV values over 50 seconds for the z-axis for Bicycle One with a suspension seat-post with the accelerometer placed on the seat-post for the two extreme conditions of a very smooth and a rough road.

We have not provided a vertical scale to Figure 5 because the issues of overloading of the accelerometer that we used, but the estimates are appropriate for comparison purposes between the two conditions. Figure 5 confirms that the vibration induced by a rough surface is made of a series of impacts with great variation in amplitude with a number of occasional very large amplitude 'shocks' and 'transient vibrations'. The vibration induced by the smooth surface is relatively low and consistent. Different grades of road surface may require different averaging methods: VDV for rough surfaces and r.m.s for smooth surfaces. However, such an approach would make comparisons difficult.

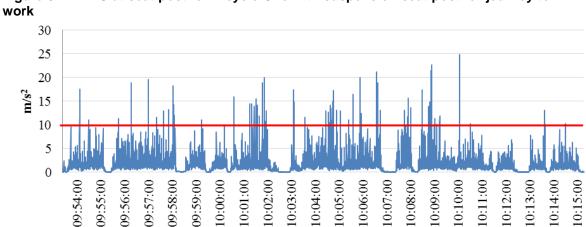
Figure 6 RMS at seat post for Bicycle One with suspension seat post for journey to

Figure 6 shows the time history for a commute to work by one of the authors (ESC) of duration 21 minutes.

It may be seen in Figure 6 that the road surface is variously uneven and then even for short sections, with different degrees of defects up to the category 'rough' for the majority of the journey. There a large number of peaks in excess of 10 m/s^2 , which is an acceleration known to damage heath (Griffin, 1994). Considering that this journey in ridden six times a week by the author (ESC), this finding reveals cause for concern.

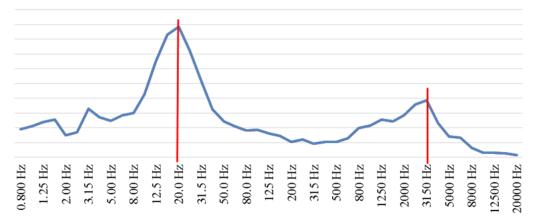
Figure 7 Seat post r.m.s per third octave frequency spectrum Bicycle One with suspension seat-post and gel saddle

Frequency spectrum analysis has been undertaken to identify resonant frequencies of the Bicycle One/Rider system. Figure 7 shows the frequency spectrum of the r.m.s. acceleration amplitude at the seat post with suspension and a gel saddle, and experienced on the journey to work. Figure 8 shows the same, but for the saddle.

In Figure 7 there is a resonance at 3.125 kHz but none at this frequency in Figure 8. This tends to confirm that the gel saddle has a high degree of absorption of vibration, for which it was designed, and it can be argued that other saddles might present a different profile and therefore the frequency spectrum should be observed over a larger range than just up to 400Hz.

Figure 7 and 8 show distinct resonances below 400 Hz. Where the accelerometer is placed on the seat-post, the resonance is at 20 Hz, which coincides with the natural resonant frequency of the head: 20 to 30 Hz (Bruel & Kjaer in Peters et al., 1996). Where the accelerometer is placed on the gel saddle, the resonance peaks at a lower frequency: 16 Hz. No measurement was taken at the saddle on Bike 1 with the original setting of fixed post and basic saddle (this was the condition in which a severe headache had been experienced). Nonetheless, it is reasonable to assume that the system has a similar resonance at the seat post, and the reduction of the severity of the headache might be due to a significant shift of the resonance due to the greater absorptive nature of the gel saddle, as much as a reduction in amplitude of vibration.
