The opportunities and challenges of improving the condition and sustainability of an historic building at an international tourist attraction in the UK

Author: Dr Samantha Organ

The University of the West of England, Bristol

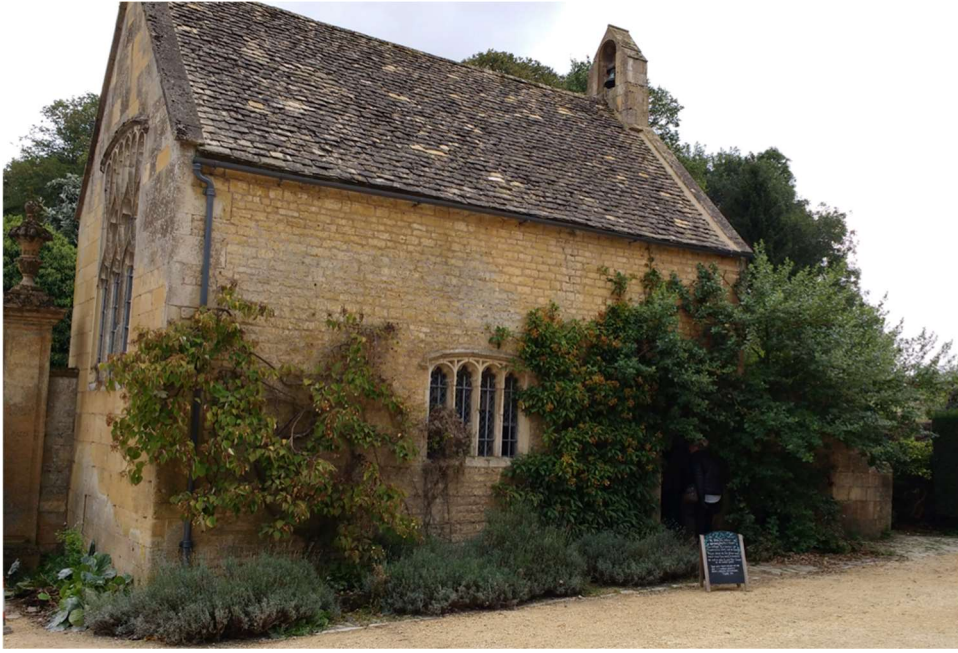
Figure 1: northwest and northeast elevations of chapel

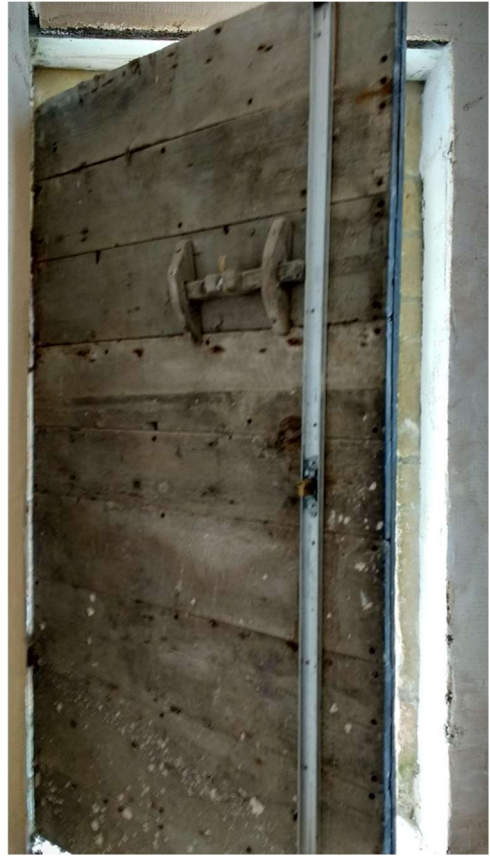
Figure 3: Chapel door internally

When the door swung inwards it pressed into the new lime plaster. Consequently, the main contractor tapered the lime plaster to avoid constant damage from occurring. The alternative would have been to alter the original door and opening which was decided to be inappropriate from a conservation perspective, as this contributed to the overall narrative of the building.

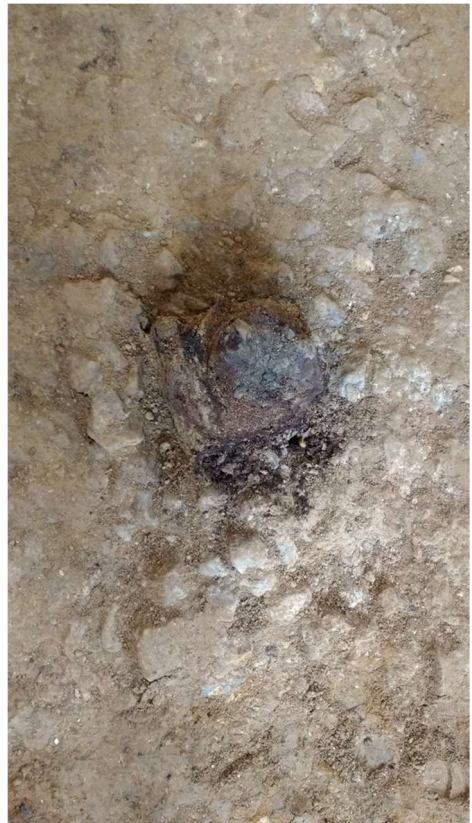
Figure 6: Chapel floor with existing timber posts

Timber inserts were positioned above the original timber posts which were found during floor excavation (Figure 9). These timber inserts reflect the history of the building with its changing uses, providing visitors with opportunities for narrative encounters and ‘place-making’, through the representation of a timeframe (Newman, 2016) both spatially and temporally (Jamal and Hill, 2004). This representation of time and space as part of the narrative is important. It is an attempt to (1) avoid a reductionist approach by prioritising space over time, which thus represents a place with a series of discontinuous events, (2) provide visitors with objective, constructive and personal authenticity (Jamal and Hill, 2004), and (3) enable the creation of a functional, adaptable space. It was considered particularly important to feature the brick floor with timber inserts to represent the changes the chapel underwent under Johnston.

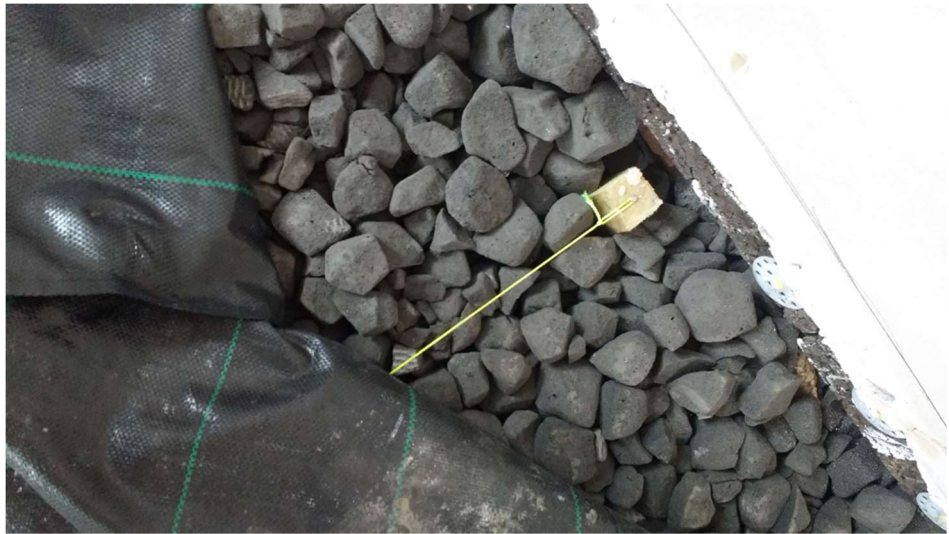
Figure 7: Chapel floor insulating hardcore

that, unlike traditional hardcore, individual pieces had a diameter of between 20mm and 40mm (Interviewee C1) (Figure 7). To reach the manufacturer's designated compaction ratio of 1.3:1 the contractor spent two hours with a vibrating-plate compactor across the floor. However, there was concern that the insulating hardcore had slight movement when the project team walked across the surface. Where hardcore is insufficiently compacted, it will settle over time (Holland, 2012) and can result in cracking occurring in the screed (Pye and Harrison, 2003). On liaising with the manufacturer's technical team, a technical video with the wider project team, and the insulating hardcore was compacted for a further two hours with the geo-textile placed between the hardcore and vibrating-plate compactor. This sufficiently stabilised the hardcore in preparation for the underfloor heating pipes in clips to be laid. The video also highlighted that the lime screed (Figure 8) specified was thicker than traditional screeds. This additional time required in inspecting the insulating hardcore and liaising with the contractor and manufacturer is the risk identified by Pulaski et al. (2006) that unfamiliar products can lead to inefficiencies in the construction process.

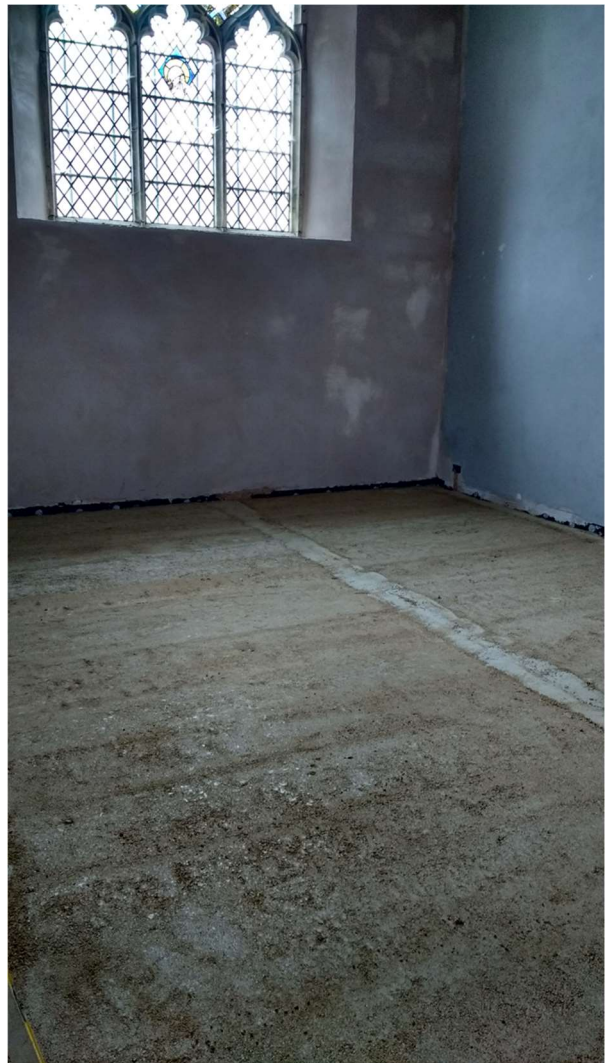
Figure 8: Chapel floor lime screed

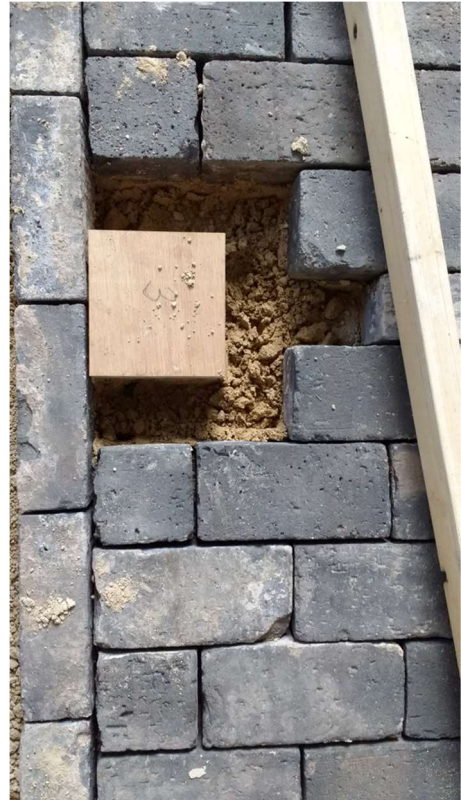
Figure 9: Relaid brick floor with timber inserts above original timber posts discovered during excavation
