# Bullet impacts and built heritage damage 1640–1939

## Abstract

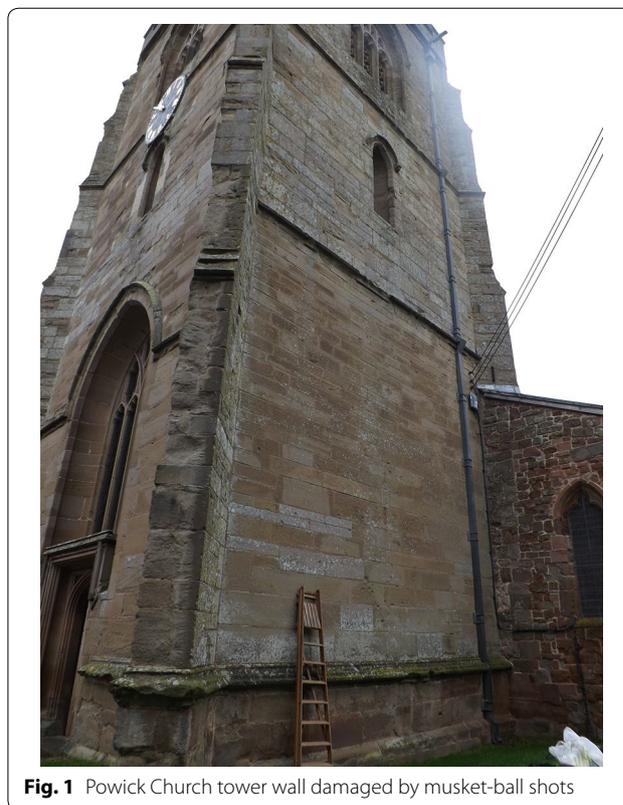
**Fig. 1** Powick Church tower wall damaged by musket-ball shots

Scottish troops exploited the elevated position of the church to observe the surrounding countryside, but were discouraged from continuing to do so by musket-ball shots fired by the approaching Parliamentary troops ([16] p. 75–78) using either a matchlock or a flintlock musket [17]. Figure 1 shows an overview of the affected wall. Though not clearly visible in this image, the majority of the musket-ball pockmarks are located at the height of the ladder and above.

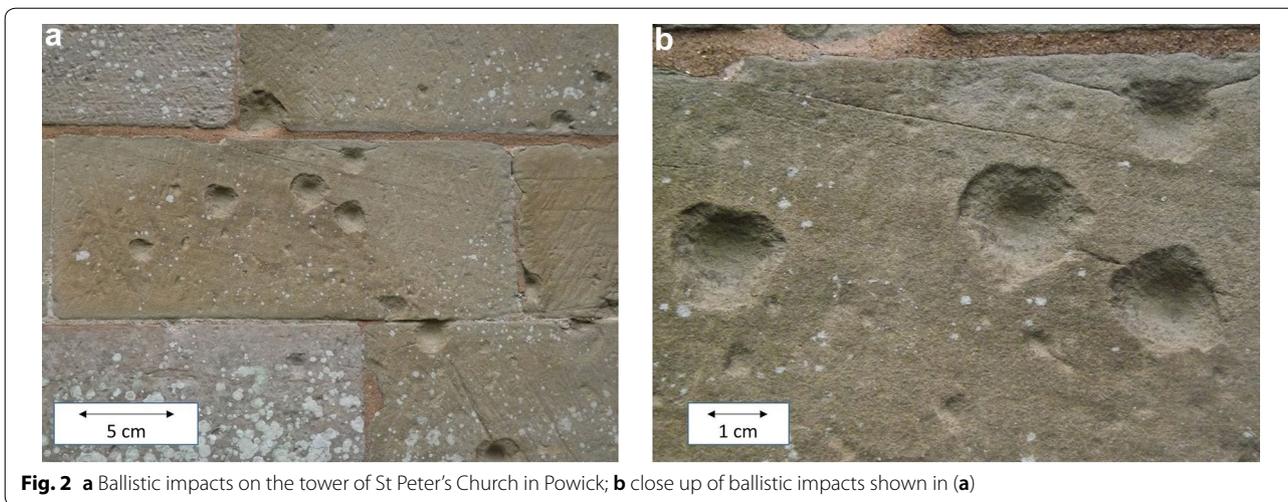
**Fig. 2** a Ballistic impacts on the tower of St Peter's Church in Powick; b close up of ballistic impacts shown in (a)

A closer look at these pockmarks shows the relatively limited damage 17th century ammunition inflicted on sandstone (see Fig. 2); the indentures of the musket balls are visible as a concavity in the stone surface with a deeper direct impact centre surrounded by a more shallow removal of materials at the near-surface.

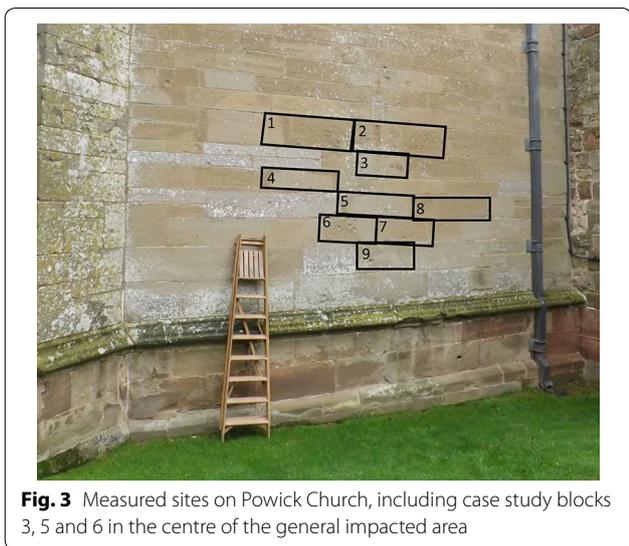
**Fig. 3** Measured sites on Powick Church, including case study blocks 3, 5 and 6 in the centre of the general impacted area

To understand what effect ballistic impacts from the 17th century have on the deterioration of the stone, rock surface hardness (RSH) measurement surveys were carried out across nine impacted building blocks (see Fig. 3). These blocks represent a range of impact densities, from a single impact on a block (block 8) to six impacts within short distances of each other (block 6).

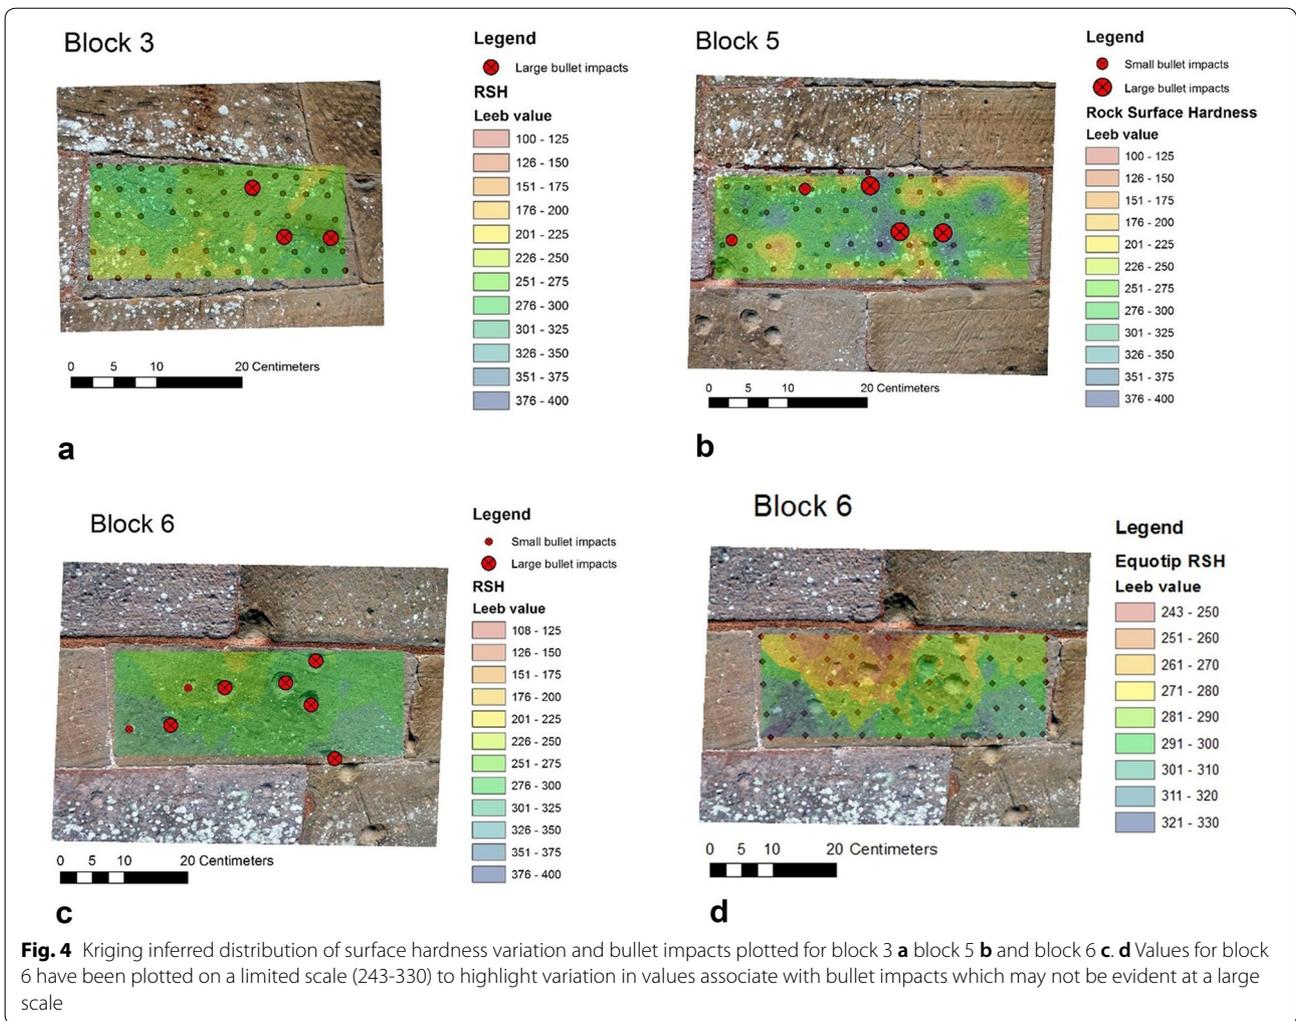
**Fig. 4** Kriging inferred distribution of surface hardness variation and bullet impacts plotted for block 3 **a** block 5 **b** and block 6 **c, d** Values for block 6 have been plotted on a limited scale (243-330) to highlight variation in values associate with bullet impacts which may not be evident at a large scale

For this study, three of the blocks were selected for further analysis, representing low number of impacts (block 3), mixed small and large impacts (block 5) and high density of large impacts (block 6) to illustrate spatial patterns in surface hardness associated with ballistic impacts. Figure 4 shows the results for all three blocks.

As illustrated by Fig. 4a, relatively little variation in surface hardness measurements is exhibited on block 3, which received only three large ballistic impacts. In fact, the areas directly surrounding the impacts appear a little more robust than the areas further removed from the impact. The majority of the deterioration appears to have taken place towards the bottom-left of the block, which could be associated with deterioration patterns often observed in sandstone building stone based on moisture movement through the blocks [28] at the intersection between porous stone and mortar [29]. The more remarkable observation is that the areas where the bullets have impacted appear to have strengthened, rather than weakened. This same pattern is repeated at block 5, where areas of most severe weakening are outside of the impact zones. It is likely that this is a function of the flexural strength of the sandstone and the nature of a musket ball, which lacks the energy density of point-tipped contemporary projectiles, such as the  $7.62 \times 39$  mm bullets commonly used in AK-47 and other assault rifles,

However, when ballistic impacts are closely spaced together there does appear to be a more focussed deterioration, as demonstrated in block 6 analysis (Fig. 4c, d). As shown in Fig. 4d, which was plotted on a limited Leeb hardness scale to reflect variations within the individual block, the areas immediately surrounding the large impacts have deteriorated further (Leeb values ranging from 243 to 290) than the areas towards the bottom of the block (Leeb values ranging from 280 to 330). This leads to the hypothesis that low-impact ballistic damage in principle does not cause extensive weakening of the surface; in fact, a singular impact could exhibit strengthening rather than weakening of the surface, though this is measured through about 350 years of exposure, but that clusters of low-impact damage do lead to enhanced deterioration of structural strength of the block and therefore need to be assessed as a potential conservation risk.

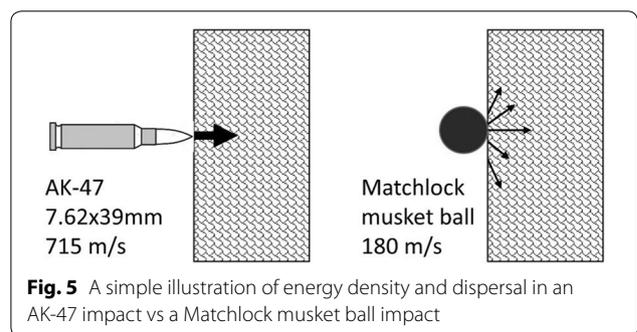
**Fig. 5** A simple illustration of energy density and dispersal in an AK-47 impact vs a Matchlock musket ball impact

as illustrated in Fig. 5. The matchlock muskets used in the Civil War only had an effective range of 183–380 m and swiftly lost velocity [30] having reached a maximum speed of 180 m/s [31]. As Powick Church is in an elevated position it is likely that the Parliamentary soldiers had to fire up slope, which would have further decreased the damage potential of the ballistics.

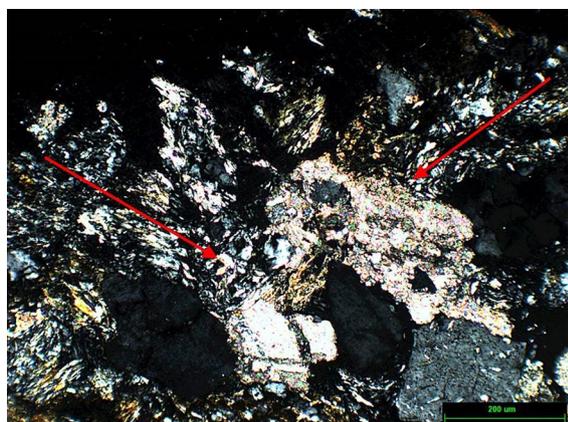
**Fig. 6** Realignment of clay matrix within sandstone upon impact of a ballistic

in a process comparable to that observed in the simulation tests of .22 calibre lead bullets on a similar sandstone surface in previous research [10]. Surprisingly, this could indicate that a singular impact point from a low-impact projectile (such as a musket ball) could actually be stronger than the material surrounding it.

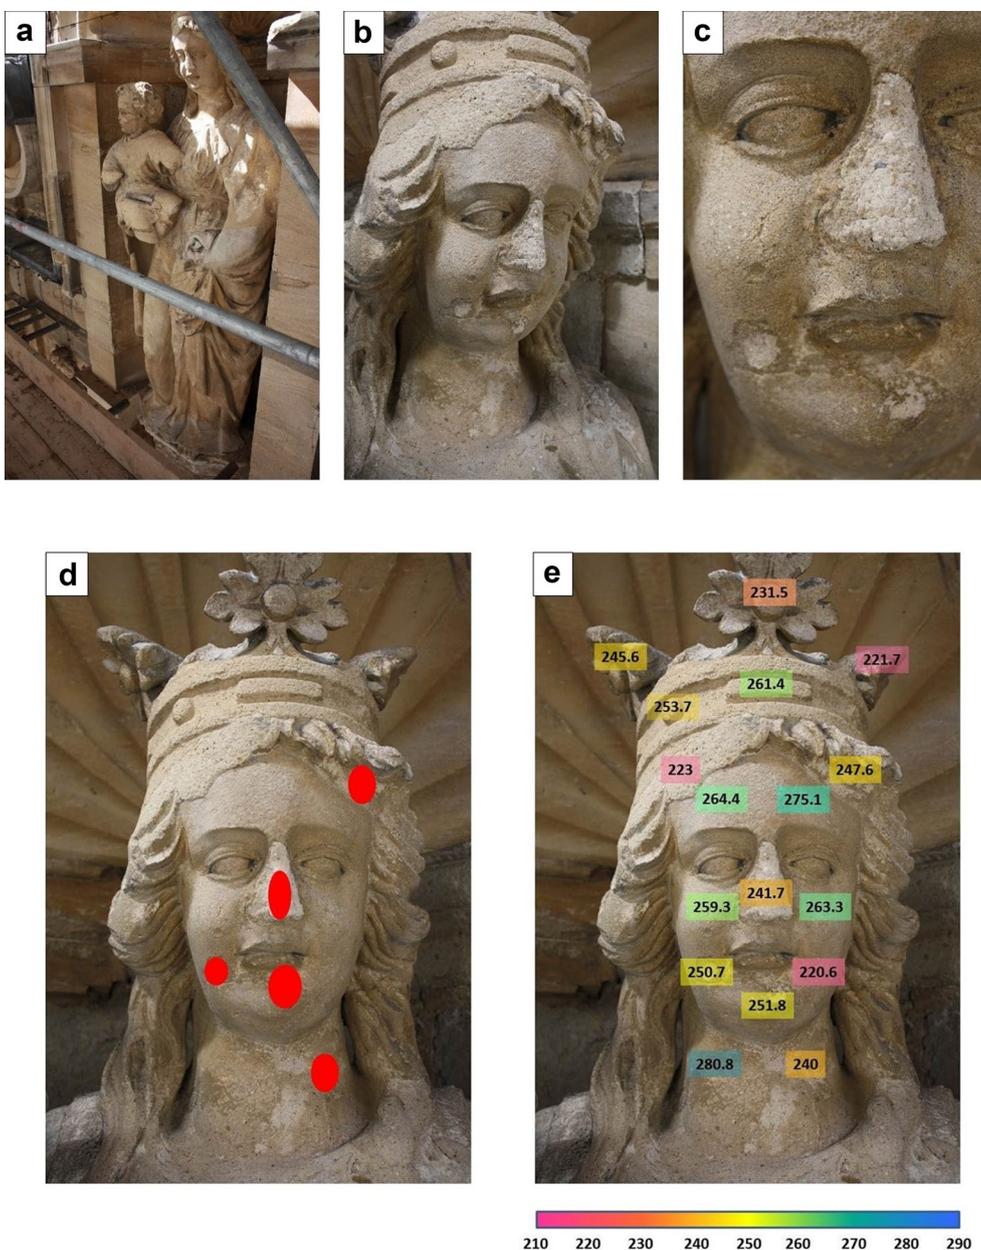
**Fig. 7** **a** Overview photo of the statue. **b** Damage to head and neck of the statue. **c, d** Sites of suspected ballistic impacts. **e** Rock Surface Hardness (Leeb values) results, n = 10 per site

As shown in Fig. 7c, d, there is no obvious visual pattern of accelerated deterioration of the impact zones. On the neck of the statue, the impacted side (right, Leeb

value 240) shows noticeably lower Leeb values than the non-impacted side (left, Leeb value 280.8). This trend reverses on the chin and lower cheek, where impacted areas measured were higher on the impacted side than the non-impacted side. However, when the variability of the measurements is taken into account as an indicative factor in weathering progress [42] with higher standard deviations indicative of relatively more intense weathering of the surface, three distinct groups of measurements emerge; as Fig. 8 shows, group 1 consists of high

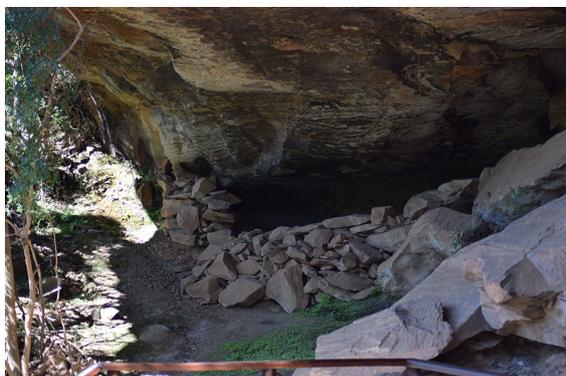
**Fig. 10** **a** Overview of the site, **b** therianthropes (half-human, half-antelope), hartebeest and hunters with bullet damage, **c** close up of bullet damage shot at approximately 135° angle relative to rock face, **d** close up of bullet damage shot at approximately 90° angle relative to rock face

Due to the sensitive physical and social nature of San Rock Art it was not possible to acquire measurements at this site. However, visual analysis shows that the soldiers were likely standing directly in front of the left hand side of the large panel, shooting directly at the large eland (Fig. 10d) where energy appears to have dissipated from a central point, as illustrated in Fig. 11a. In contrast, the therianthropes (Fig. 9c) appear to have been shot at from a more sideways angle (approximately 135°), as evidenced by the elongated impact (Fig. 11b). Visual comparison indicates that bullets shot at this kind of angle tend to ‘gouge’ the rock face, leaving a deeper indentation than those bullets shot at a 90° angle and potentially leaving the surface more vulnerable to deterioration.

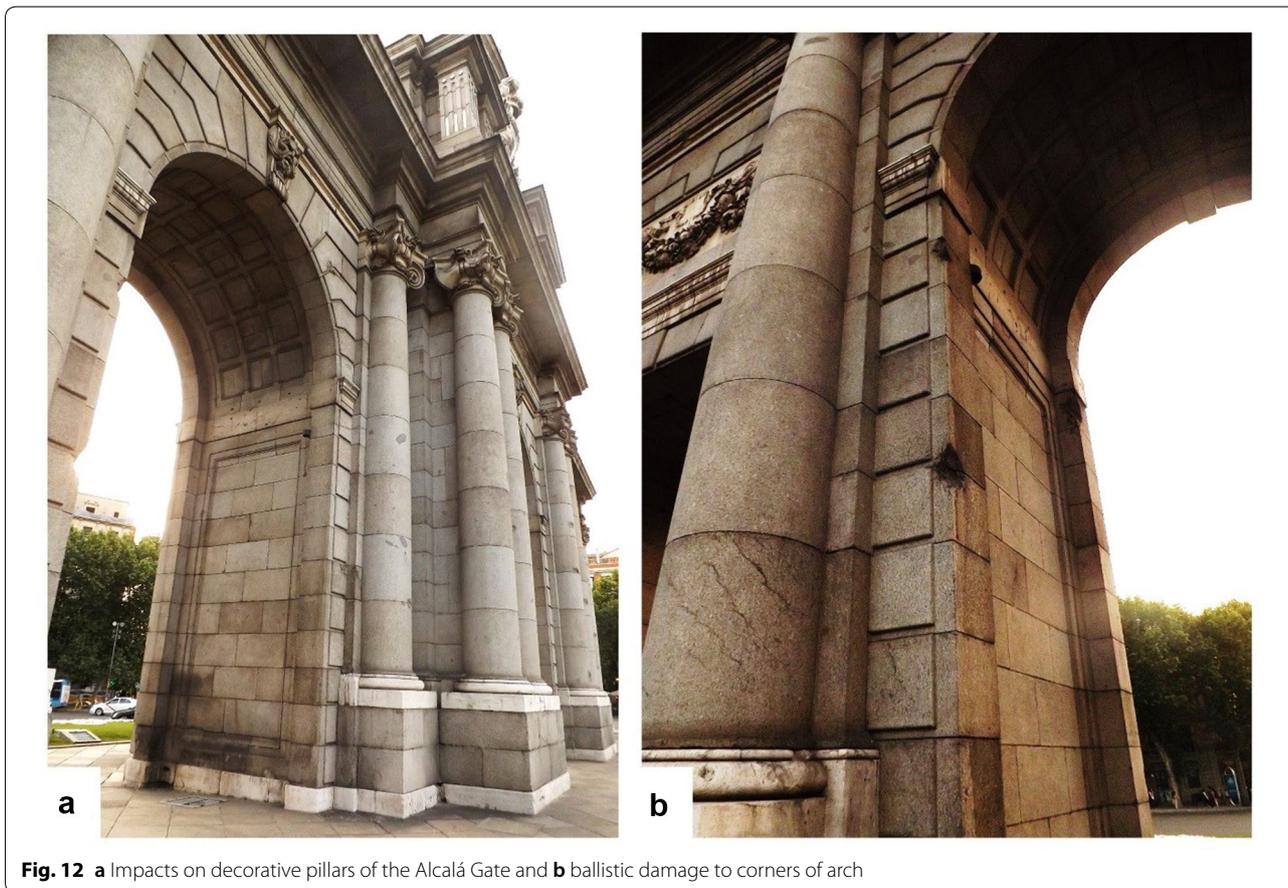
**Fig. 13** Overall view of an area of the building showing ballistic impacts

commissioned as the architect of several buildings in this new Campus, including the School of Medicine [53]. The School of Medicine was built between 1930 and 1935 and the Spanish Civil War commenced shortly after the building was finished. The university campus was assaulted between 15 and 18 November 1936 and was part of the battlefield throughout the rest of the war (1936–1939). Consequently, the building was severely damaged. Between 1941 and 1945 the damaged sections of the building were repaired, or where necessary rebuilt, by Miguel de Los Santos, incorporating bullet and shrapnel impacts across the whole building façades (see Fig. 13).

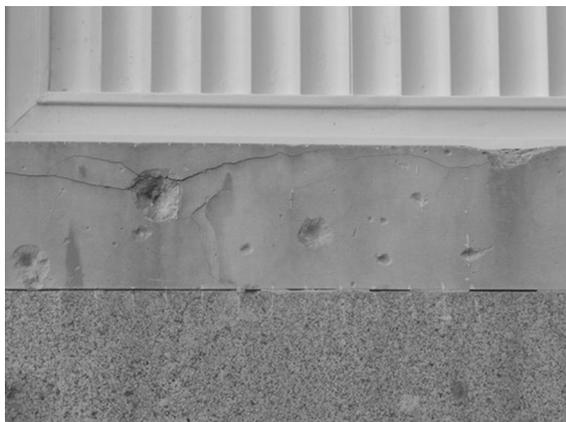
**Fig. 14** Impacts of different sizes in a window ledge. Smaller ones, which are likely the result of small size shrapnel, show inside granular disaggregation, while larger ones, coming likely from either rifles or large steel shrapnel, flaking, scaling and loss of fragments

The building is made mainly of brick, with the plinth, window ledges and other decorations made of limestone. In this case study, we focussed on the window ledges (Fig. 14), which are built out of “Almorqui” stone from Alicante, east Spain, which was a popular stone type in

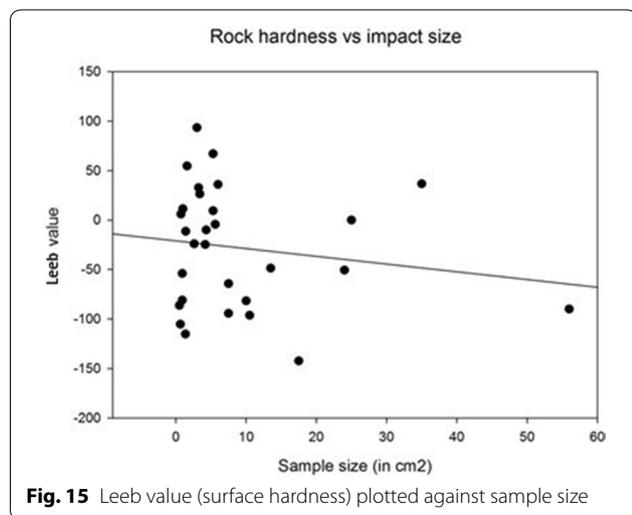
Leeb values, representing surface hardness, have been plotted against impact size (Fig. 15) using undamaged stone as the benchmark (0). At first sight, there is no clear correlation between Leeb value and impact size, although smaller impacts (less than 6 cm<sup>2</sup>) show more variable behaviour than larger ones. The total average values for all the impacts displayed a high standard deviation showing that there was no common behaviour for all the impacts. This is likely caused by the above-mentioned coexistence of rifle and shrapnel impacts, as well as the possibility of short-range impacts of small projectiles causing a similar size impact to long-range larger projectiles.

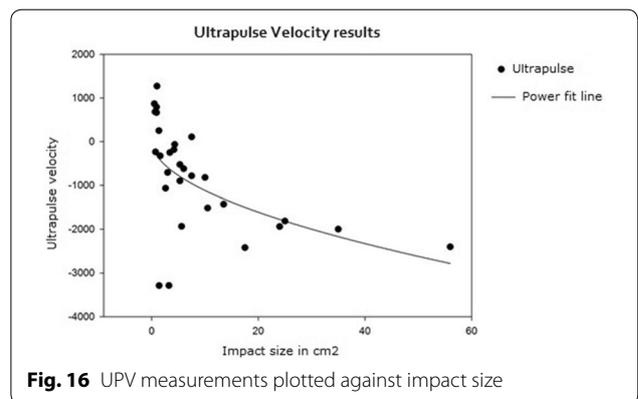
As it is likely that these impacts have deteriorated sub-surface structural stability, rather than just surface and near-surface deterioration as measured by the Equotip Leeb values, additional Ultrasound Pulse Velocity (UPV) were taken which detect voids and fissures. As Fig. 16 illustrates, there is a visible logarithmic correlation between the impact area and UPV, which fits well with the visual examination of impacts: the smallest ones show some dusting or granular disaggregation within, and as they grow larger, material loss scale also increases, going from granular disaggregation, through flaking, to eventually show losses in small chunks related to fracture formation through energy dissipation. Where impacts had taken place close to the top surface of the ledge, thereby lacking confining pressure from the top, fracture development was more obvious which is also reflected in lower values than expected according to the logarithmic trend line.

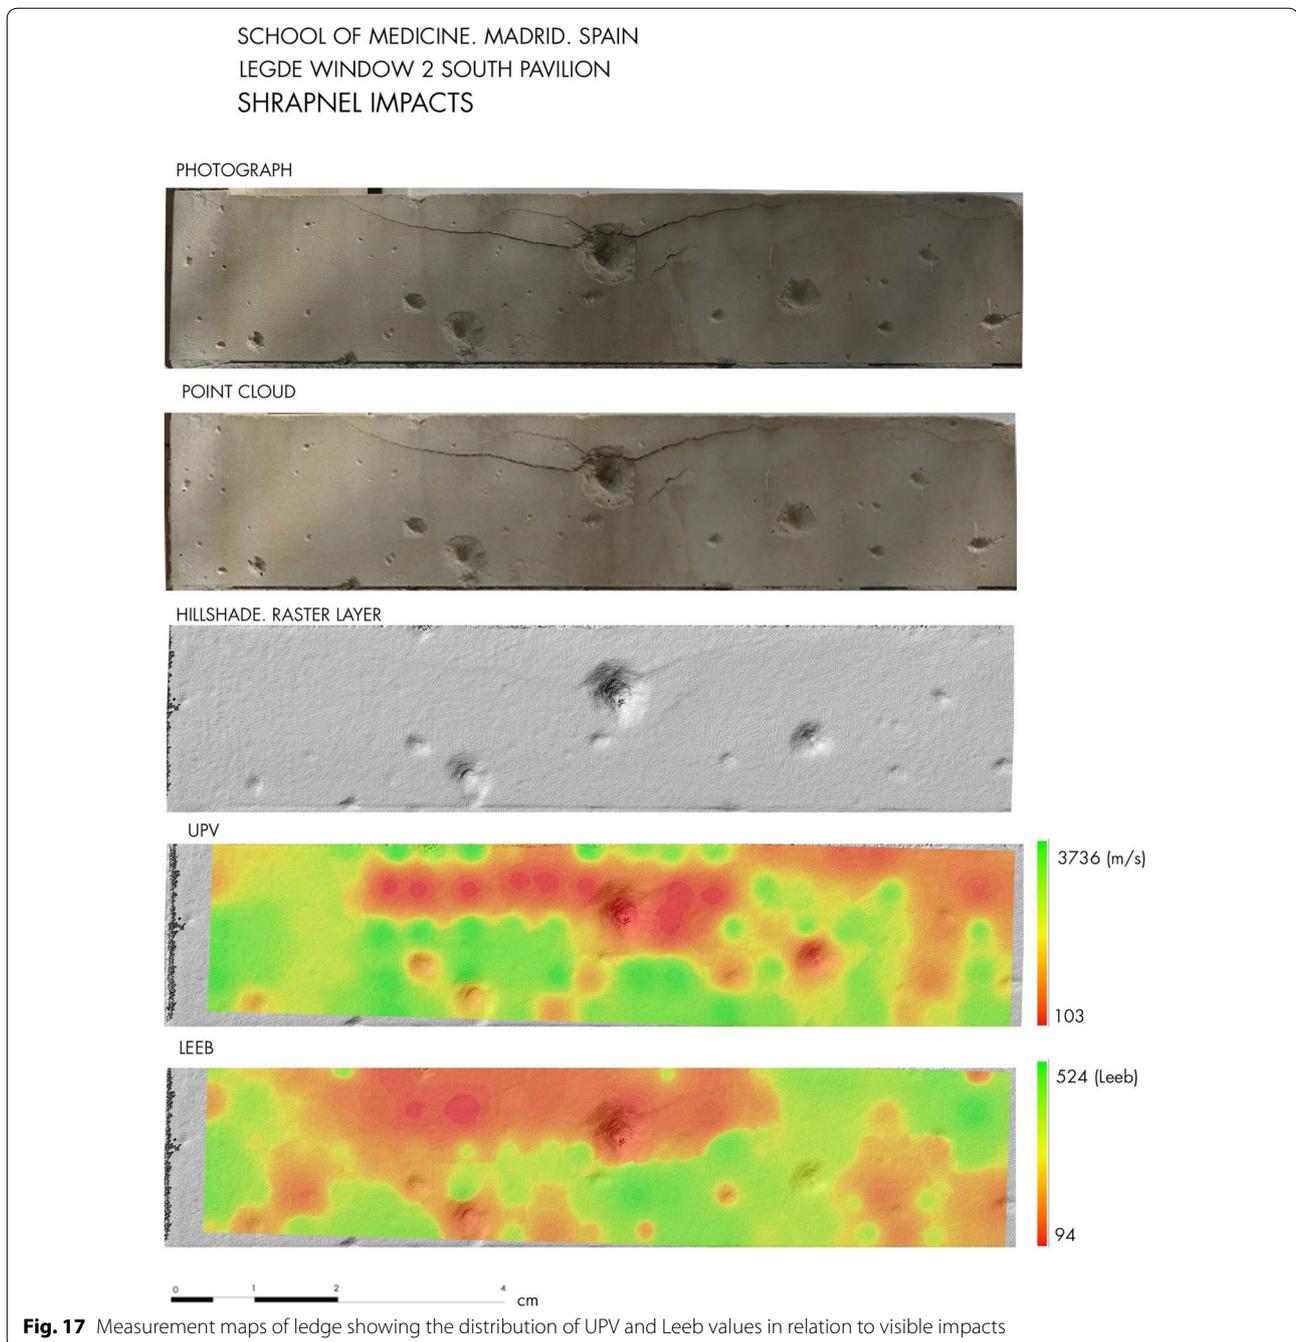
To further this potential relationship between subsurface deterioration and impact size and placement, the results were mapped using ArcGIS and 3D scanning (Fig. 17). The results show large horizontal and perpendicular to the surface fractures, which are the main “bulk” changes in these ledges. These window ledges are confined laterally but unconfined vertically on the top, and that affects the fracturing pattern of the whole ledge. Most fractures are horizontal and located on the top third of the ledge, regardless of the size and position of impacts, which likely is related to the lack of confinement of the ledges on the top face. Larger shots also have a fracturing pattern which includes fractures parallel to the external surface. These are often concealed, but are here detected with UPV.

Unlike the results reported in case studies 1 and 2, where damage appeared to be restricted to the surface and near-surface in the area immediately surrounding the impact zone, stress generated by the Madrid impacts travels through the surface and causes deterioration away from the initial impact zone. This fundamental change in damage pattern, causing wider spread subsurface structural damage through fracture network development,
