Effect of flood conditions on the deterioration of porous clay-based brick

Mol, L* & Tomor, A
University of the West of England, Bristol, UK
* lisa.mol@uwe.ac.uk

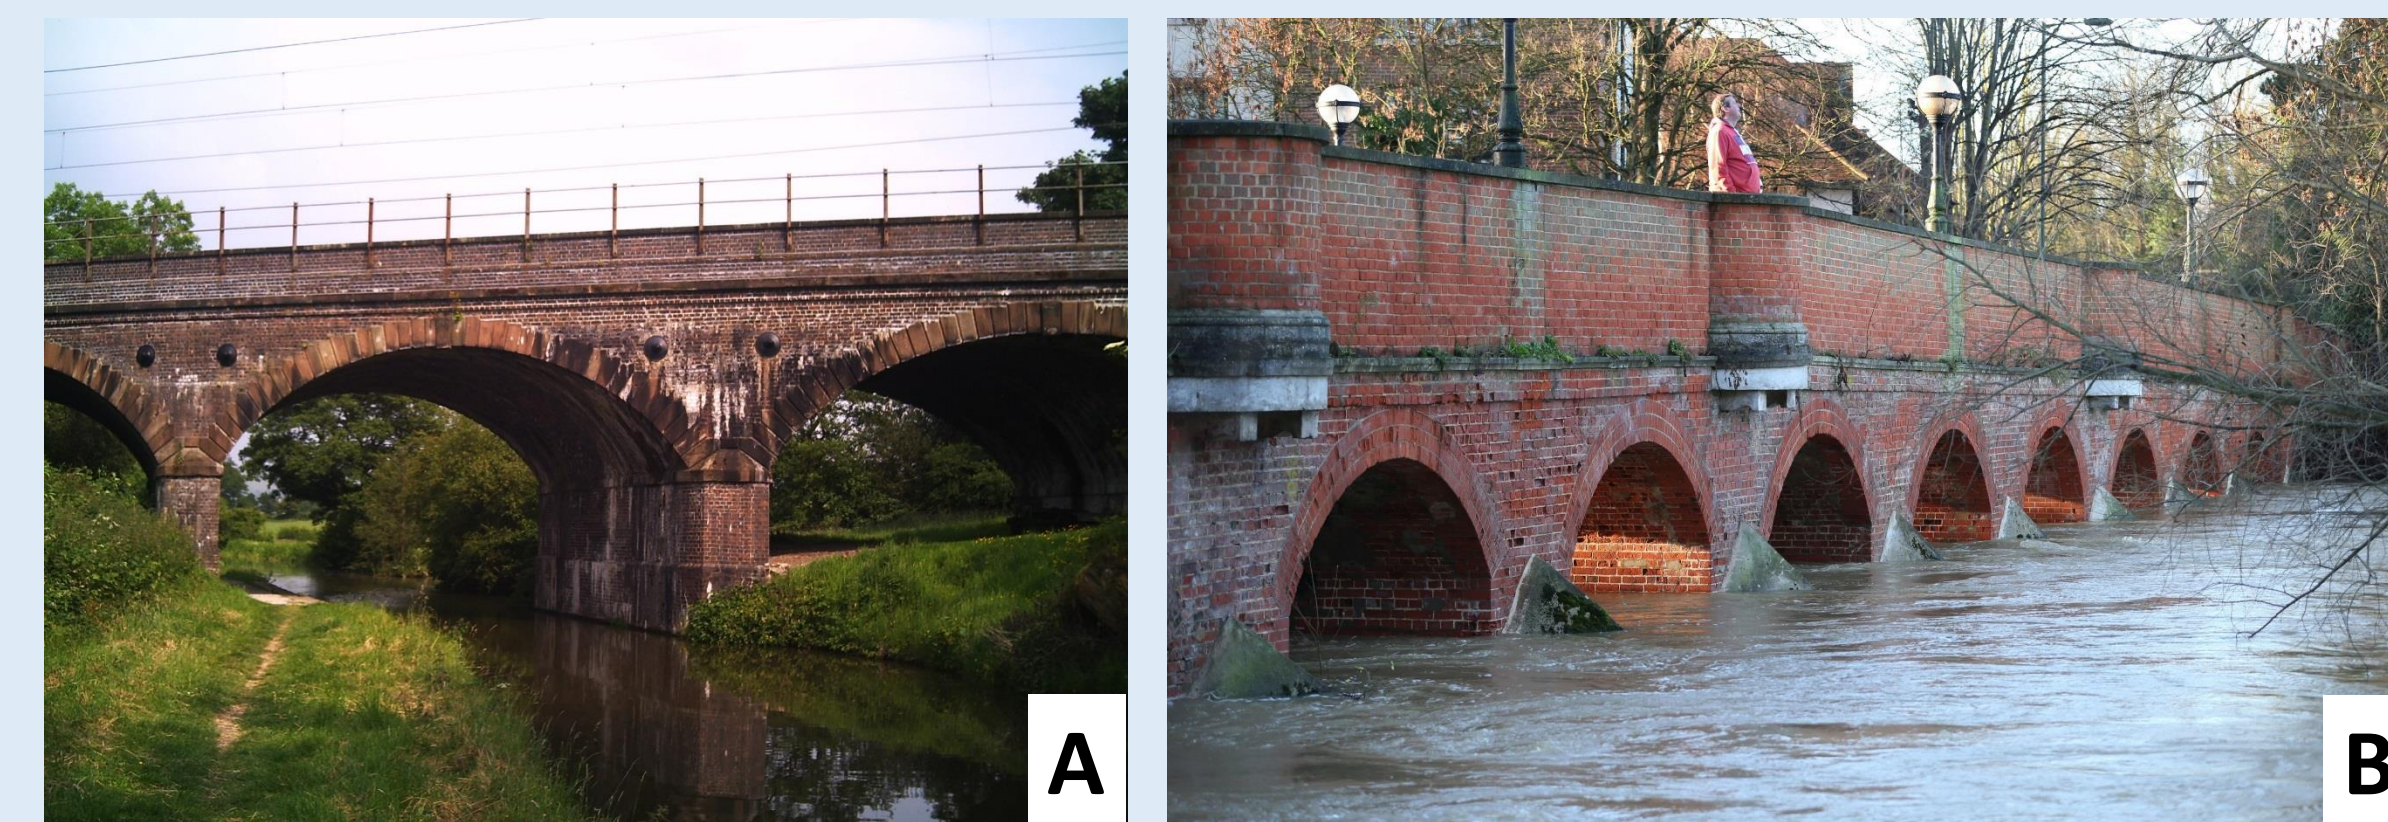
Figure 1: Flooding of the River Mole (UK), showing normal river conditions (A) and flood conditions (B)

Brick masonry represents a significant percentage of historical building material in the urbanised landscape around the world. In particular, historic structures in the UK dating from the onset of the Industrial Revolution (1880s) were predominantly built out of this friable material and can be subjected to deterioration processes due to the friable nature of the bricks (figure 1).

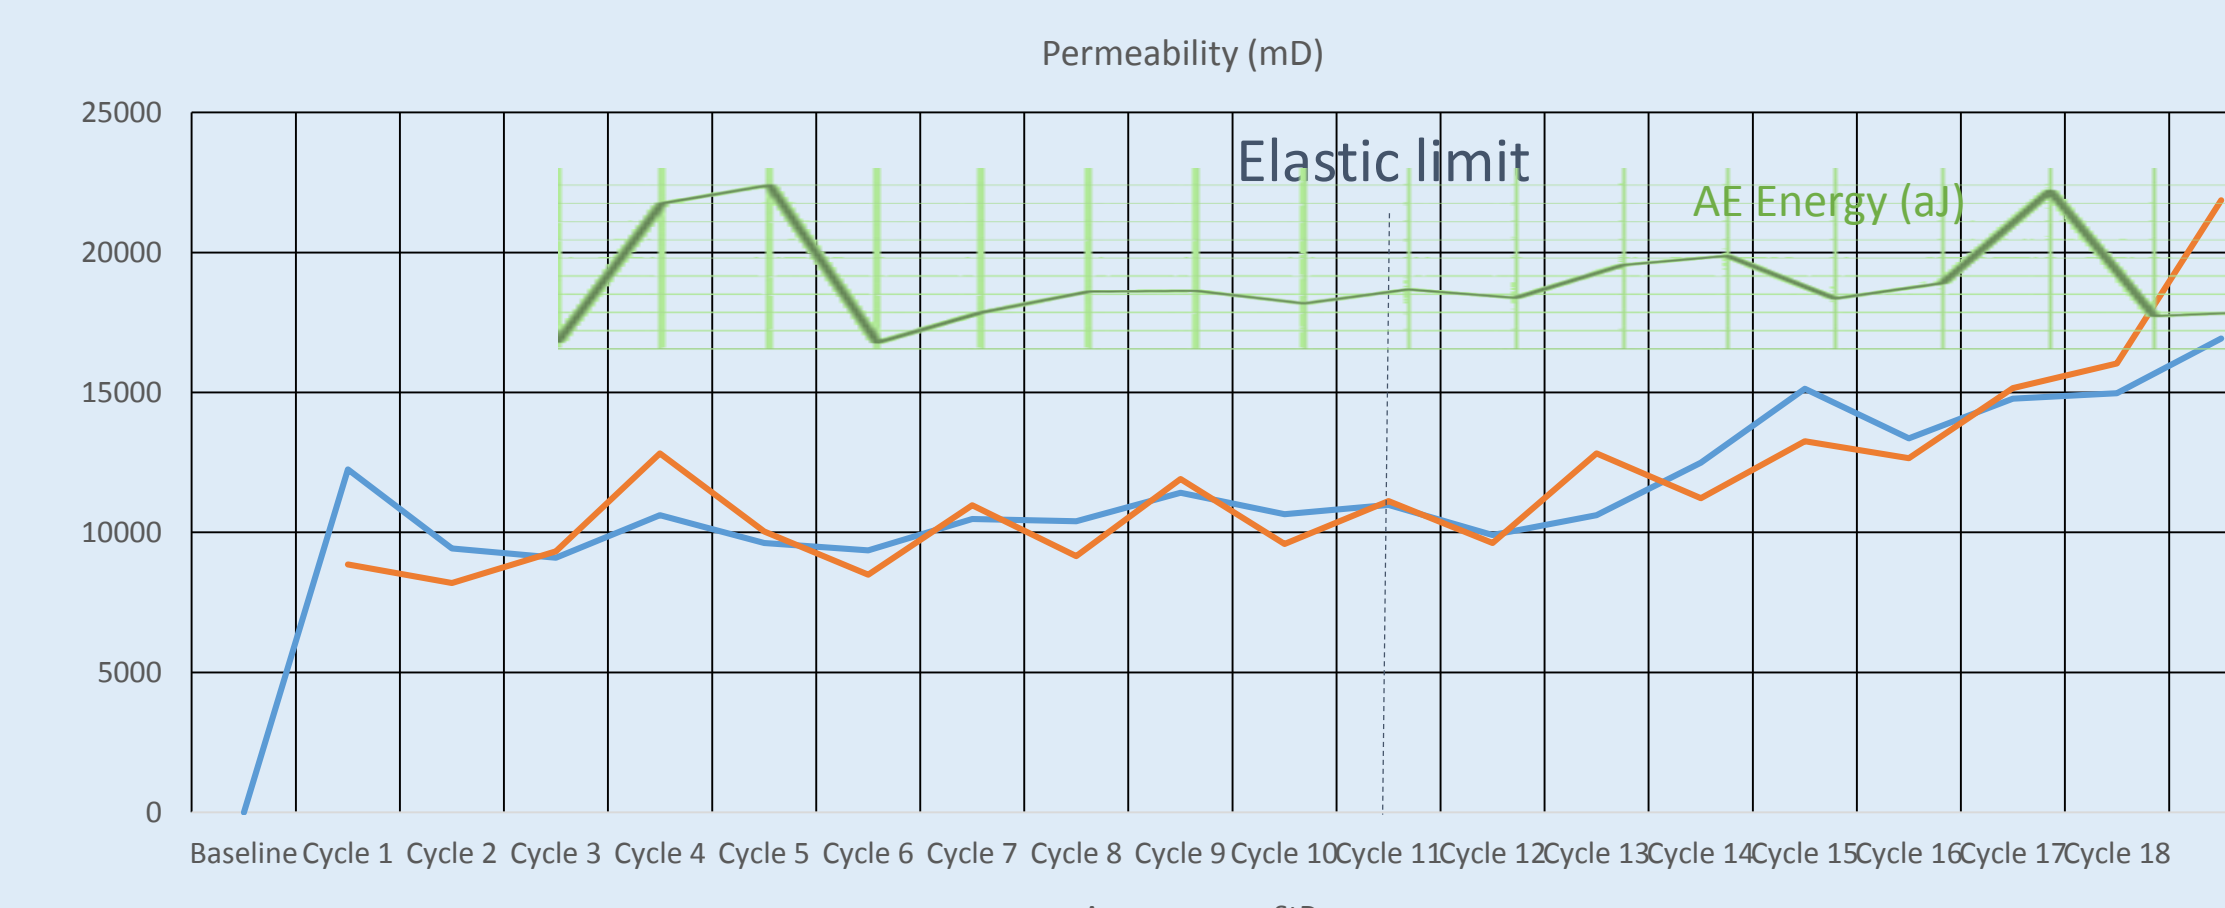
Figure 3: Permeability measurements per cycle, average of all 5 bricks (n=50 per measurement cycle), with acoustic emission (aj)

Permeametry provides a good indication of progressive failure across the prism, showing cyclical decrease and increase of failure, with acceleration of permeability increase as point of failure approaches (cycles 13-18, figure 3), as indicated by deflection patterns measured in the prism (figure 4)

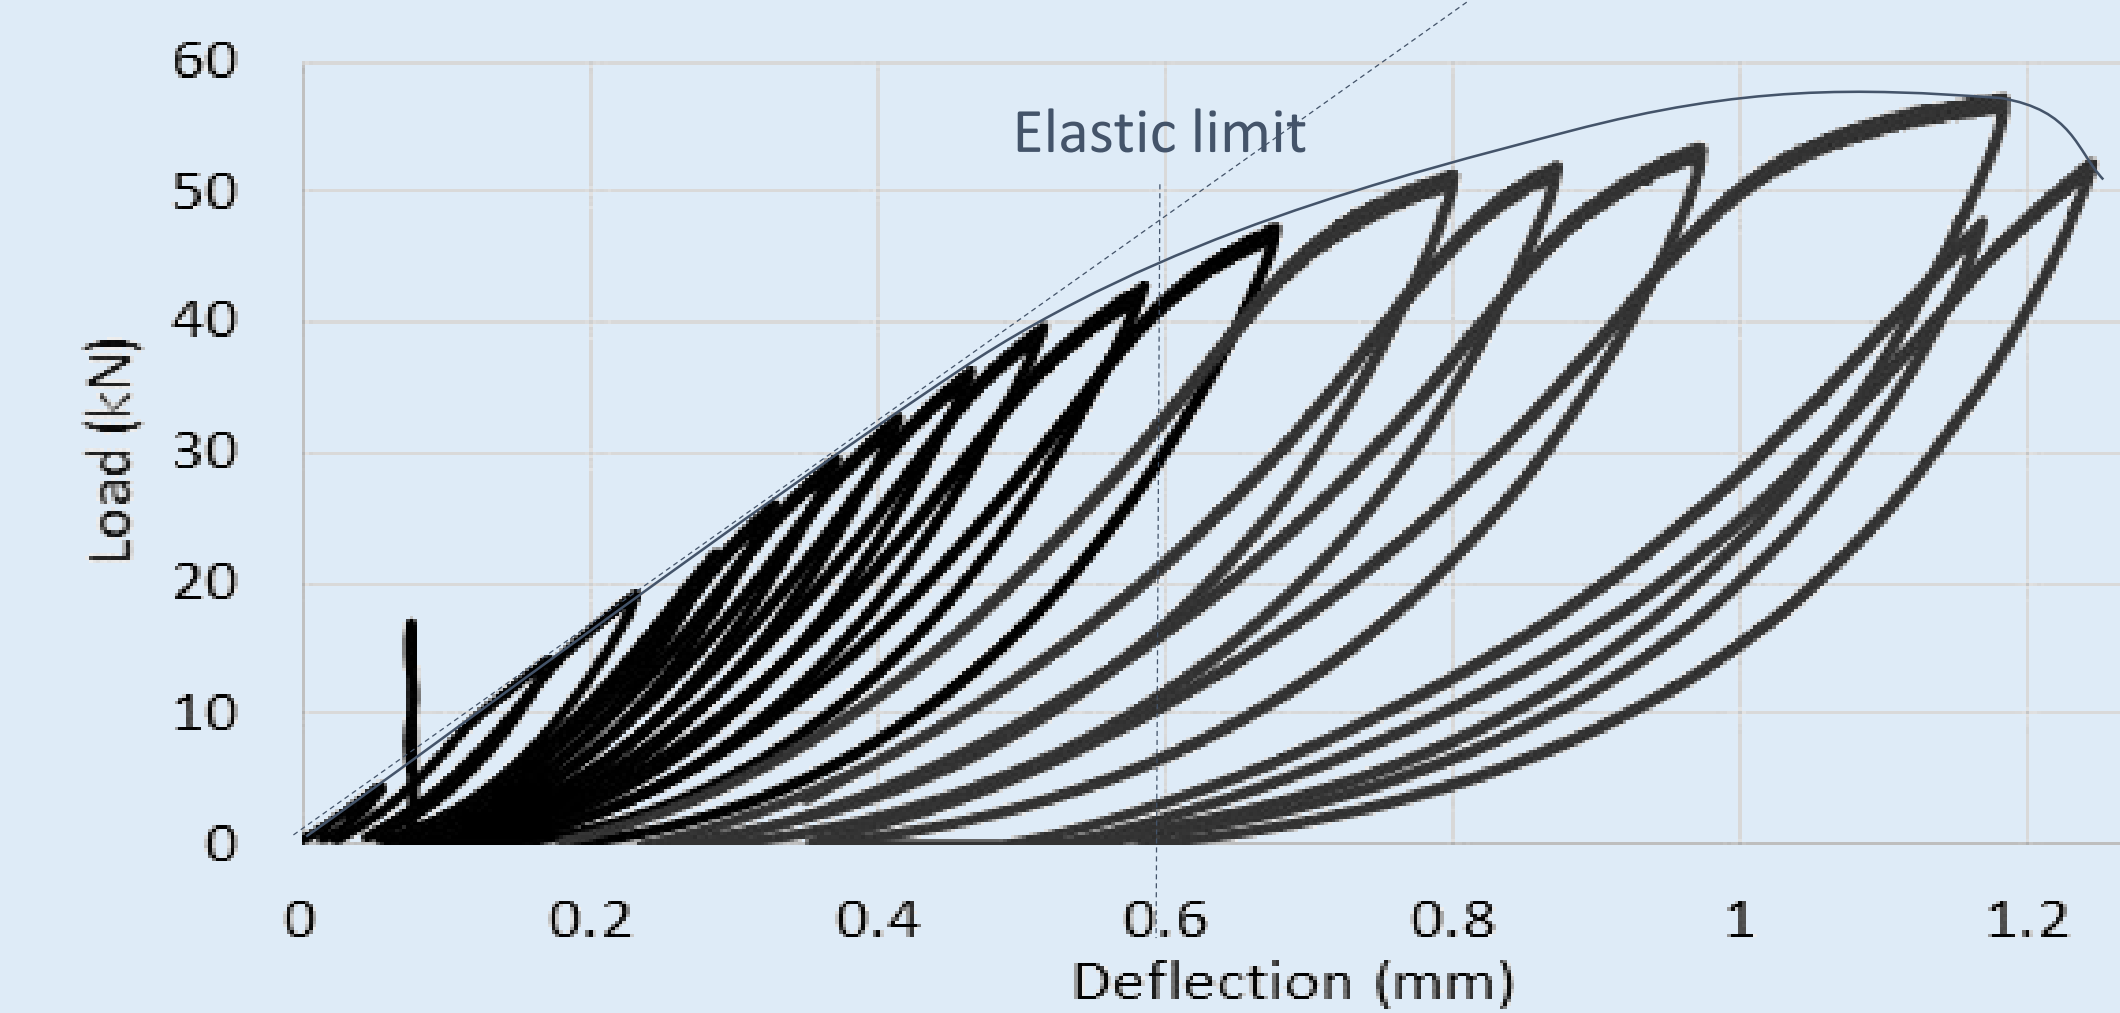
Figure 4: Load and deflection measurements, indicating the elastic limit pre-failure

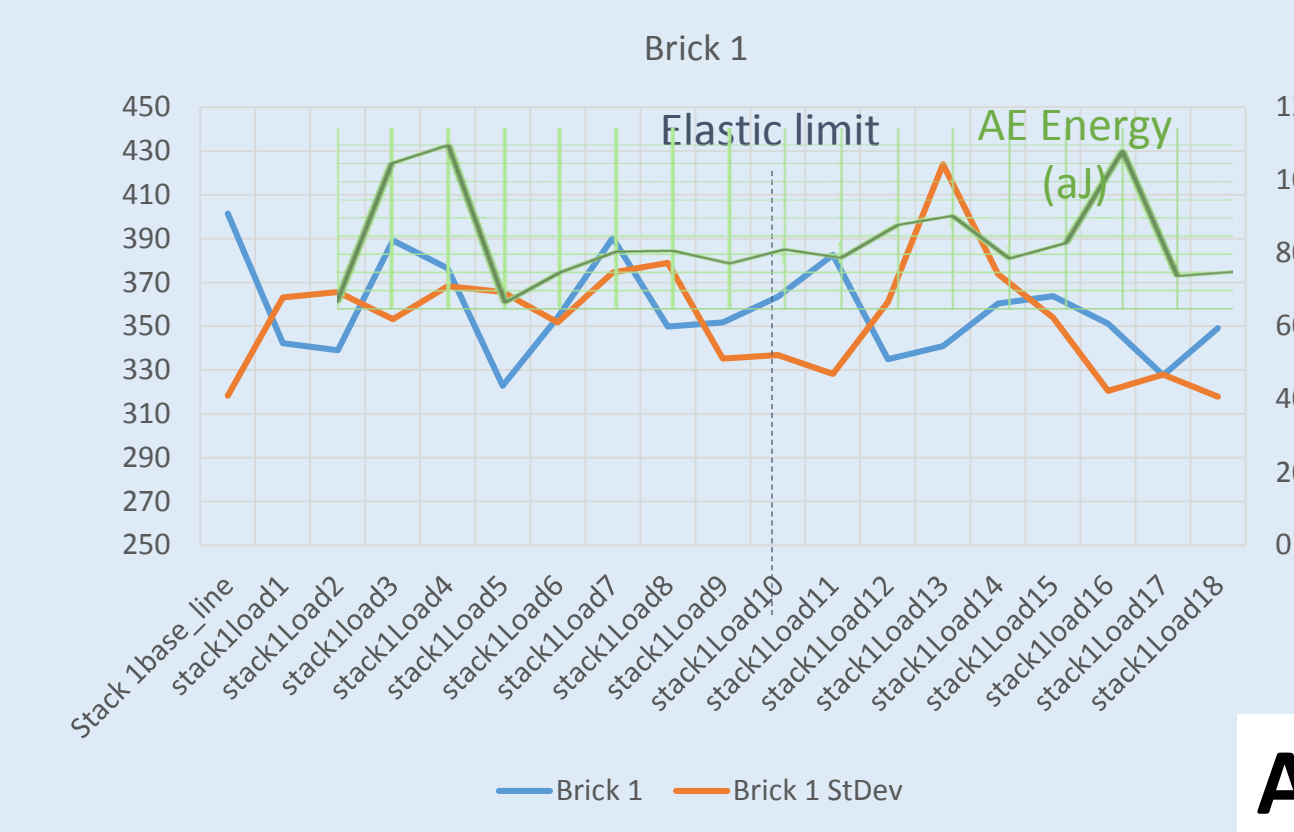
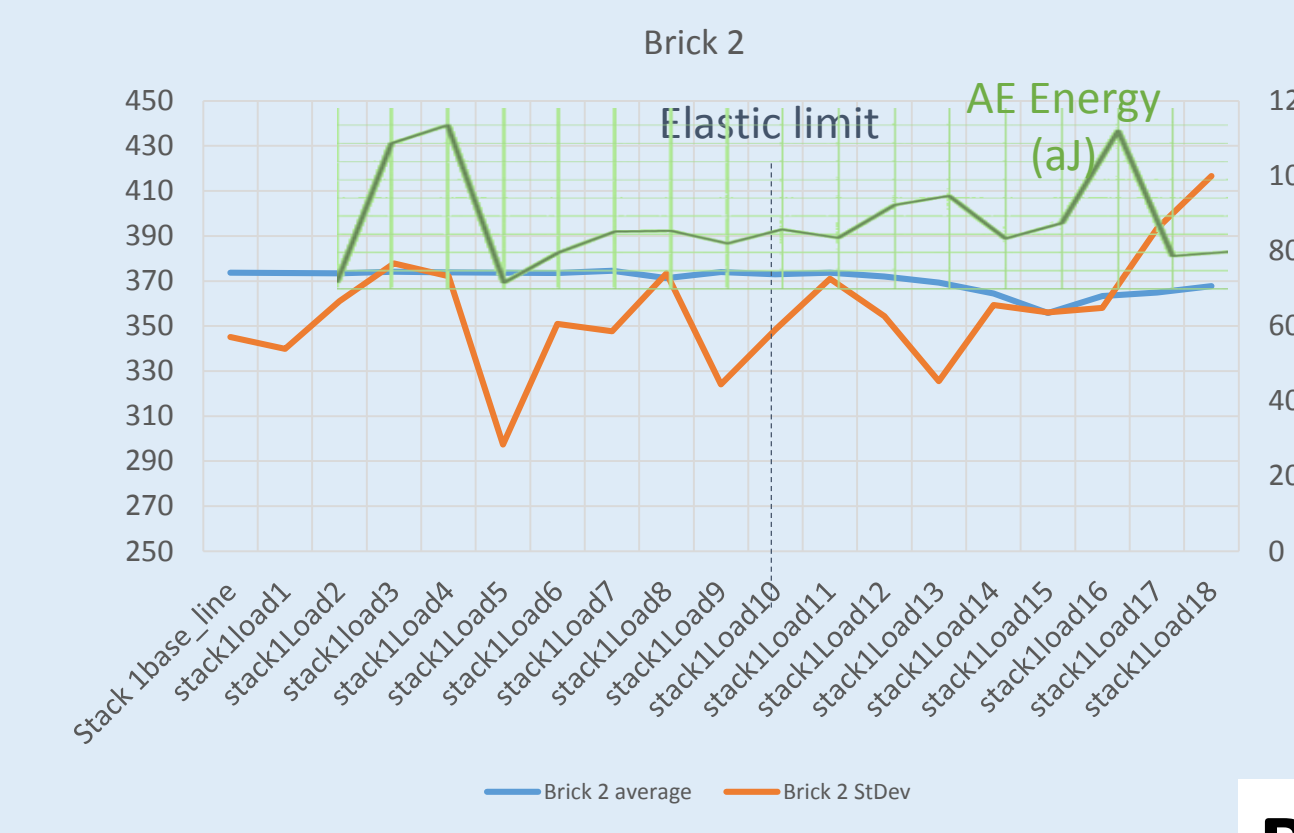
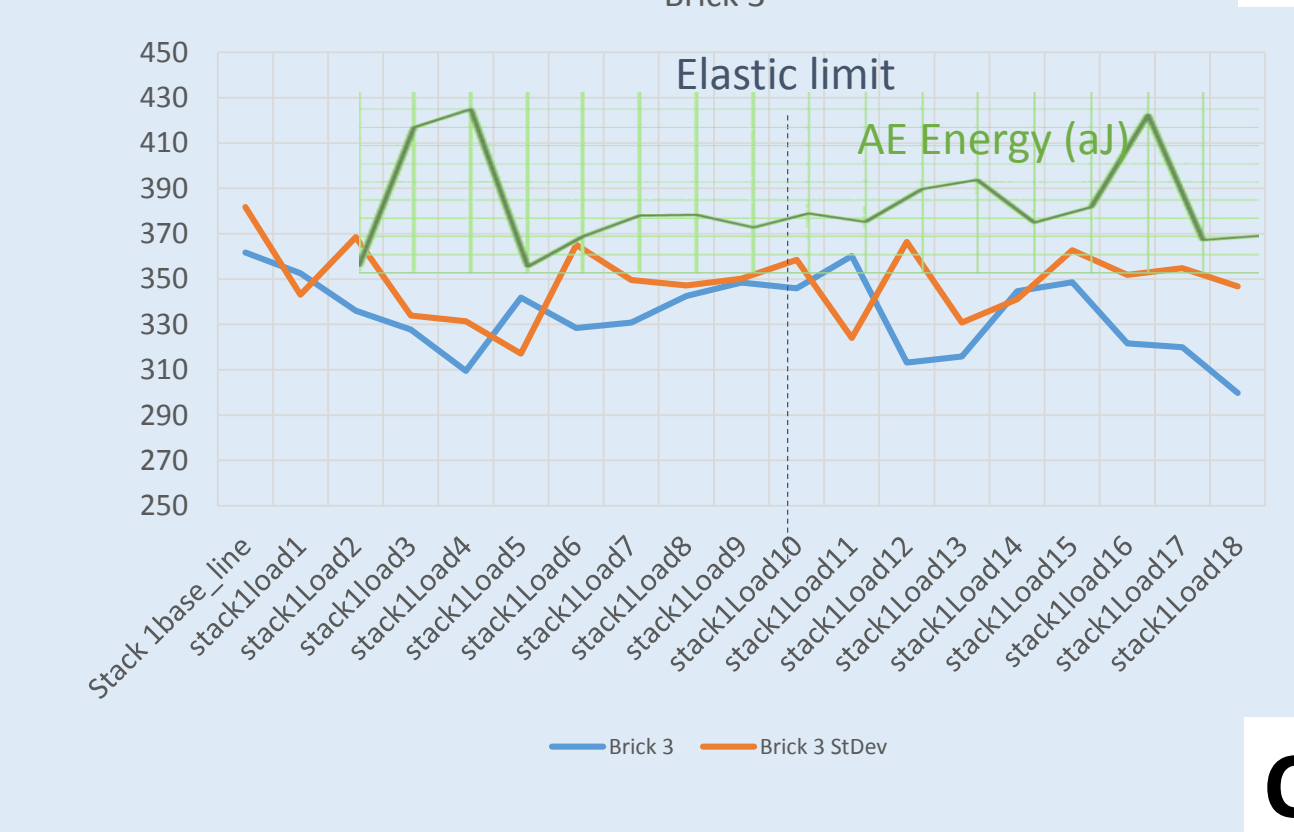
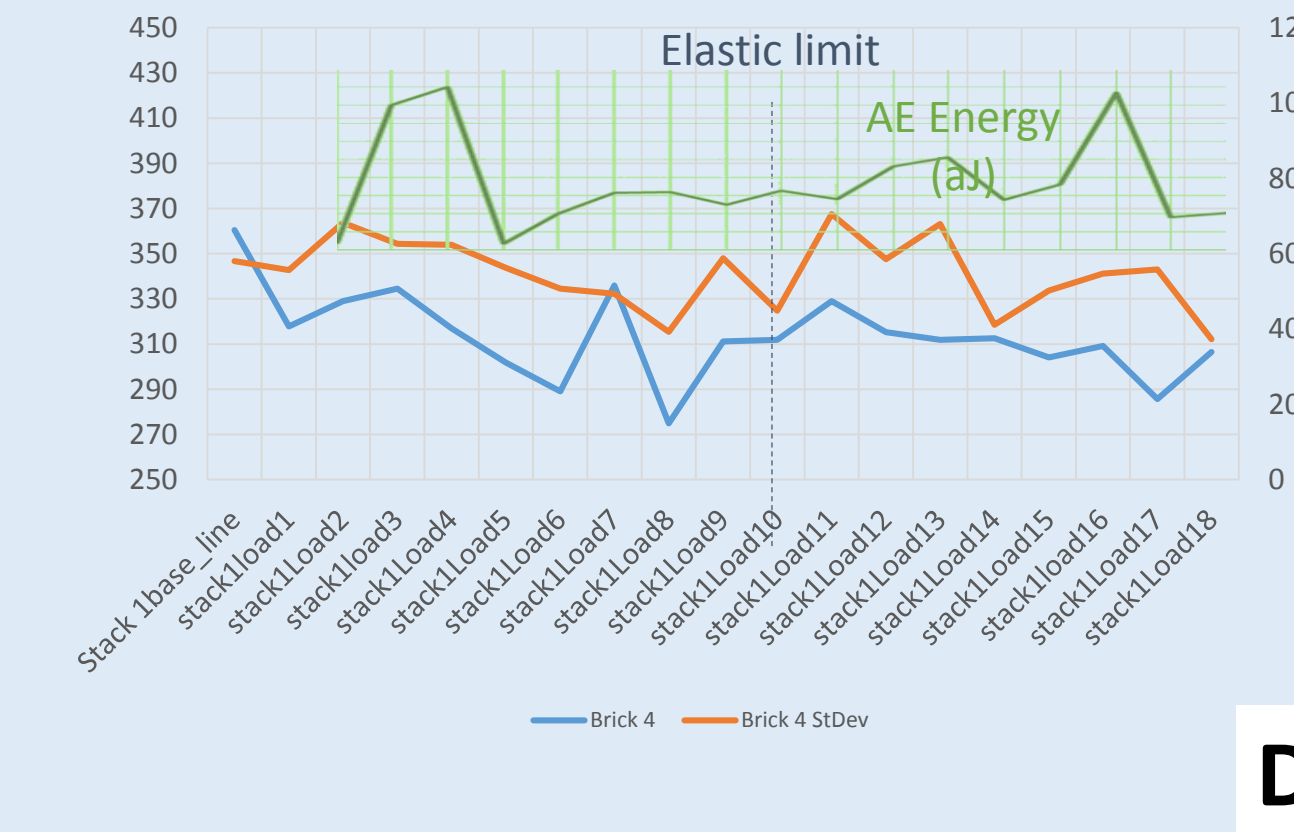
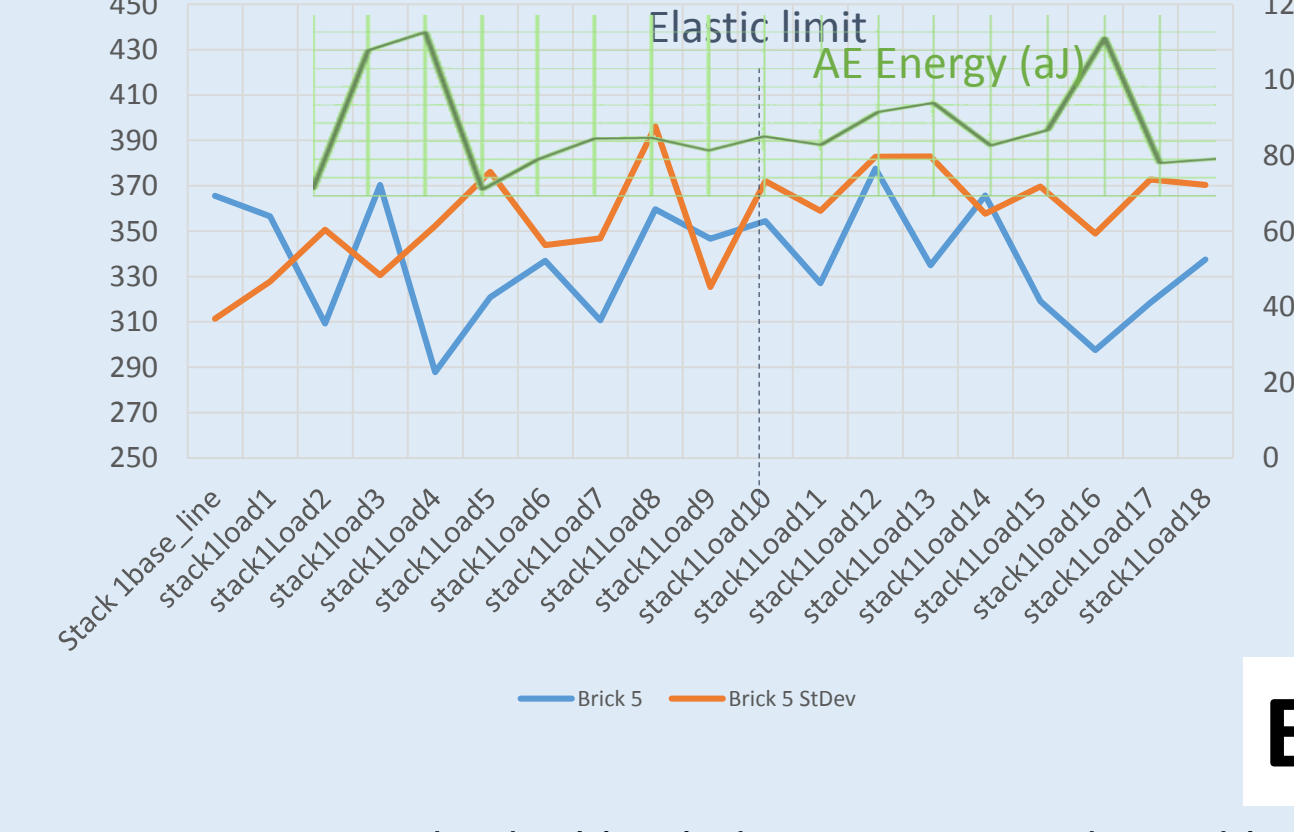
Figure 5 A-E: Individual brick deterioration, indicated by rock surface hardness values (Leeb, n=10 per brick per measurement cycle) and standard deviation. A lowering of Leeb value indicates strength deterioration. Overlain is maximum acoustic emission (aj), which appears to be a precursor to cyclical loss of strength

1. Within the prism, the top and bottom bricks (1 and 5, figures 5 A and E) showed the greatest variability in surface hardness, indicating loss of strength within the surface associated with compression cycles. This compression was less evident in the centre bricks, which exhibited a more gradual deterioration.
2. During the final pre-failure cycles (13-18) the centre brick (3, figure 5 C) deteriorated rapidly, which coincides with the observed failure pattern

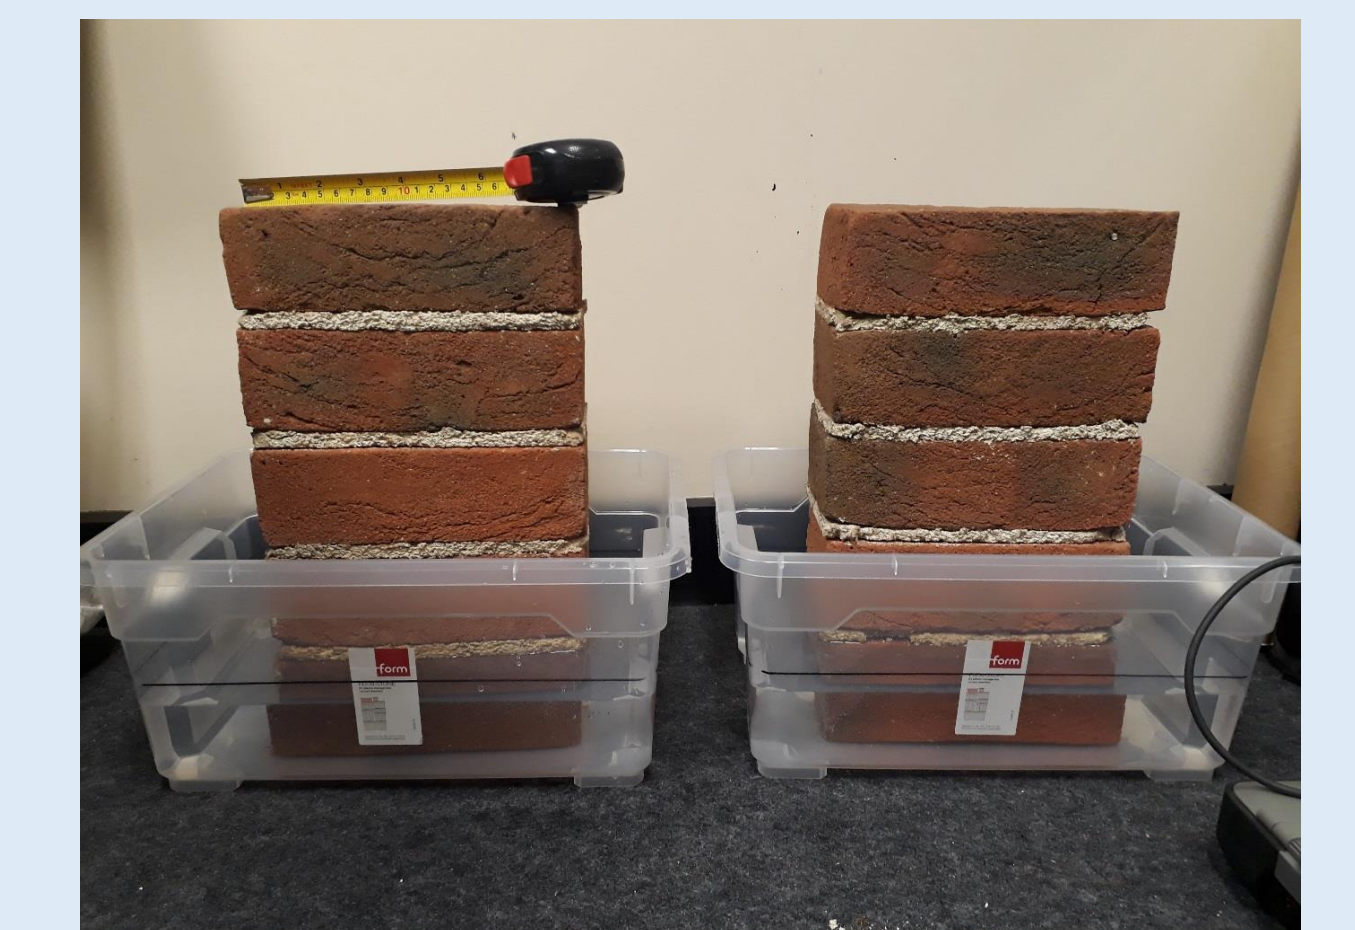
Figure 6: Submersion experiment set-up

Two brick prisms were submerged in 2,5cm of water for 9 days (figure 6), and were measured before submersion and then at 3-day intervals. Water levels were maintained at 2,5 cm to compensate for loss of water through evaporation and capillary rise.

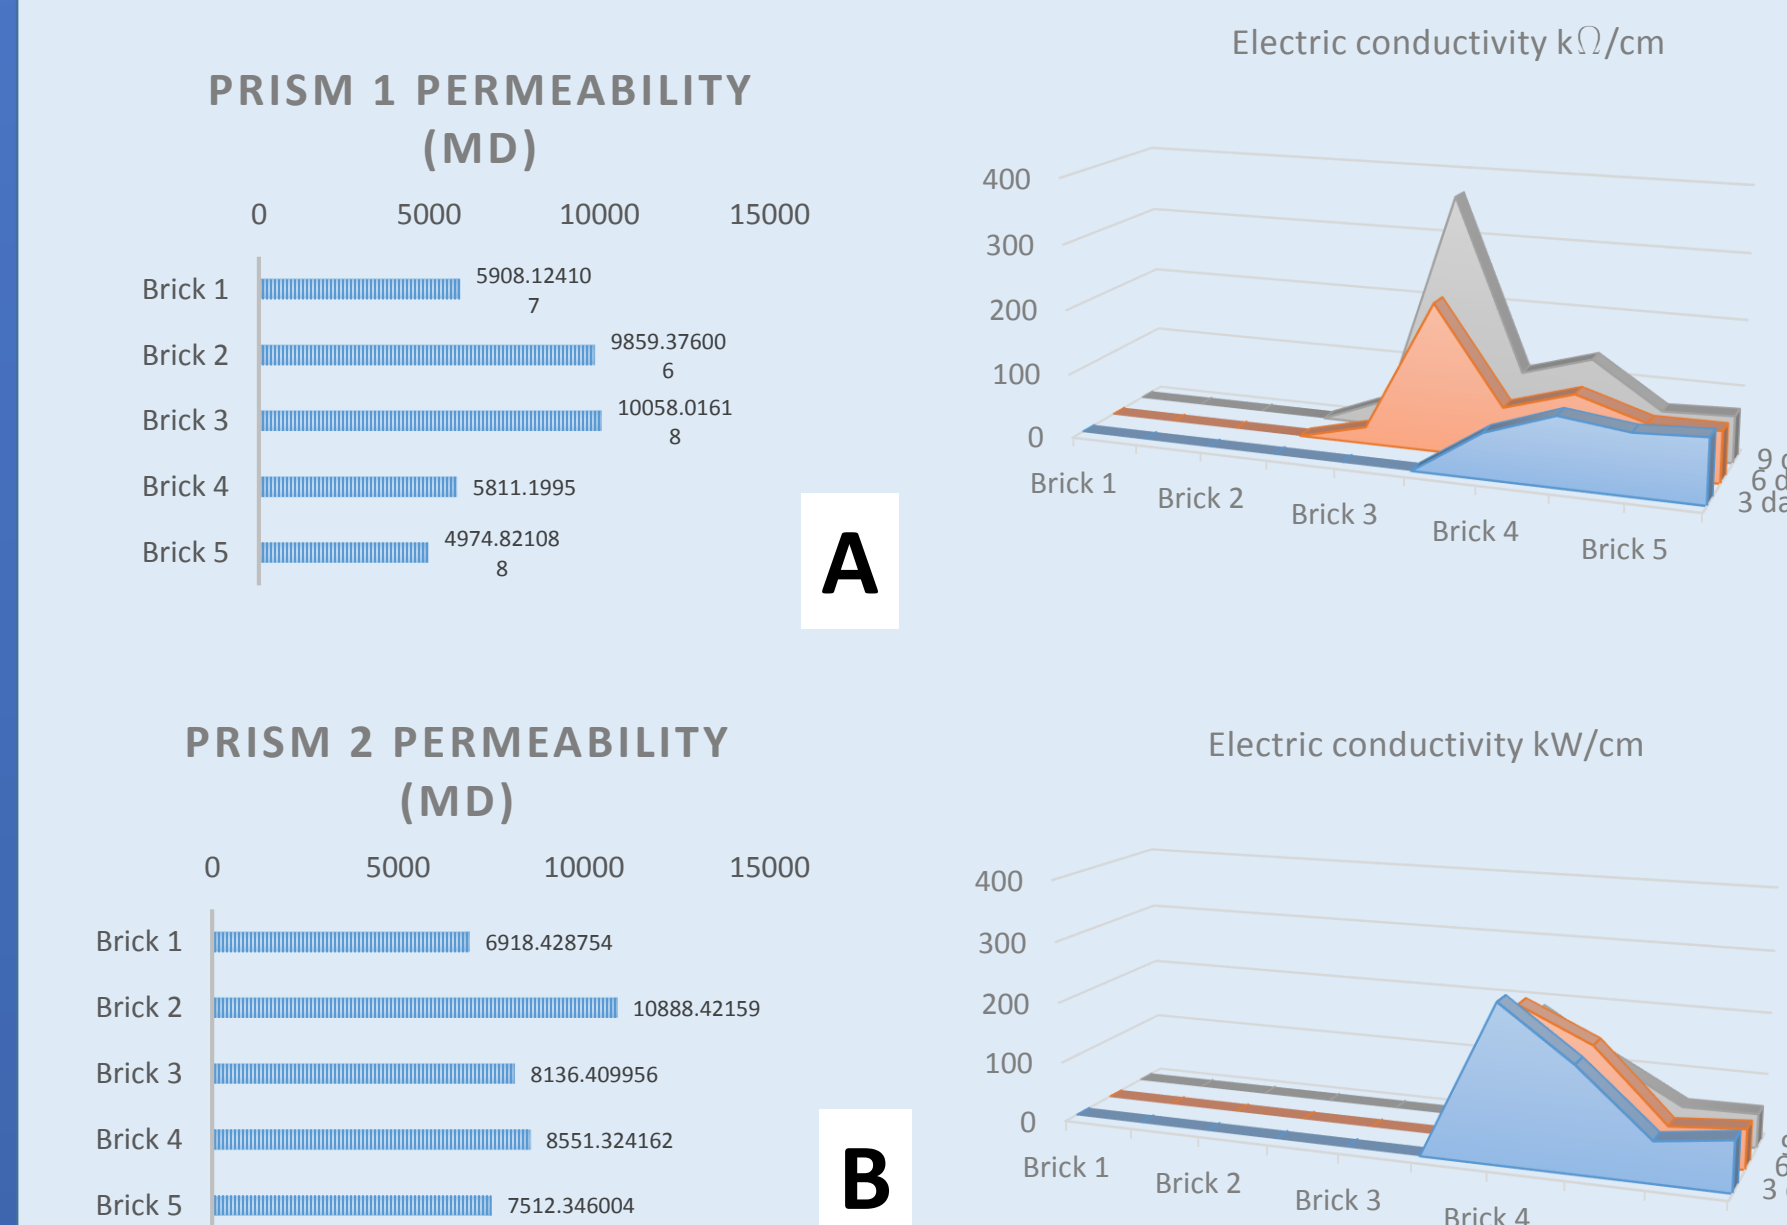
Figure 7: Pre-submersion Permeametry tests (TinyTerm III)

Permeametry measurements pre-testing indicate high porosity across both prisms (figures 7 A and B). The surface conductivity measurements, using a Proceq Resipod (figure 8 A and B), indicated that capillary rise did not rise above brick 3 (centre brick) over the course of the 9-day experiment. Surface hardness measurements (figures 9 A and B) indicated deterioration of the brick across the prisms, but most rapidly across bricks 4 and 5 (bottom bricks nearest the water).

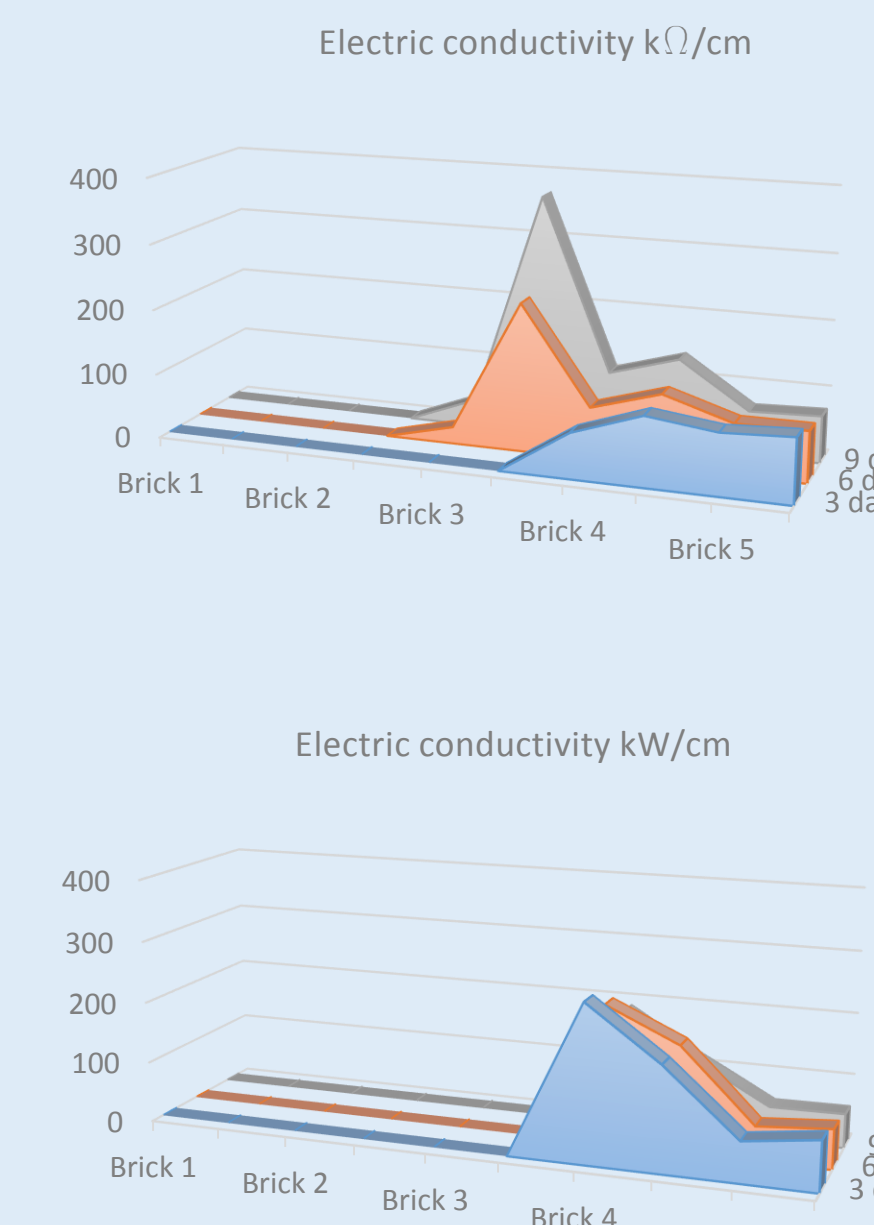
Figure 8: Proceq Resipod surface conductivity measurements

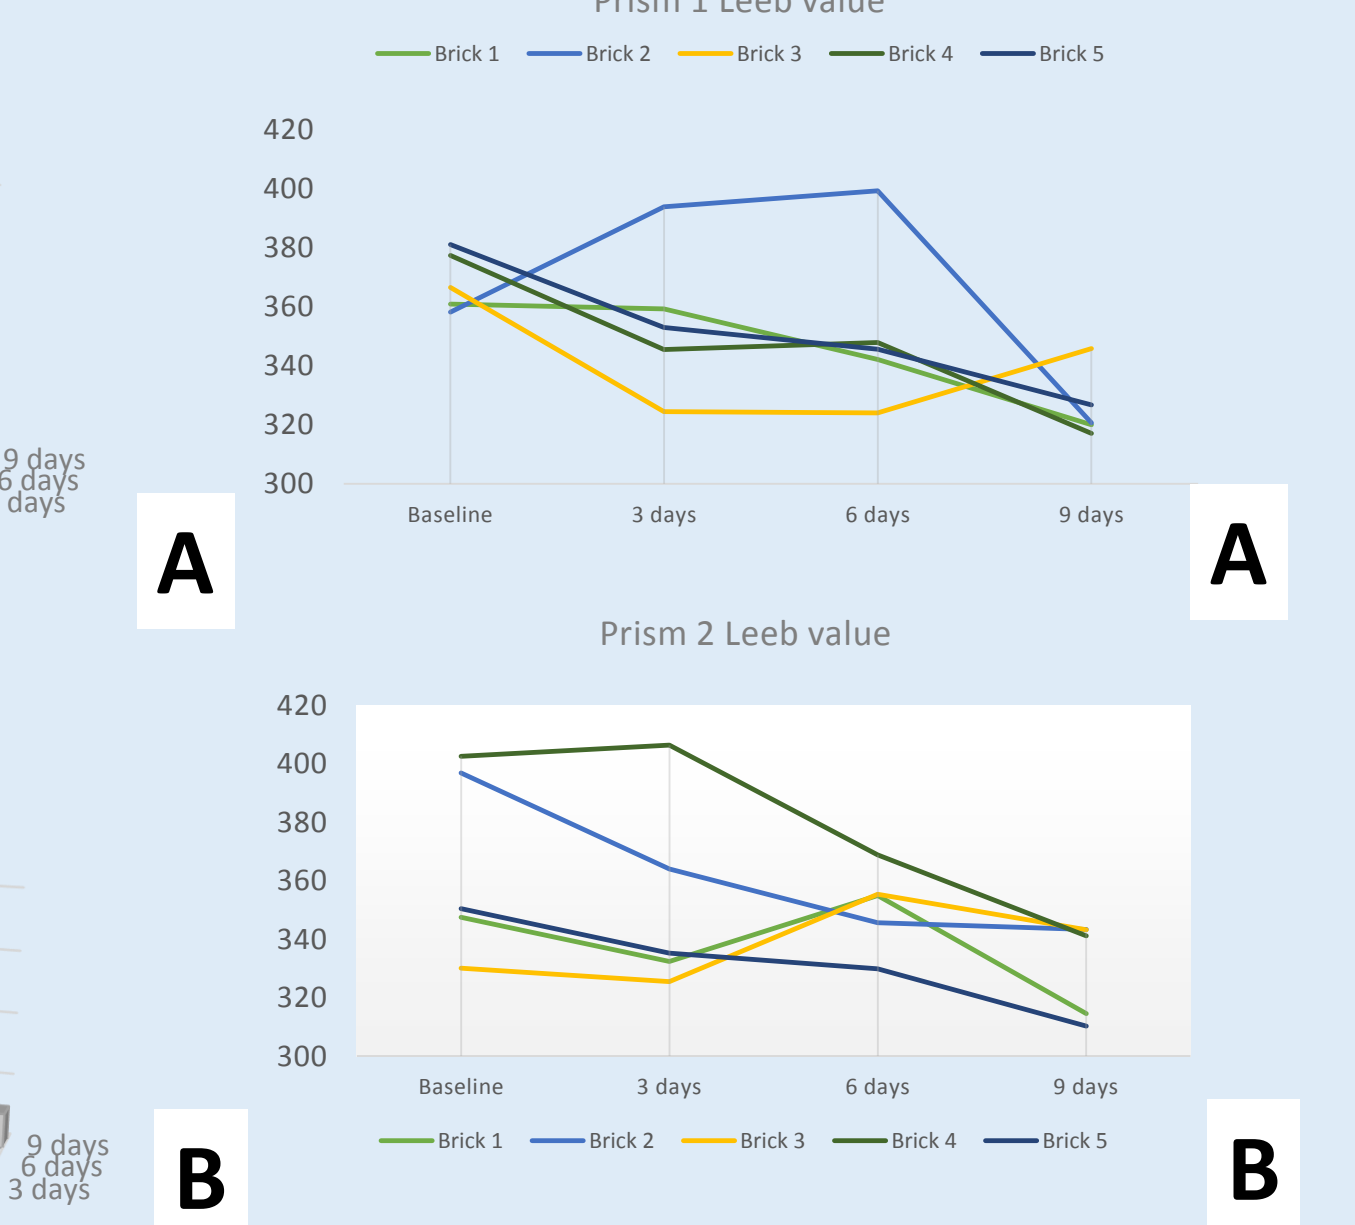
Figure 9: Surface Hardness measurements (Proceq Equotip 3)

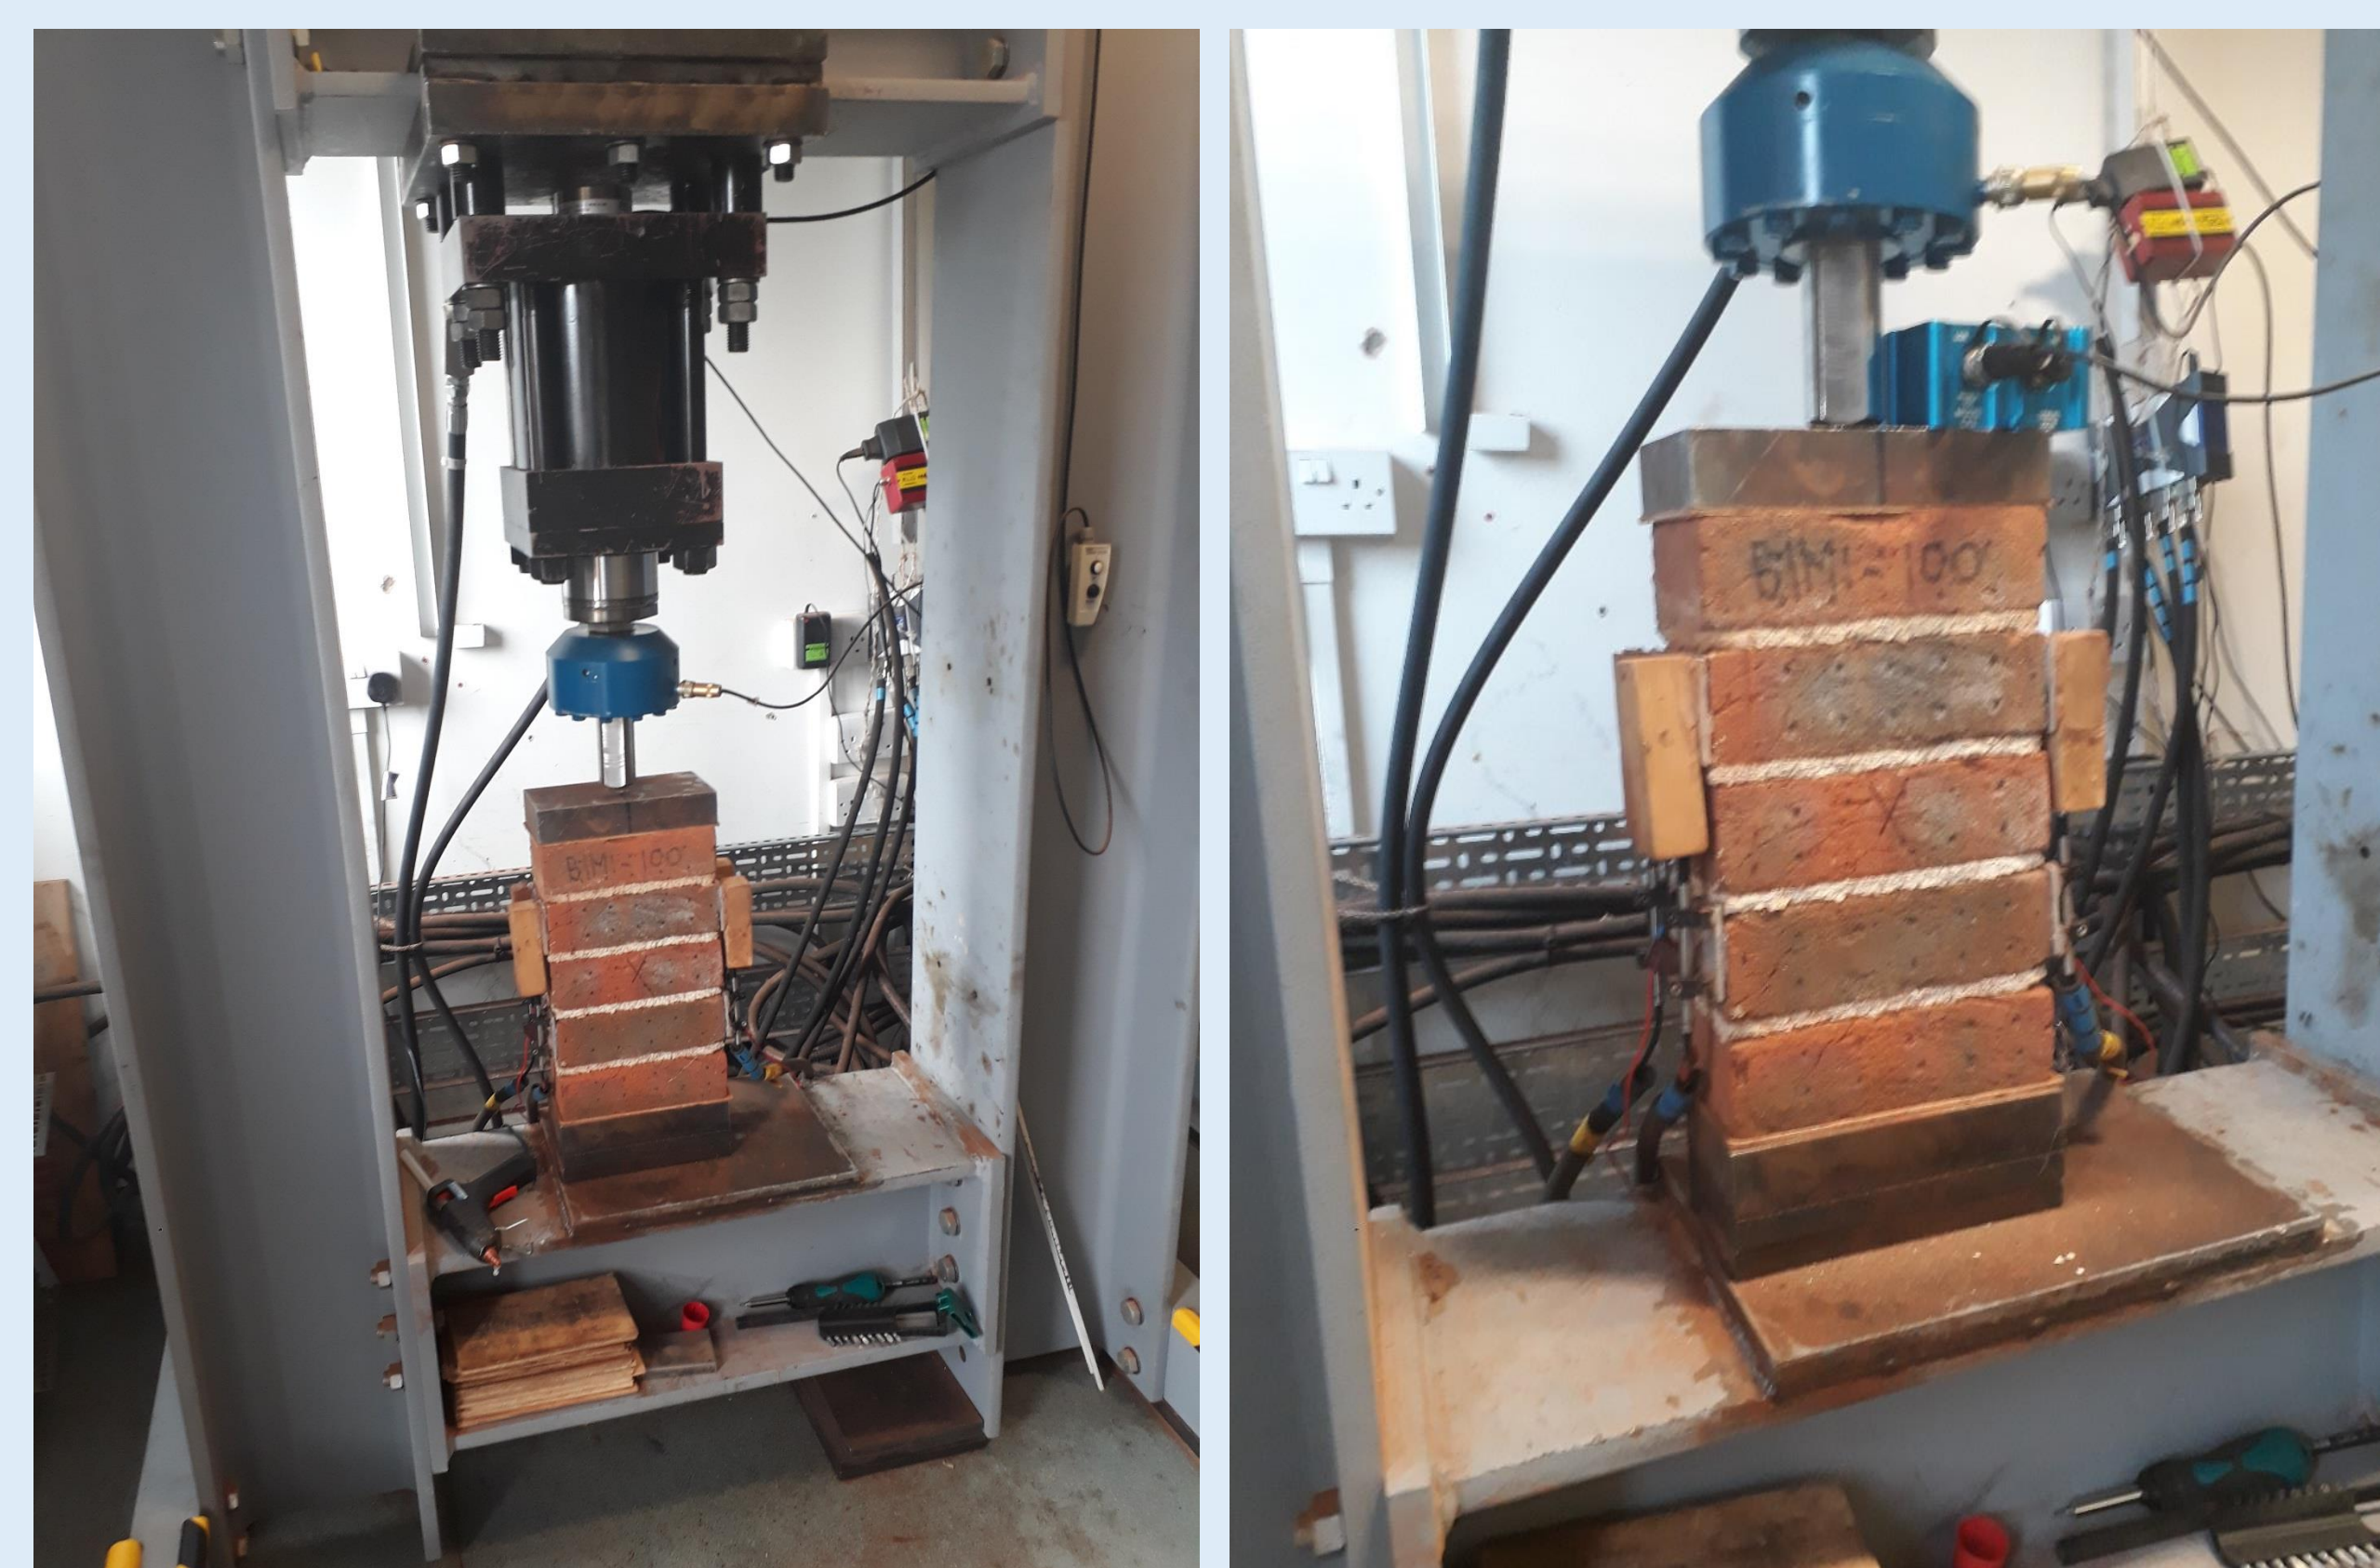
Figure 2: Loading rig set-up in the Masonry Bridges

A series of small-scale laboratory tests were carried out on brick masonry to identify the effects of saturation on the material properties and changes in the rate of deterioration. Brick masonry prisms have been loaded to failure under quasi-static and long-term cyclic compression (figure 2) and their condition and material parameters monitored using acoustic emission technique, accelerometers, linear variable differential transformers (LVDTs), permeametry and brick surface hardness measurements. Under quasi-static loading saturated specimens show significant reduction in the load capacity and increased fracture development.
