CULTURAL HERITAGE DOCUMENTATION AND CONSERVATION: THREE-DIMENSIONAL (3D) AND GEOGRAPHICAL INFORMATION SYSTEM (GIS) TECHNIQUES FOR SHRAPNEL DAMAGE OF FACADE SCHOOL OF MEDICINE OF THE COMPLUTENSE UNIVERSITY OF MADRID

Presentation preference: Poster

Topic: Techniques: Digital documentation and recreation

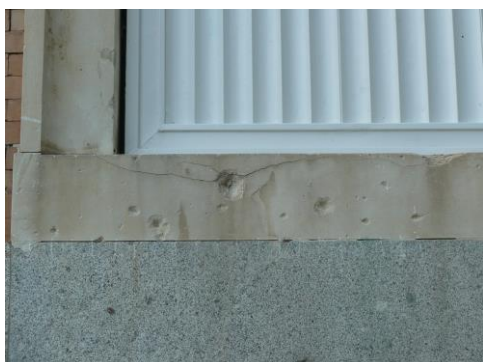
Figure 1. Shrapnel damage in the School of Medicine

A digital 3D model of the areas affected by shrapnel was produced to accurately document the location and characteristics of each impact. Single image photogrammetry was used to produce this 3D digital model of the walls, which was then used for GIS-based surface modeling. This approach yielded a dataset of accurately georeferenced physical characteristics of each of the impacts. This 3D analytical data provides a new insight into the damage caused by shrapnel impacts, which aids not only the restoration and preservation of this site but could be carried across to conflict sites where conservation analysis can play a crucial role in post-conflict heritage conservation.
