On the Use of Web Mapping Platforms to Support the Seismic Vulnerability Assessment of Old Urban Areas

Cosimo Columbro ¹, Rafael Ramírez Eudave ², Tiago Miguel Ferreira ³, Paulo B. Lourenço ²
and Giovanni Fabbrocino ^{1,4,*}

Keywords: seismic vulnerability assessment; urban-scale survey; web mapping platforms; historic centers; masonry structures

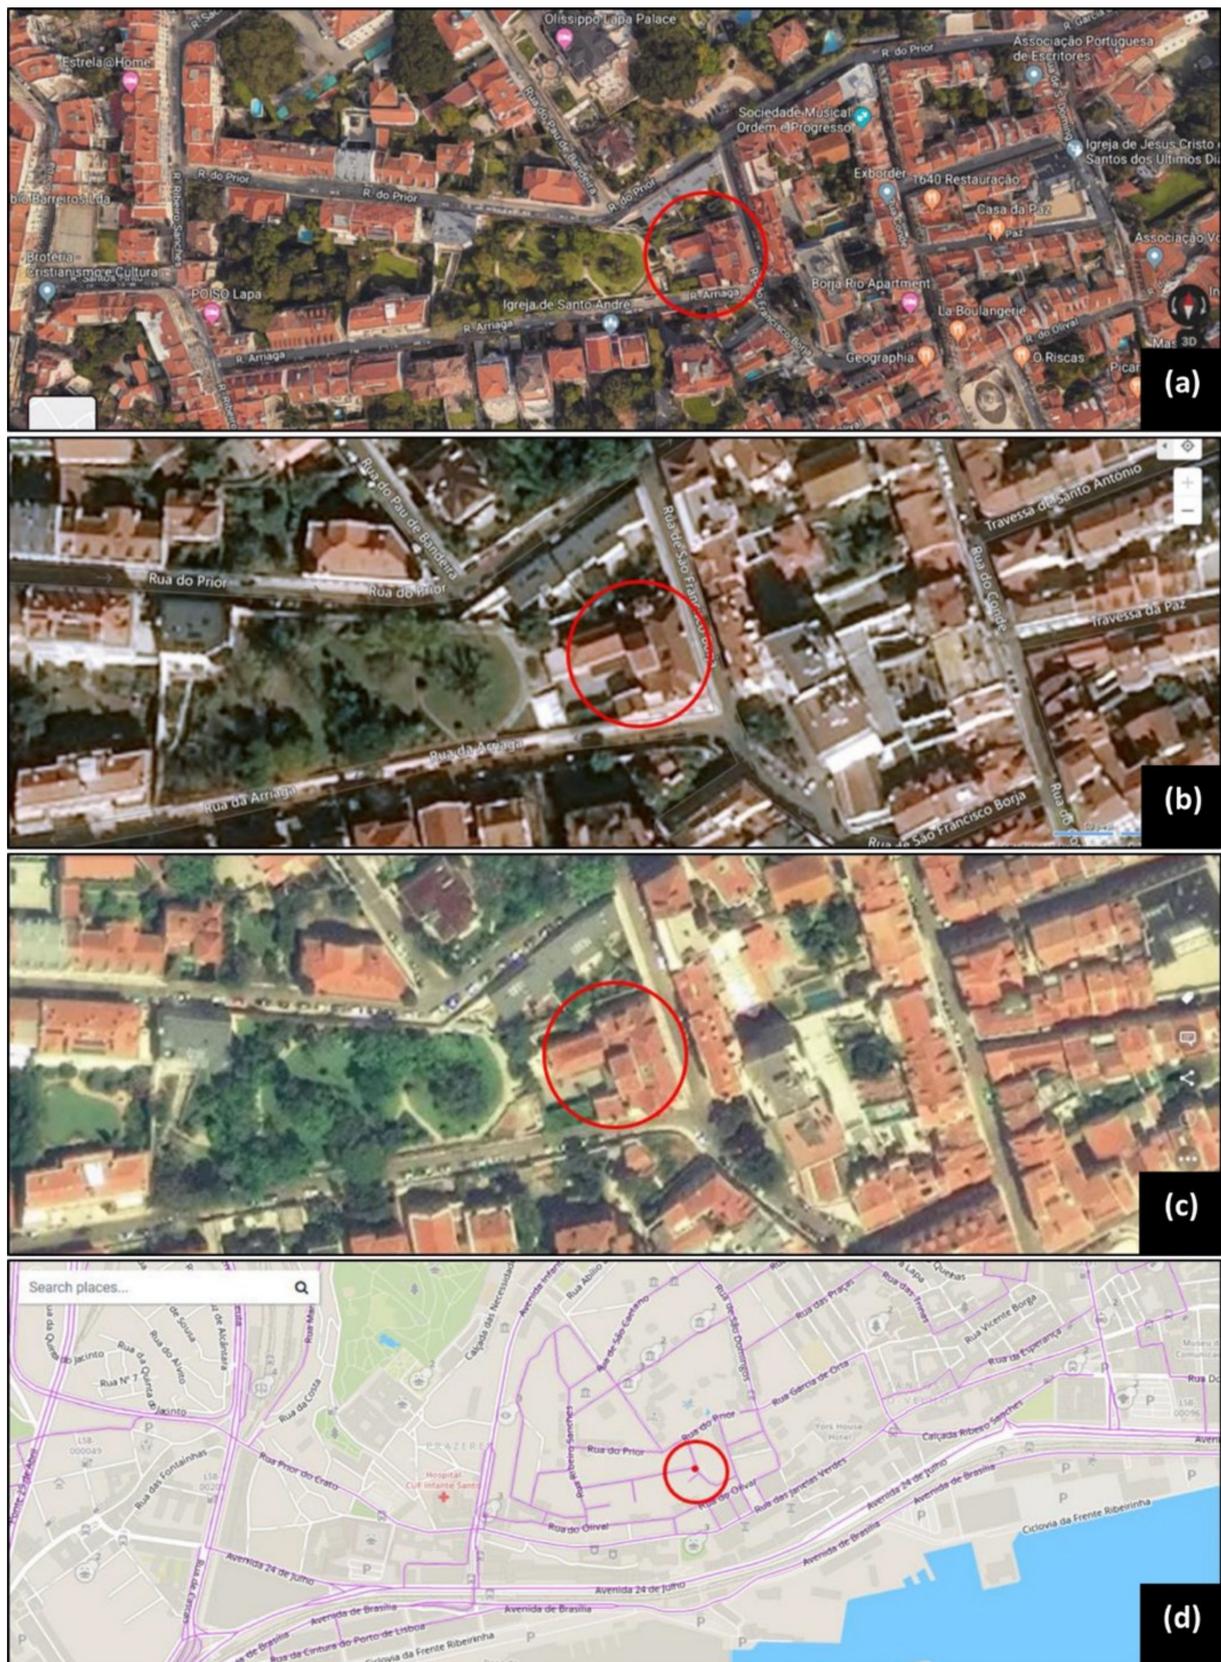
Figure 1. Comparison of the satellite images for evaluating plan regularity by using different web platforms: (a) Google Maps, (b) Bing Maps, (c) Mapillary, (d) OpenStreetCam.

A comparison between the images obtained from the different tools to identify the location of the building and its conservation status (Parameter 17, in Table 3) is given in Figures 1 and 2.

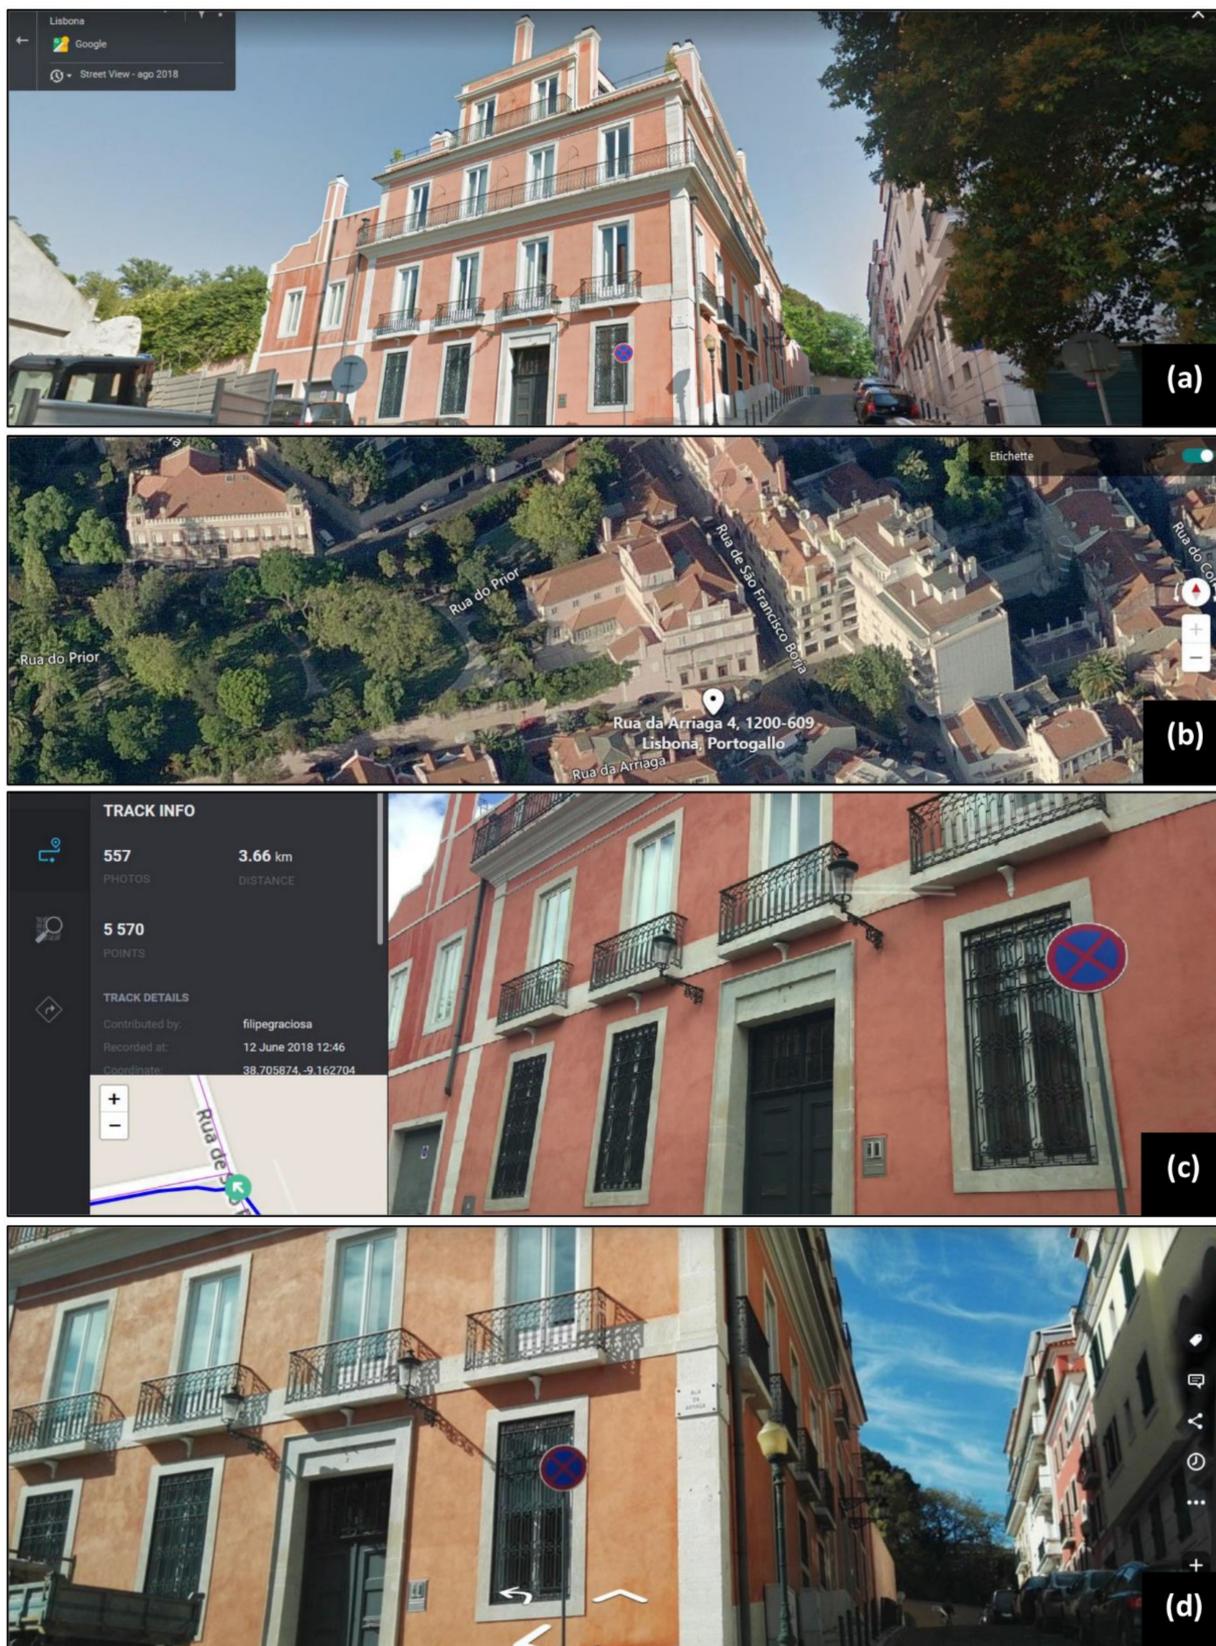
Figure 2. Evaluation of the façade images for assessing the conservation state by using different web platforms: (a) Google Maps, (b) Bing Maps, (c) OpenStreetCam, and (d) Mapillary.

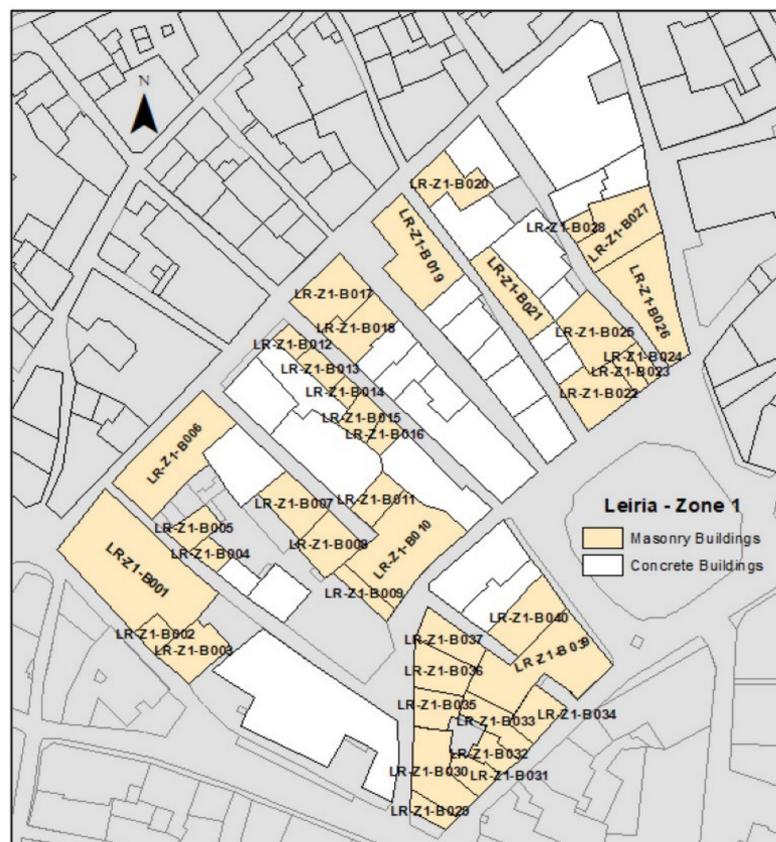
Figure 4. Region of study (Zone 1), emphasizing masonry-based constructions and the key assigned during the data acquisition campaigns.

The slope of Zone 1 is completely flat, whereas Zone 2 is inclined from north to south with a minimum slope of 3% and maximum slope of 23%, and an average of 14%. For Zone 3, two portions are separated by the main street, the southern part is flat, and the northern part has a minimum slope of 14% and a maximum slope of 35% with an average of 23% [37]. Only Zone 1 has been analyzed in this work. In Zone 1 there are 39 masonry buildings. For distinction and organization purposes, all buildings were labeled resorting to a unique code (Figure 4).

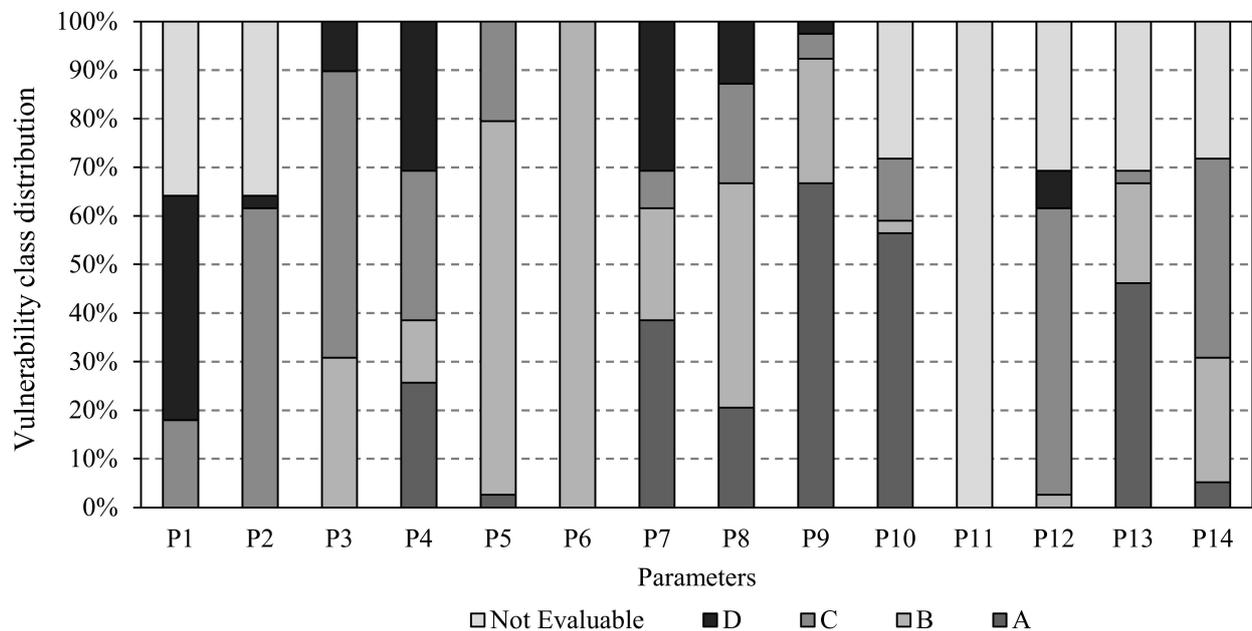
Figure 5. Vulnerability class distribution for each parameter throughout the total of samples.

Some challenges were found while assigning vulnerability classes for the parameters contained in the Vulnerability Index Method. As shown in Figure 5, some parameters were not evaluable for some buildings. This situation was often caused because of a lack of street images. Furthermore, parameter P11 (horizontal diaphragms) is unable to be assessed only from exterior images.

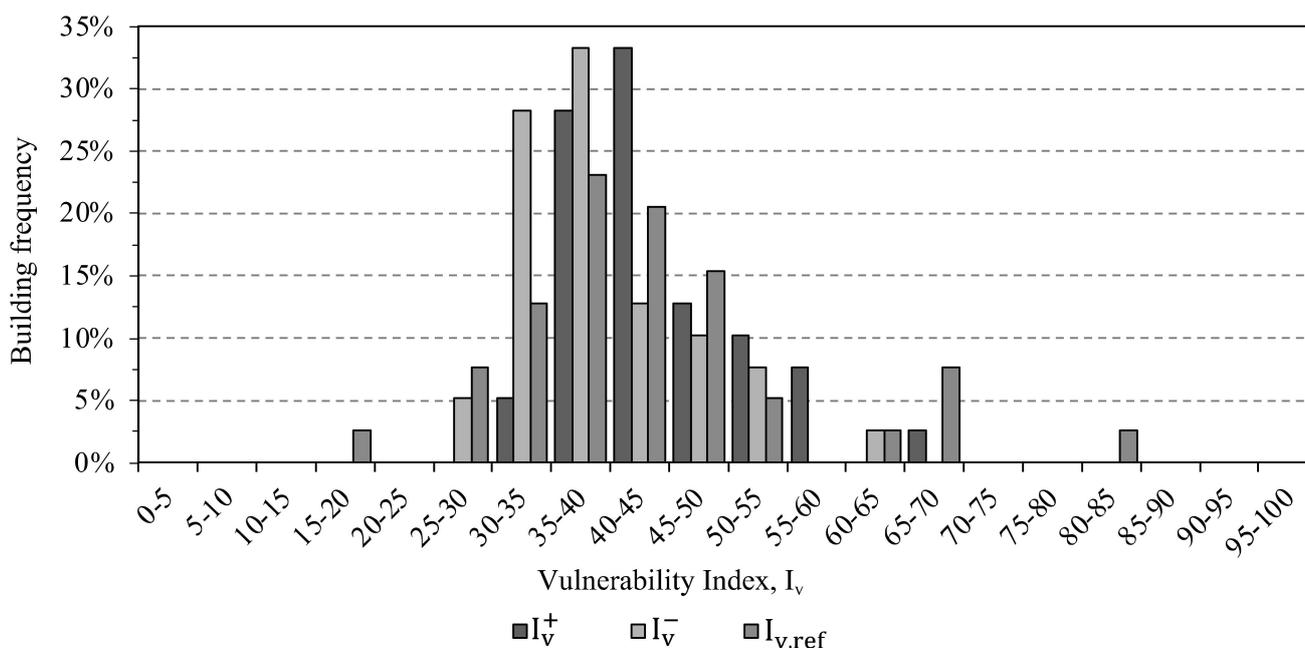
Figure 6. Vulnerability index obtained from $I_{v,ref}$, I_v^+ , and I_v^- , showing the normality of distribution.

In order to verify that the data followed a normal distribution, the Shapiro–Wilk test was performed on both groups of Vulnerability Index, I_v^+ and I_v^- . The hypothesis of normality was satisfied, with a value of p -value equal to 0.06 for both cases and therefore higher than $\alpha = 0.5$, assigned level of significance. The graphical representation of the frequency distribution of the reference vulnerability index $I_{v,ref}$ (corresponding to the vulnerability classes that were assessed on-site) and the comparison with higher and lower values computed, I_v^+ and I_v^- , are presented in Figure 6.

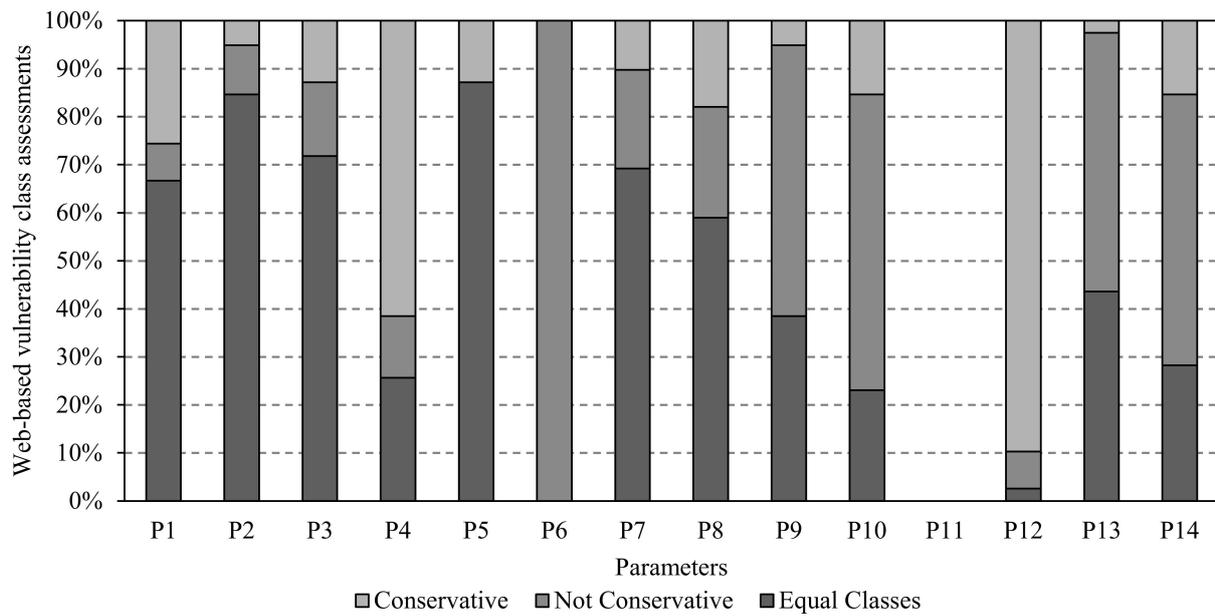
Figure 7. Comparison between the reference vulnerability index and the classes assigned using remote surveying.

Figure 7 illustrates the divergences found among the parameters that were effectively assessed by means of web-based images when compared to the on-site survey. It shows the proportion of web-based assessments that were conservative, non-conservative, and equal to the assessments performed in-situ. In most cases, the vulnerability classes assigned during the web-based survey correspond to those considered in the reference survey. Attention must be paid to the selection of the vulnerability class for Parameter 6 since this parameter is associated with the soil classification according to relevant National and International seismic design codes. Geological and geotechnical data can be retrieved by documents and data distributed by public administration but can also be estimated by means of the analysis of the topographical slope of the soil surface [38]. This methodology is certainly useful and validated at a large scale, but it can present some limitations in urbanized areas, where a more careful analysis of the built and natural environment must be carried out. In the case of the investigated area, it is worth noting that the area is characterized by a flat soil surface pointing out an alluvial subsoil generated by the floods of the nearby Lis river. Based on this, a “loose soil without impulse and without rock foundation”, Type D according to Eurocode 8 classification [39], was considered, differentiating on this point the work from a preceding one that referred to the same area [37].

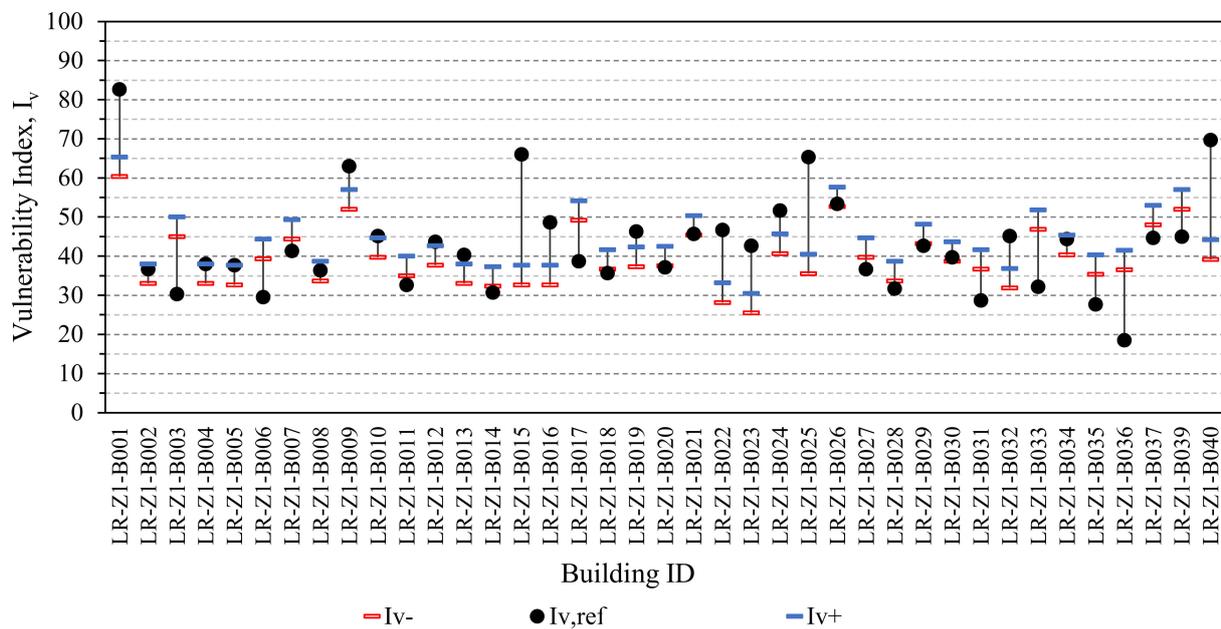
Figure 8. Comparison between the reference vulnerability index and the computed ranges by using remote surveying; the Building ID refers to the keys in Figure 4.

The graph given in Figure 8 shows, for each building, the relationships between the reference and herein obtained vulnerability indexes.

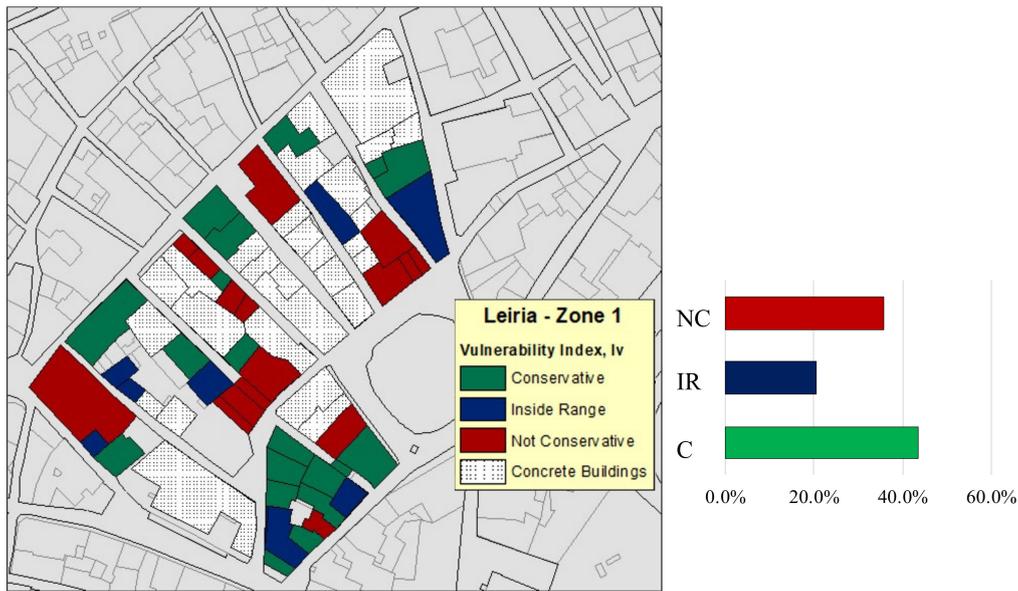
Figure 9. Comparison between the indexes calculated in this work and the field-campaign reference values.

Around 64% of the buildings resulted in a range of vulnerability index values that is higher or coincident with the reference value. The graph given in Figure 9 presents the percentages of the cases in which the reference vulnerability index falls within the computed range (more and less conservative scenario, I_v^+ , and I_v^-) and in which the same range of values is more or less conservative than the reference value. The GIS application software adopted in this study was ESRI ArcMap 10.8.1 [40].

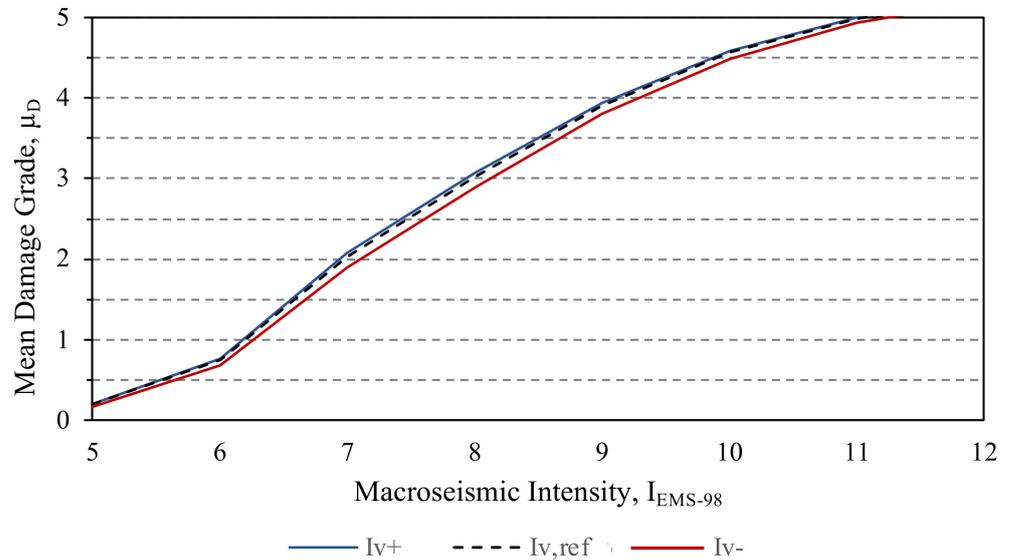
Figure 10. Vulnerability curves for the mean $I_v^+ = 44.15$, $I_v^- = 39.15$, and $I_{v,ref} = 42.88$. This curve exemplifies that the minimum and maximum values are reasonably close to reference values, supporting the hypothesis of having an accurate approach.

Following the above-presented analytical formulation, it is possible to obtain damage curves for a given I_V that represent a certain damage grade μ_D expected to occur because of a seismic event of a given macroseismic intensity. This damage grade represents a minimum value of 0 that represents no damage at all and a maximum value of 5, representing the total collapse of the structure. Figure 10 presents the construction of the curves for the mean I_V^+ , I_V^- and $I_{V,ref}$ found throughout the sample. The reference vulnerability curve fits within the range of the two curves calculated in the previous section.

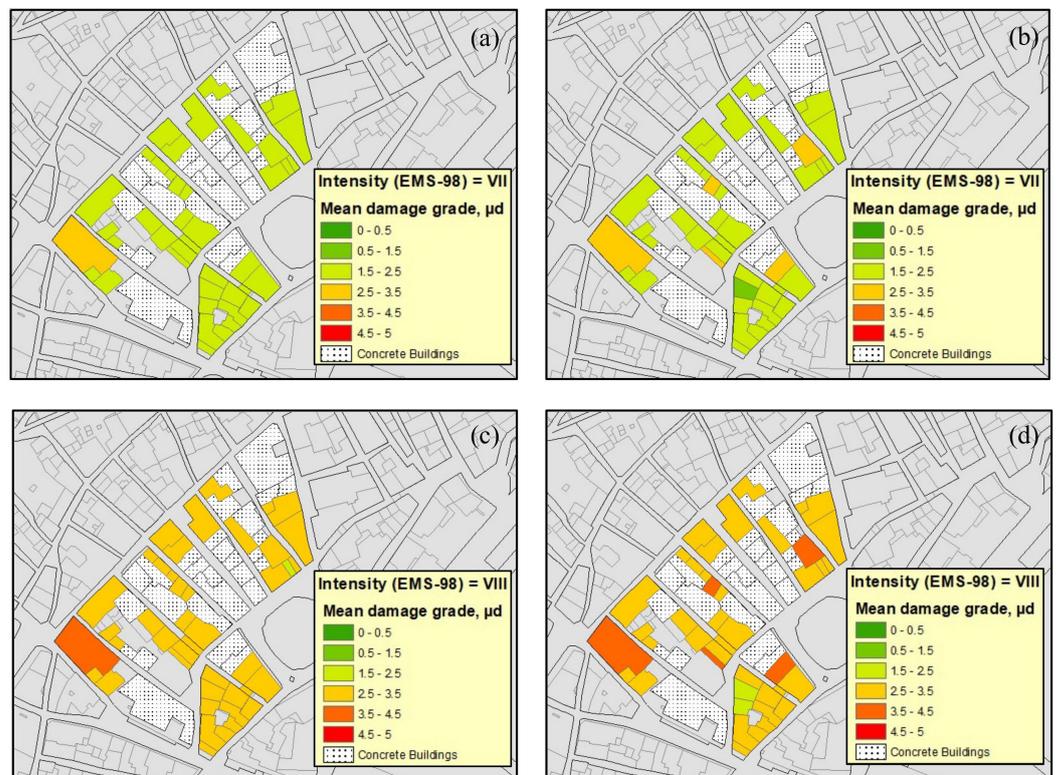
Figure 11. Damage scenario for different macroseismic intensities I_{EMS-98} , considering central values (a,c); and reference values (b,d) of the Vulnerability Index I_v .

The mean damage grade μ_D corresponding to the mean of the I_V^+ , I_V^- values of each building (from now named “central value”) was used in the following analysis. The mean damage grade μ_D was computed for two classes of macroseismic intensity (VII, VIII), for each building, and both for the central and the reference value of the vulnerability index. The comparison between the results obtained in this work is given through the GIS map

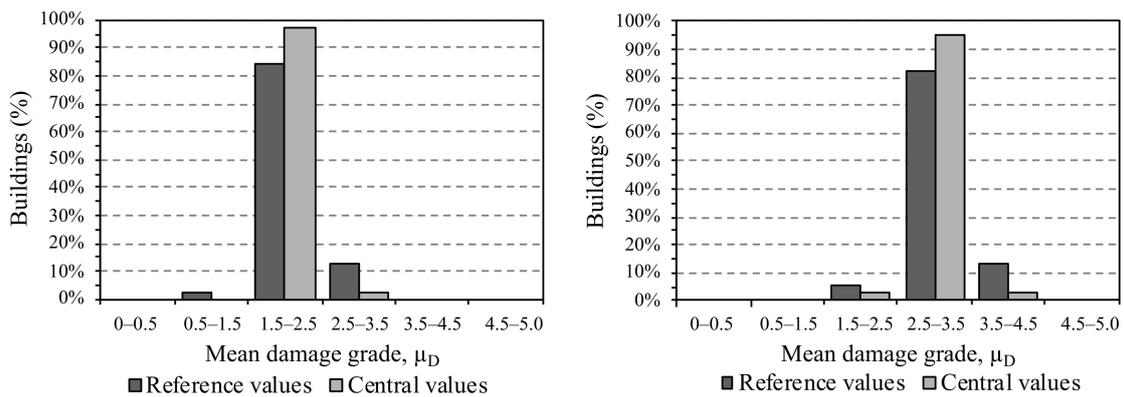
Figure 12. Mean damage grade distributions obtained from both approaches for $I_{EMS-98} = VII$ (left) and $I_{EMS-98} = VIII$ (right).

of Figure 11. The values of the mean damage grade μ_D computed were grouped into six classes, corresponding to the damage levels (Figure 12).

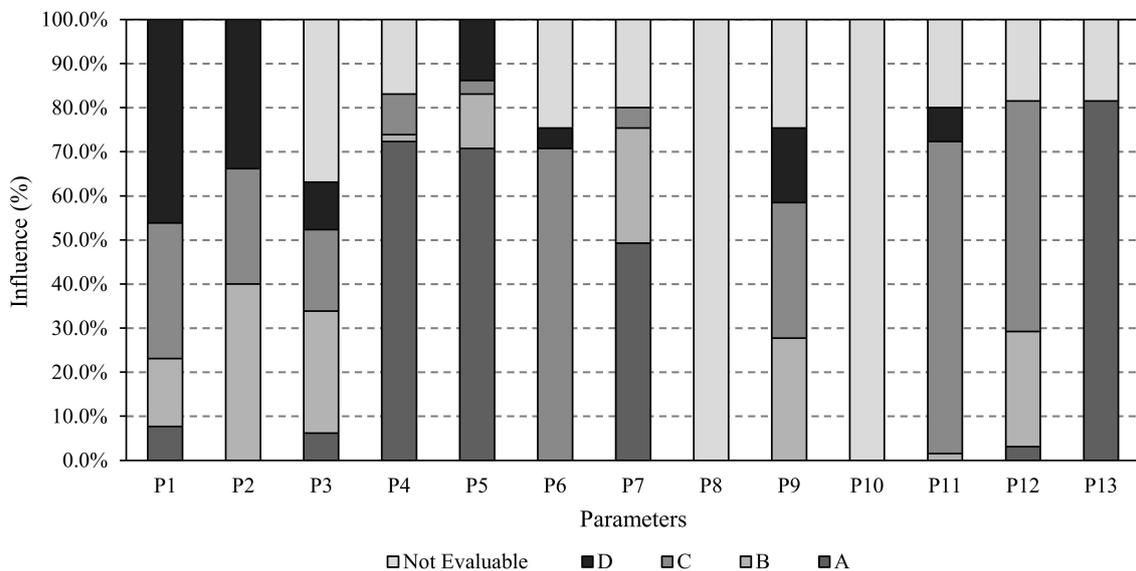
Figure 13. Vulnerability class distribution for each parameter, considering the façade approach.

An alternative way to estimate the seismic performance of existing masonry buildings moves from the idea that intrinsic features of the structure often prevent the box behavior under lateral loads. As a consequence, local mechanisms [42] play a key role in the definition of the vulnerability index. Performance estimation based on local mechanisms is herein addressed as façade approach, FA. All the buildings were analyzed under this specific assumption, and the corresponding Seismic Vulnerability Index, I_v , was computed. The procedure is like that presented in Section 5.1 but moves from a set of specific parameters identified in Table 5, as discussed in Section 3.1 (Figure 13). The challenges observed in the implementation of the building approach were present when performing this assessment, namely due to the lack of street images.

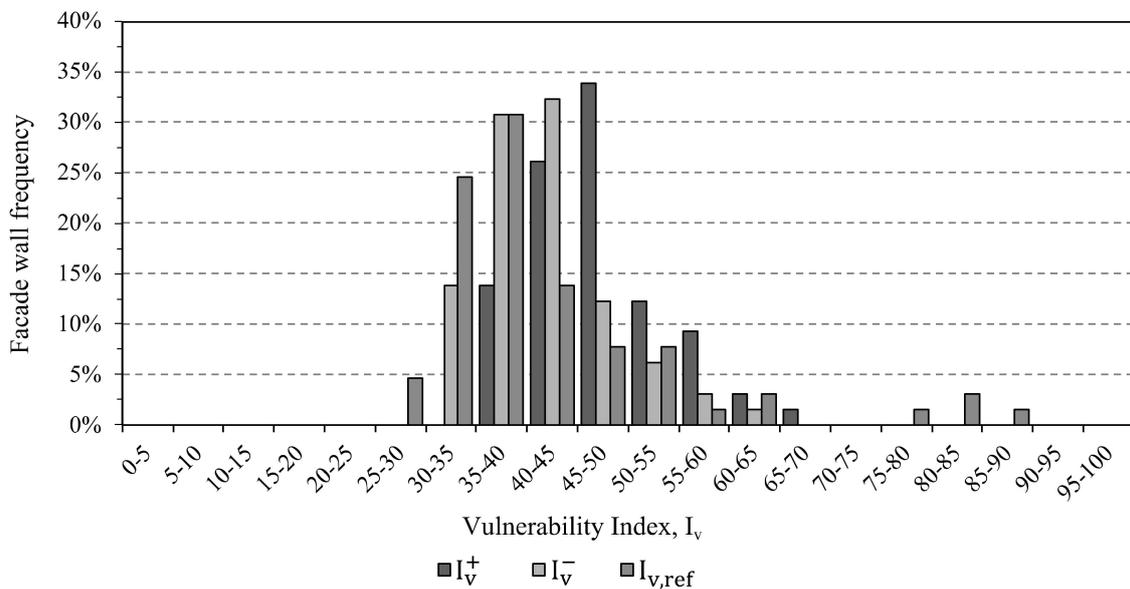
Figure 14. Vulnerability index distributions obtained from $I_{v,ref}$ and overall comparison. The hypothesis of normality was not sustained in this approach.

The Shapiro–Wilk test was performed on both groups of Vulnerability Index, I_v^+ and I_v^- . The hypothesis of normality was not satisfied, with a value of p -value equal to 0.01 for both cases and therefore lower than $\alpha = 0.5$, assigned level of significance (Figure 14). The graphical representation of the frequency distribution of the reference vulnerability index $I_{v,ref}$, and the comparison with higher and lower values computed, I_v^+ and I_v^- , are presented in Figure 15. Once again, the results of this work are more concentrated than the reference values.

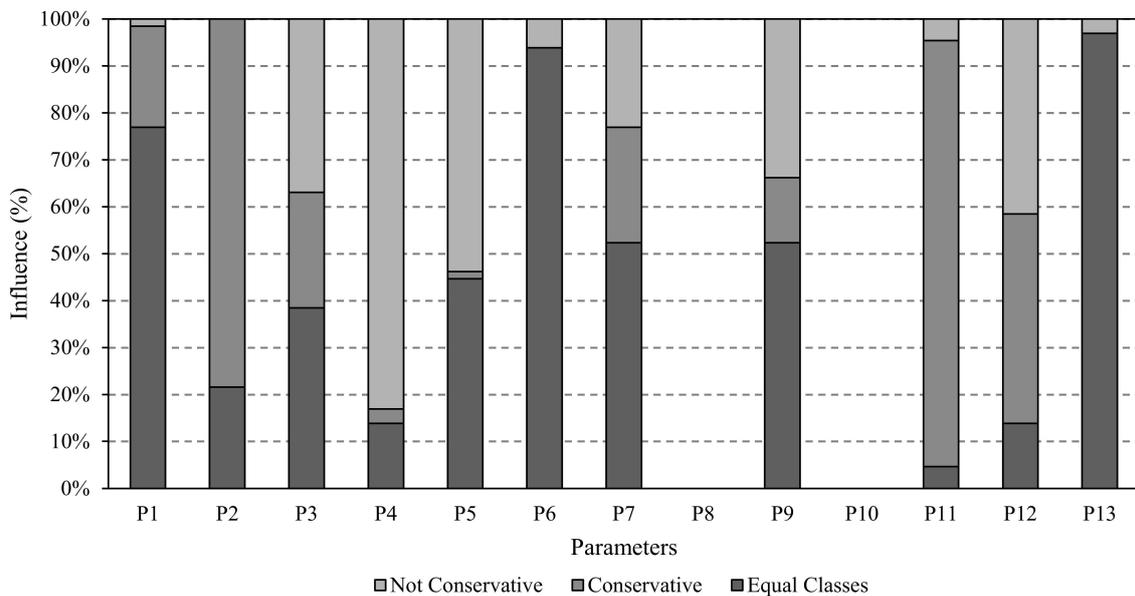
Figure 15. Comparison between the vulnerability classes assigned for each façade-related parameter.

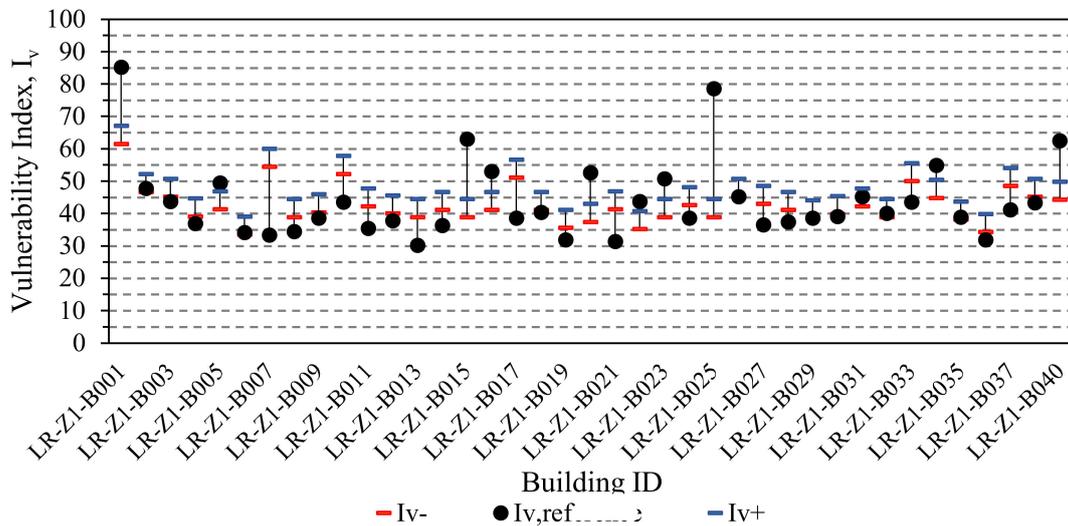
Figure 16. Comparison between the reference vulnerability index and the computed range.

The average reference value (42.42) is close to the lower bound of the calculated range of 42.34–47.90. The standard deviation value obtained herein is quite different from the reference one, 5.71 and 12.79, respectively. Figure 16 presents the ratio between the reference (in-situ survey) and the evaluation classes of the vulnerability parameters.

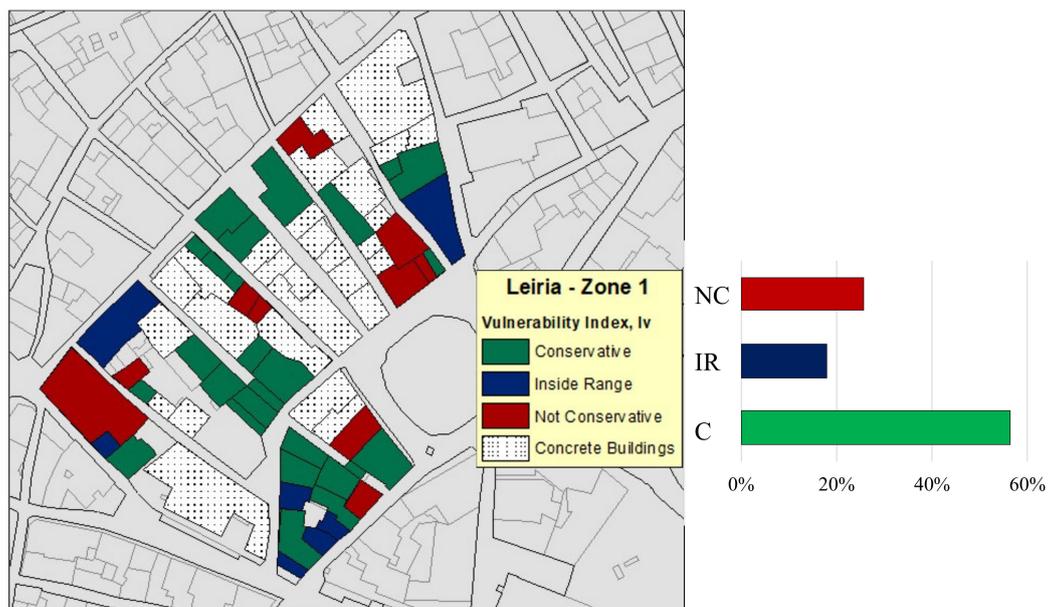
Figure 17. Comparison between the Vulnerability Indexes evaluated in this work and the reference values for the façade approach.

These results are coherent with the building approach. In fact, 6 of the 13 parameters evaluated show a compatible vulnerability class. The vulnerability classes assigned in this work are the same as those calculated in the reference work. The graph in Figure 16 presents the relationship between the computed and the reference values. It is important to note that each building was assigned the maximum vulnerability index value computed considering all the relative façades. Approximately 74% of the buildings show a vulnerability index value higher or coincident with the reference value (Figure 17).

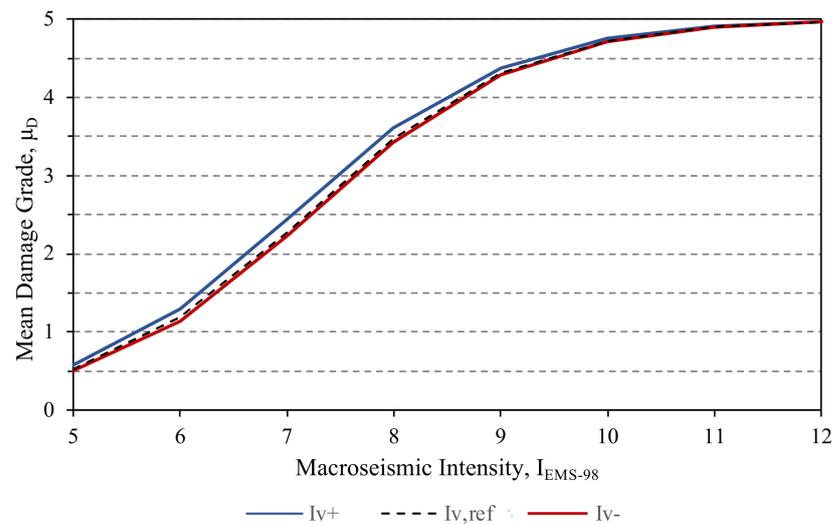
Figure 18. Vulnerability curves for the mean $I_v^+ = 47.90$, $I_v^- = 42.34$, and $I_{v,ref} = 42.42$. Minimum and maximum values are close to reference values, supporting the feasibility of the approach.

The Vulnerability Index for the façade walls was calculated using Equations (3) and (4), and adopting the following coefficients: $a = 2.51$, $b = 2.5$, $c = 5.25$, and $d = 11.6$; and a ductility factor $Q = 2.0$, as recommended by Ferreira et al. [43]. The application of this analytical formulation led to the following vulnerability curves: the upper and the lower average value of the vulnerability index distribution are plotted side-by-side with the reference vulnerability curve.

The reference vulnerability curve fits within the two computed vulnerability curves, such as for the building approach. The central value of the range of vulnerability index was used in the following analysis and shown in Figure 18. The mean damage grade μ_D was computed for two classes of macroseismic intensity (VII, VIII) and compared with the reference value of vulnerability index distribution (Figures 19 and 20).

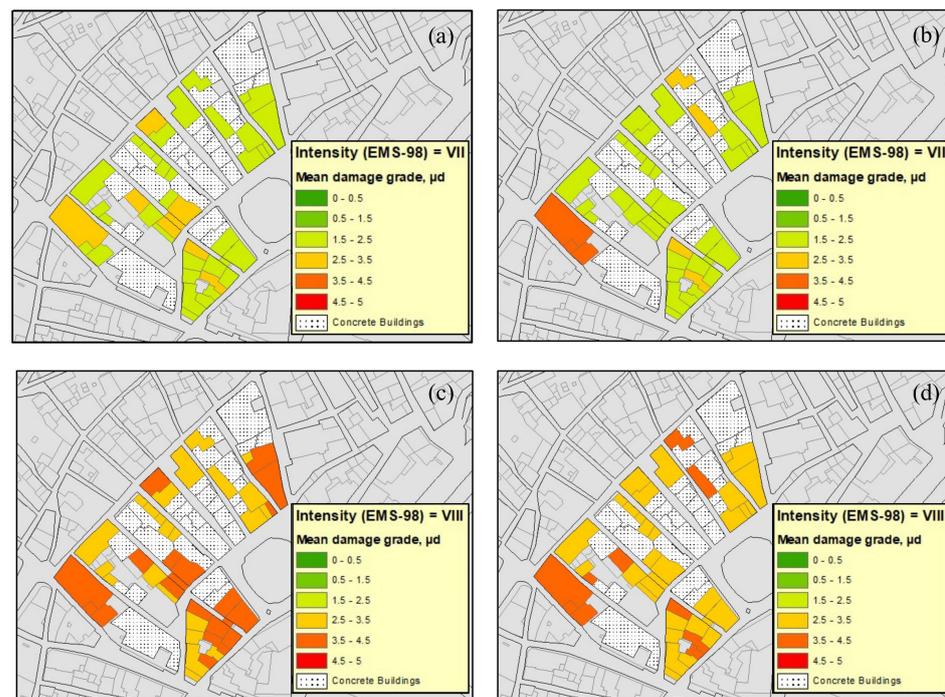
Figure 19. Damage scenario for different macroseismic intensities I_{EMS-98} , considering central values (a,c) and reference values (b,d) of Vulnerability Index I_v , based on the façade approach.

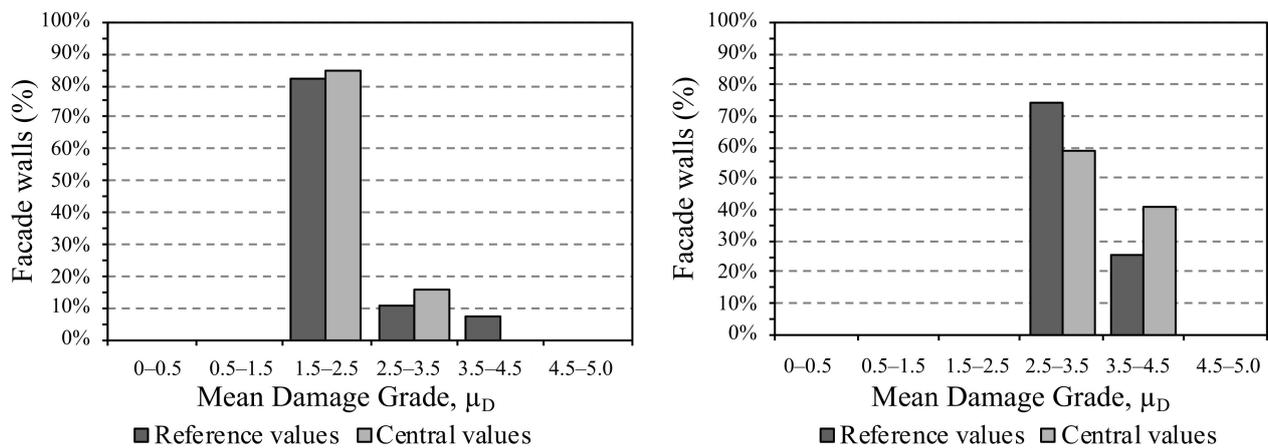
Figure 20. Mean damage grade distributions obtained from both intensities: $I_{EMS-98} = VII$ (left) and VIII (right) for the façade approach.
