Developing Test Methods for Compression after Lightning Strikes

Abstract

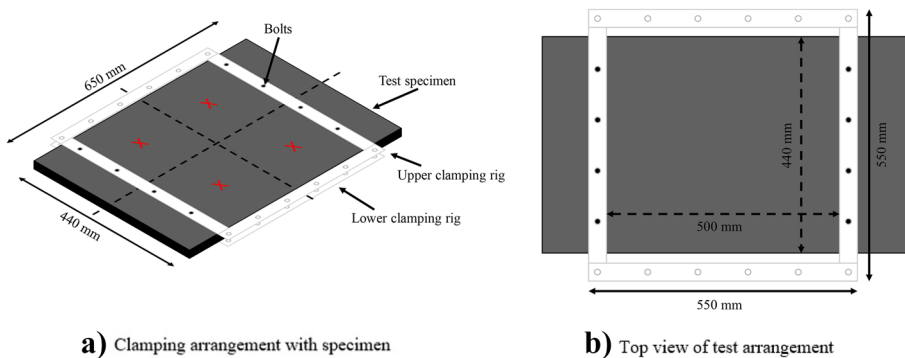
Fig. 1 Lightning specimen **a)** in the test bed (strike points shown with red x's), and **b)** its clamping arrangement

The material used in these tests was Hexcel's HexPly[®] IM7/8552 carbon/epoxy pre-preg with a nominal ply thickness of 0.125 mm. The stacking sequence was quasi-isotropic [45/90/-45/0]_{4s} for all specimens. The nominal overall thickness was 4 mm. A large test panel was designed (650 mm × 440 mm) and was struck in four quadrants to ensure material homogeneity and uniformity in manufacture. Figure 1 shows the schematic of the test specimen between the reinforced stainless-steel frame underneath and a white stainless-steel frame on top to distribute the loading pressure. Holes were drilled along the short edges and the specimen was bolted through these holes to securely fix the test specimen between the top and bottom frames. Figure 1b shows the dimensions of the top and bottom clamping frames and the resulting test area. This test area (500 mm × 440 mm) was then sectioned into four quadrants, one for each lightning test. Ideally, multiple lightning strike tests should be done at each current, but due to the cost and complexity of lightning tests and the current lack of data, valuable information can still be obtained with single strike tests in the current study.

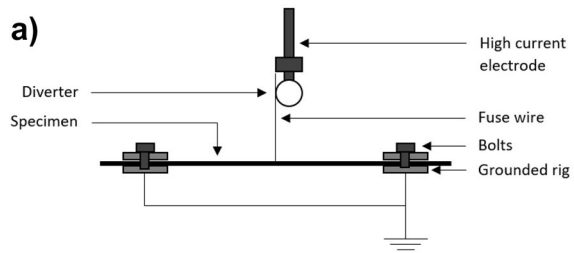
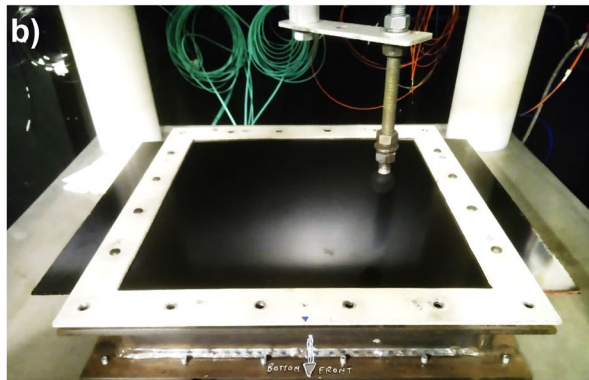
Fig. 2 Laboratory generated lightning strike test arrangement, **a)** labelled schematic, **b)** image of specimen in setup before test

The test specimen was bolted into a grounded rig at two opposite short sides below a high voltage electrode as shown in Fig. 2. This clamping arrangement was chosen since the specimen was longer and narrower than the testing rig. The bolted connection along both short edges maintains firm and tight contact between the specimen and the grounding clamps. The purpose of the bolts is to ensure tight contact between the specimen surfaces and the

grounding clamps, which is the primary route to ground for the injected specimen current. A very small fraction of the induced current may flow through the bolts from the specimen to the grounding clamps, but any such local effects are between the grounding upper and lower clamp and relatively far from the lightning attachment point (approximately 150 mm). The bolts have a small diameter (~ 8 mm) and the bolt holes will not be within the final post-strike test specimens. The drilling process is not expected to have any tangible effect on the mechanical properties of the specimen and resulting CAL strength. The use of different electrode sizes and shapes have been studied within the literature and this has been shown to affect the size of the predicted lightning damage [55–57]. Therefore, in this work to minimise variability, a small insulating plastic sphere, known as a diverter, was used to minimise any material being blown from the electrode onto the sample surface during the experiment, and a thin metallic fuse wire was used to guide the lightning arc to the exact point as required on the sample. The fuse wire, with a gap distance of 50 mm, instantaneously atomises during the initial stages of the arc formation and has no effect on the current flow or damage to the specimen.

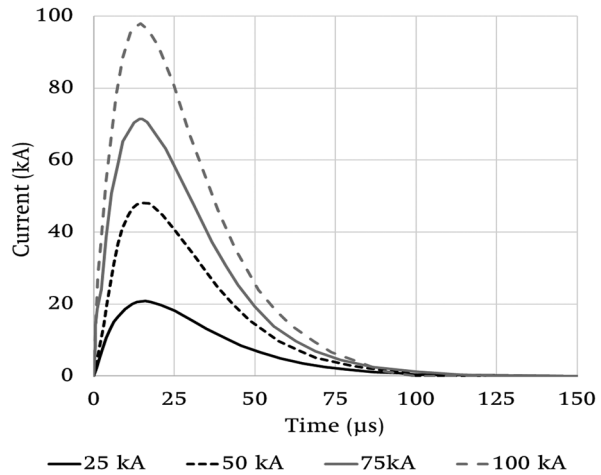
Fig. 3 Four laboratory generated D lightning waveforms with different peak currents

use of 250 mm×220 mm quadrants should be sufficient to contain the damage of the current waveforms used in this study. Figure 3 presents the injected current waveforms, showing slightly lower peak currents than the stated values. For example, the 25 kA waveform has an actual peak current of 21 kA. However, for convenience the four waveforms will be referred to as 25, 50, 75 and 100 kA throughout this paper. After these experiments, the specimen was carefully cut into its respective quadrants using a diamond-coated disk for further analysis.

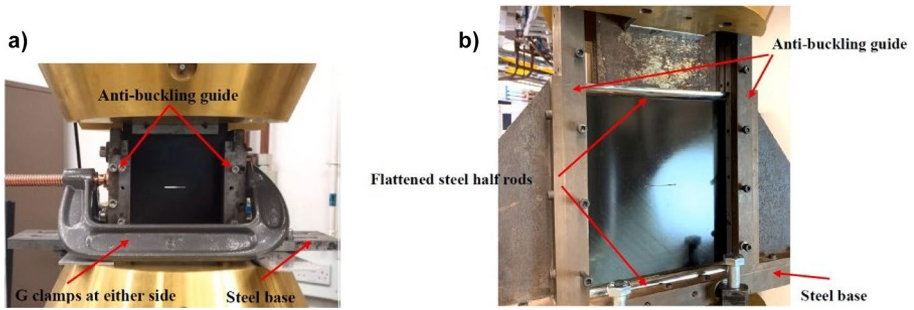
Fig. 4 Modified CAI jigs [59]: **a)** 120 mm wide notched specimen clamped to the test machine and **b)** 220 mm wide notched specimen edge-loaded

Previously, two CAI jigs (Fig. 4) modified from the standard CAI test jig [58] were successfully used to study the strength scaling in notched compression tests [59]. These jigs were selected for this study because their design would enable easy accommodation of a wide range of specimen dimensions from 120 to 220 mm in width. Unlike the standard CAI test boundary conditions, steel jaws were used in the smaller rig to clamp the top and bottom ends of the specimen over a width of 100 mm. Anti-buckling guides were then used to gently constrain the slightly wider specimen (Fig. 4a). The purpose of these modifications was to reduce the risk of global buckling when using large specimens with lightning damage, which may initiate failure at higher load than impact damage (which the rigs were originally designed for). Therefore, this smaller modified CAI jig can be used to adapt to the range of damage resulting from the artificial lightning strikes. The same clamping modification cannot be made to the larger jig (Fig. 4b) due to the limited width of the steel jaws of 100 mm. The modification to the larger jig is only to its size.

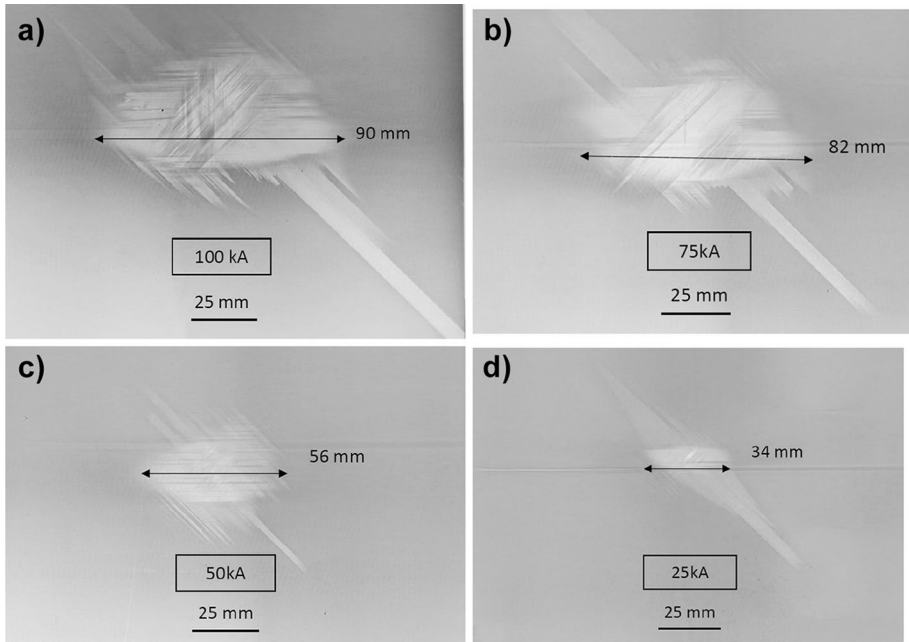
Fig. 6 CT images showing extend of internal damage after lightning strikes with a peak current of **a)** 100 kA, **b)** 75 kA, **c)** 50 kA, and **d)** 25 kA, respectively

The CT images taken through the specimen thickness, in Fig. 6, show the extent of damage in each sub-divided large test panel section and how this varies with peak current amplitude. These damage profiles dictate the CAL specimen dimensions by showing the extent of the maximum in-plane internal lightning damage through the thickness after lightning strikes at 100, 75, 50 and 25 kA peak currents, respectively. The internal damage did not reach the specimen edges so the damage in the four quadrants could not overlap in the panel.

The lowest current is expected to have the highest residual compressive strength, so the 25 kA case (Fig. 6d) is believed to be the hardest to test under compression. Therefore, CAL tests were conducted in decreasing order of peak current (100 to 25 kA) and hence decreasing damage volume to converge on an experimental design suitable for the range of peak currents.

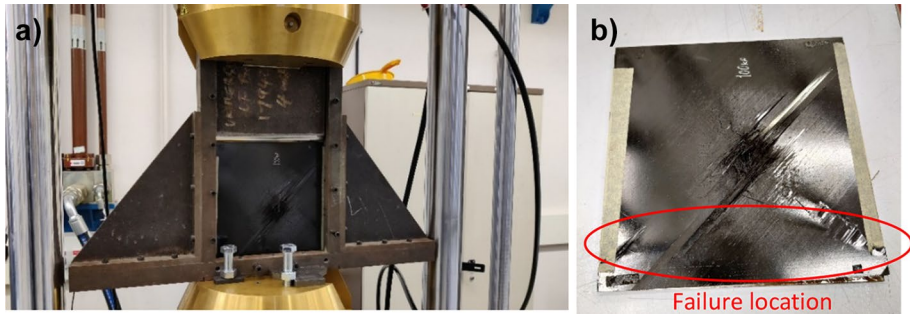
Fig. 7 100 kA CAL test a) set-up and b) failed edge-loaded specimen

The CAL specimen for the 100 kA peak current had to be large enough such that the damage area did not reach the edge of the specimen. The internal damage area was around 90 mm wide, therefore too close to the 100 mm standard CAI specimen width. When cutting down the specimen, the internal damage is also invisible, so it is extremely hard not to interfere with the lightning damage area during cutting with only 5 mm margin on either side. Therefore, the test panel was cut into a CAL specimen of 220 mm × 220 mm with the lightning damage centred at the horizontal and vertical midpoint of the specimen. Another option would have been to ignore the surface damage and cut the specimen to the standard size. However, this would have resulted in damage at the CAI specimen edge or within or near the compression test boundary conditions. In this case, damage could be expected to influence failure of the specimen in compression and the surface damage disproportionately impact the performance of the specimen. This resulted in a distance greater than 65 mm between the edge of the internal lightning damage and the edge of the specimen based on Fig. 6a. In this case the only change to the standard CAI test procedure, outlined in ASTM D7137 [58], was the specimen geometry.

The lightning damage did not initiate specimen failure and the specimen loading increased to a point where excessive out-of-plane bending was observed due to buckling. This caused an undesirable failure mode near the edges of the specimen (220 MPa, gross section), shown in Fig. 7b. It is speculated that because the lightning damage did not initiate specimen failure at a lower load, additional clamping constraints at both edges would have been necessary to eliminate the buckling behaviour and result in a direct damage-initiated material failure. This result is seen as undesirable. Smaller specimens and more constraints could reduce the tendency of buckling.

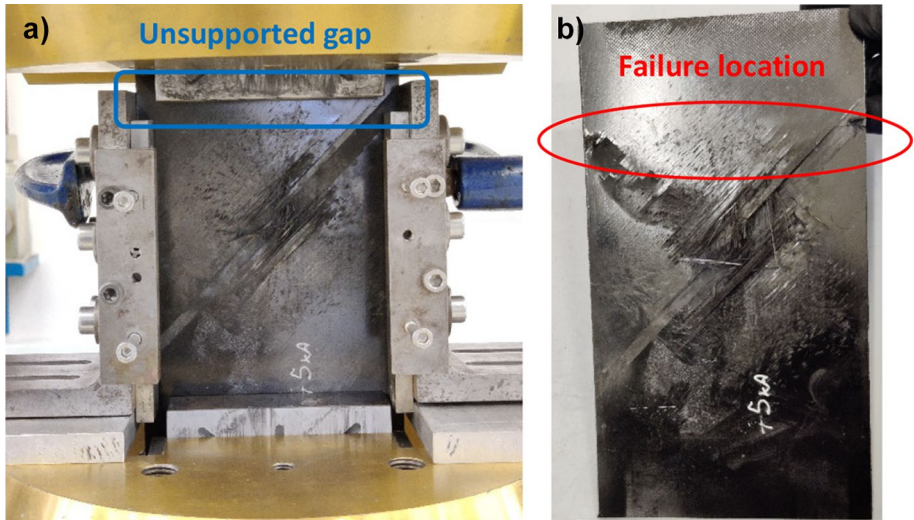
Fig. 8 75 kA CAL test a) set-up with an unsupported gap and b) failed clamped specimen

Given the challenges observed with the 100 kA specimen, the 75 kA peak current specimen was cut down to 120 mm × 150 mm. This made the specimen closer to the standard CAI size of 100 mm × 150 mm. This could be achieved because the lightning damage area was smaller for the 75 kA peak current lightning strike. This resulted in a distance greater than 19 mm between the edge of the internal lightning damage and the edge of the specimen based on Fig. 6b. However, the surface delamination was more extensive and reached the specimen edges as shown in Fig. 8a. The top and bottom edges of the specimen were also clamped to the test machine. It was expected that both measures (cutting down the specimen and specimen clamping) could reduce the tendency for buckling and out-of-plane bending. Failure occurred between the lightning damage and the end of the anti-buckling guides (264 MPa, gross section), shown in Fig. 8b. Because the failure location was at the unsupported gap in the jig but not at the specimen centre, this result was undesirable.

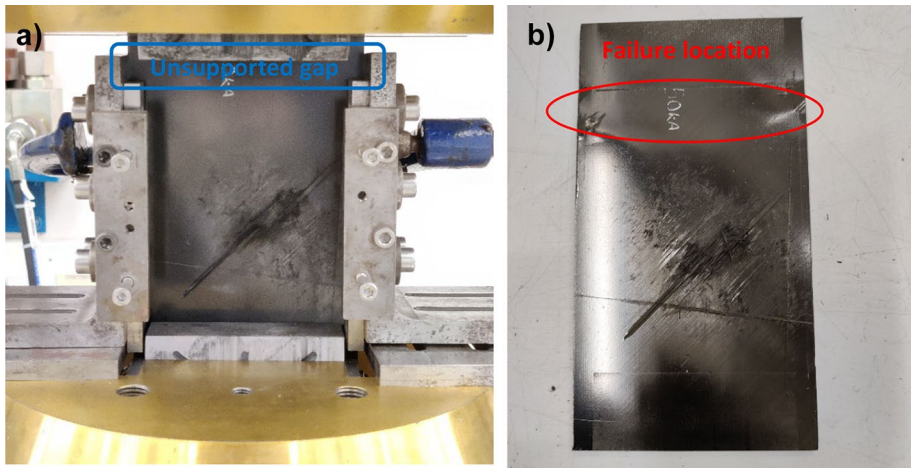
Fig. 9 50 kA CAL test a) set-up with an unsupported gap and b) failed clamped specimen

Given that the damage area decreased again for the 50 kA peak current specimen, the same specimen size as the 75 kA specimen could be used, 120 mm × 150 mm. This resulted in a distance greater than 32 mm between the edge of the internal lightning damage and the edge of the specimen based on Fig. 6c. It was expected that the failure load would be higher, but this was not the case (267 MPa, gross section), shown in Fig. 9. Failure was away from the lightning damage and at the end of the anti-buckling guide. This again highlights the limitation of the present CAI set-up as the lightning damage did not initiate specimen failure. Specimen failure was initiated where there is a small gap between the

upper loading point (grips in the current set-up) and the edge of the anti-buckling guides. The combination of compression, buckling and an unsupported gap at the corner of the specimen, initiated failure. Therefore, this setup and result was seen as undesirable. Additionally, given that the failure stress was like the preceding 75 kA specimen it confirms that the preceding test was undesirable due to buckling.

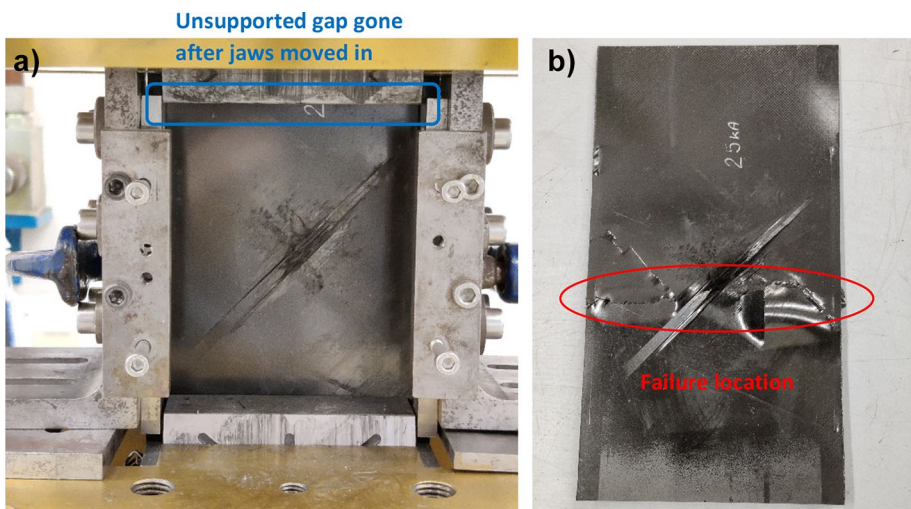
Fig. 10 25 kA CAL test a) set-up without unsupported gaps and b) failed clamped specimen

The damage area was smallest for the 25 kA specimen, therefore, the specimen was kept the same as the 75 kA and 50 kA peak current specimens (120 mm × 150 mm). This resulted in a distance greater than 43 mm between the edge of the internal lightning damage and the edge of the test rig boundary conditions based on Fig. 6d. Since the delamination was smallest, the expected failure load was highest. To avoid producing the same undesirable failure modes as the preceding tests, further modifications were made to the CAI jig. The previous unsupported gap was therefore eliminated. This was only possible by using a slightly wider specimen than the CAI standard, allowing the steel jaws to move down further without touching the anti-buckling guides. All edges of the specimen were constrained throughout the test. Failure was right in the specimen centre at the lightning damage (317 MPa, gross section), as shown in Fig. 10. The mode of failure indicates that this was a successful test.

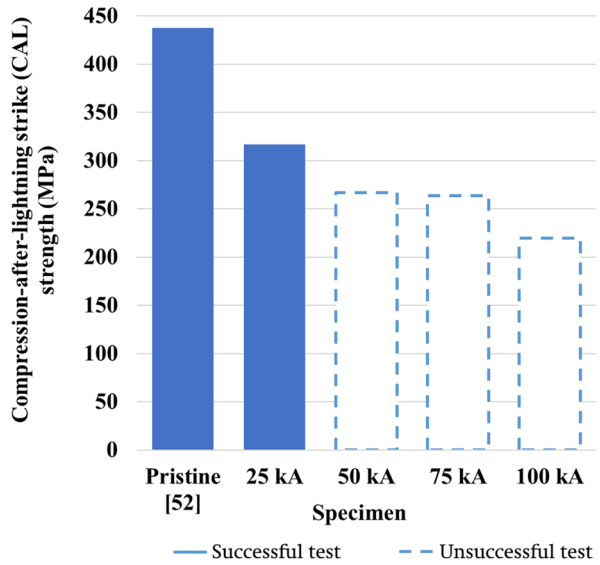
Fig. 11 Reduction in CAL strength from pristine to 25 kA peak current specimens

A summary of the reduction in CAL strength from a pristine composite specimen to a specimen subjected to 25–100 kA peak current strikes is shown in Fig. 11. The 25 kA specimen is 28% weaker than the pristine CAI strength (438 MPa [52]) of the same material and

a quasi-isotropic layup owing to the presence of lightning damage. The tests with higher peak currents were undesirable due to buckling and failure location at the unsupported gap in the jig, not at the specimen centre.

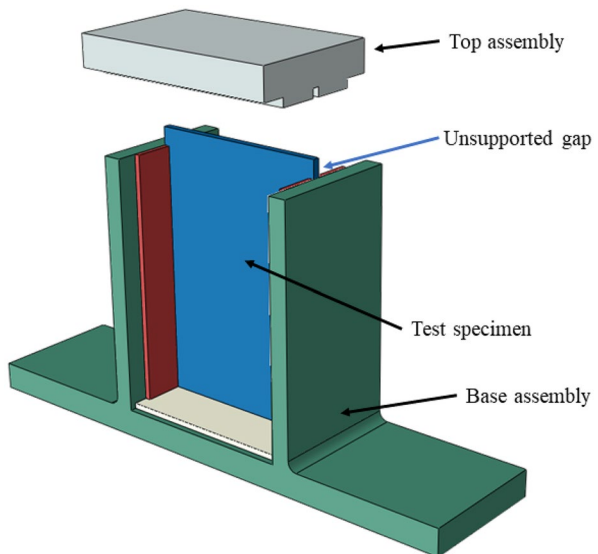
Fig. 12 ASTM D7137/D7137M standard [58] set-up with an unsupported gap

area before failure occurred at the test boundary conditions. As shown in Fig. 12 [58], there is an unsupported gap in the CAI jig which may initiate failure first if the damage in the test specimen does not initiate failure below 264–267 MPa for the tested combination of composite material and laminate stacking sequence. When this weakness in the setup was removed, the CAL strength for the selected material and laminate with damage from an artificial lightning strike with a peak current of 25 kA was found to be 317 MPa. These modifications effectively changed the failure location from the undesirable specimen edge to the centre, at the lightning damage region.
