Conserving history in changing arid environments: a geomorphological approach

Lisa Mol, Heather Viles

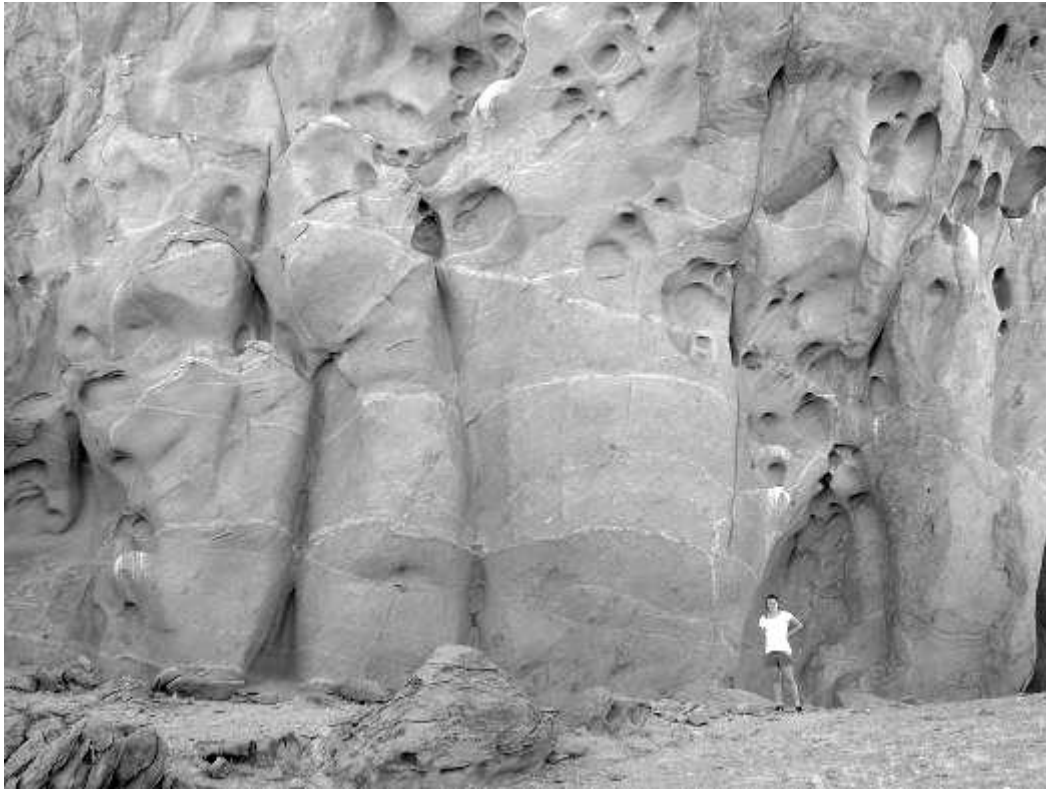
Figure 1: Salt weathering of a granitic inselberg, Namibia. Photo: Heather Viles

Research has shown that especially salt weathering is a destructive force, causing accelerated flaking and exfoliation of the surface (Goudie and Viles, 1997; Kuchitsu *et al*, 2000; Mottershead *et al*, 2003; Smith *et al*, 2005; Hosono *et al*, 2006). Figure 1 shows the impact of salt weathering on at the granite inselberg of Mirabib, central Namib desert. These inselbergs within Namibia are home to important archaeological sites such as extensive rock art sites and other evidence of early-human populations.

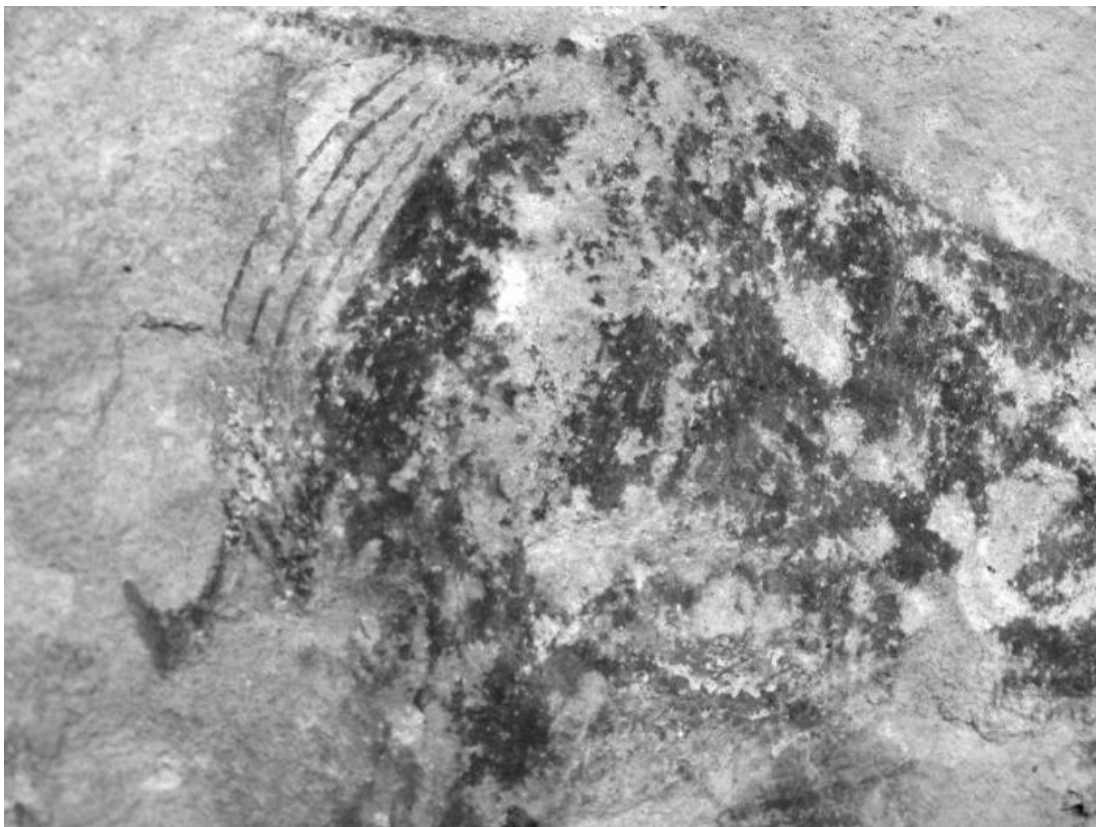
Figure 2: Damaged rock painting in the GGHNP showing the neck and part of the back of an eland

Unfortunately the rock face in these shelters is prone to crumbling, flaking and crack formation, threatening the canvas of the rock art (see figure 2). Because their rock faces are generally sheltered from direct exposure to rain and sunshine, they make ideal study sites for internal processes.

Clarens sandstone is grainy, friable and generally prone to high weathering rates. Its porous nature allows for continuous flow of moisture through the rock face. These flows are concentrated in outlets on the rock surface, where the moisture leaves the rock through small honeycomb-type outlets. This creates an environment in which cyanobacteria thrive, colonizing the pockets underneath semi-detached flakes and building substantial colonies. These are joined by algal colonies which are predominantly situated directly by the moisture outlets. This dynamic environment creates a problem for the rock art situated in this area, as detachment of the rock surface means an immediate and irrevocable loss of the rock art.

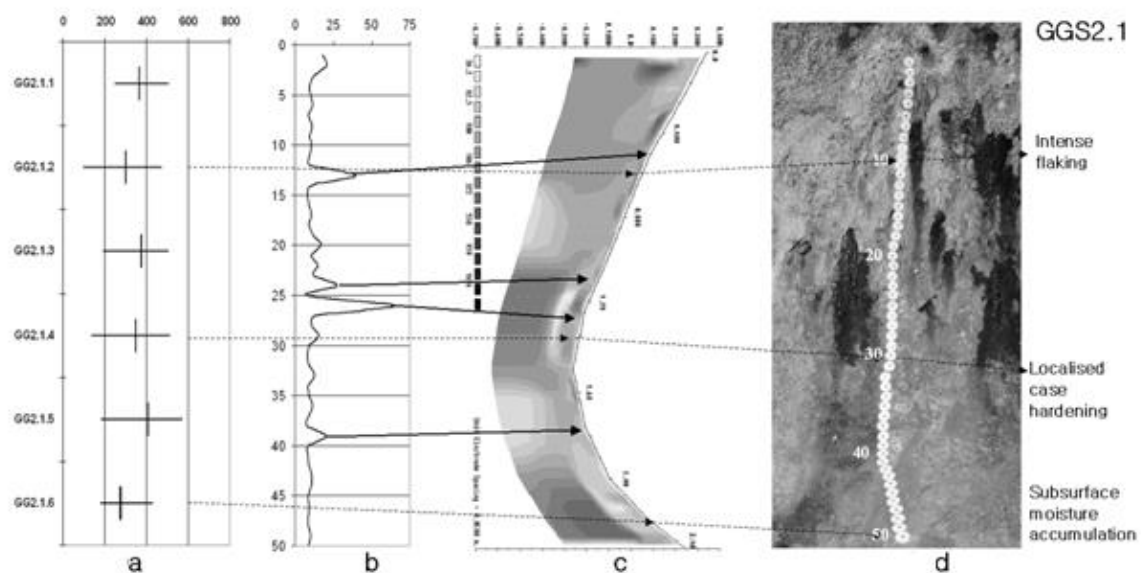
Source: Modified from Mol and Viles (2010)

Figure 3: Example of field data correlation of site 2 in the GGHP showing the relationship between lower surface moisture accumulation and surface weathering

Our measurements showed that there is a direct correlation between internal moisture accumulation and surface weathering (Mol and Viles, 2010). Where there is an accumulation of moisture the surface shows significantly lowered rock surface hardness values (as measured with the *Equotip*, see figure 3), indicating flaking, crumbling and general deterioration of the rock surface mineral structure. The moisture accumulation is further shown using near-surface saturation as measured with a *Protimeter* (figure 3 b). These are then correlated to the ERT measurements (figure 3 c) and field observations (figure 3 d). This research was carried out to further our understanding of the extremely complex interaction between moisture and weathering. A number of factors can influence the interaction between moisture and surface such as temperature, exposure although preliminary research suggests that internal moisture is relatively unaffected by outside temperatures, and that the nature of the internal moisture regime is a key-element in rock surface deterioration.

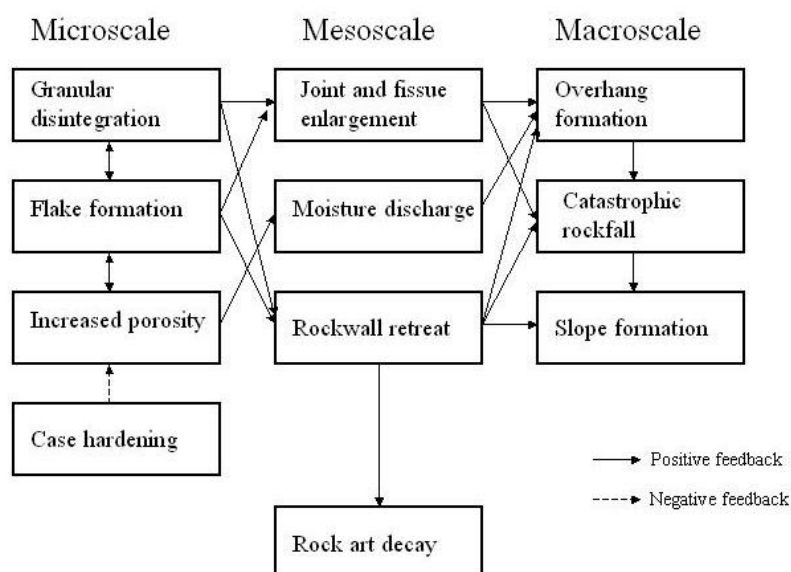
Figure 4: Flow diagram of the complexity of scale within a single research study

This figure illustrates the many connections on micro-, meso- and macro scales and the difficulty in ‘disentangling’ these.

So where does this interplay of a vast array of both internal and external weathering processes leave us? Despite the advances in weathering studies and techniques we are still stuck somewhere between a rock and a hard place really. As in most scientific disciplines, the need to see the small detail often conflicts with the necessity to understand the larger picture. It is possible to study and understand every minute weathering process that could take place on a particular rock face in a small part of a remote valley. It is also possible to study the general weathering effects of precipitation on sandstone globally. Both types of studies are helpful but neither achieves the ultimate goal of understanding weathering processes in any stone type in any environment. In addition to this, the difficulty of upscaling or downscaling conclusions drawn from specific studies is sometimes an obstacle that simply cannot be overcome (see for example Viles, 2001, for a comprehensive discussion on scale issues) The continuous interplay of factors increases the complexity of the situation even further. Figure 4 shows an example of the complexity of scale within research. In this case it is an investigation into rock weathering in southern Africa.

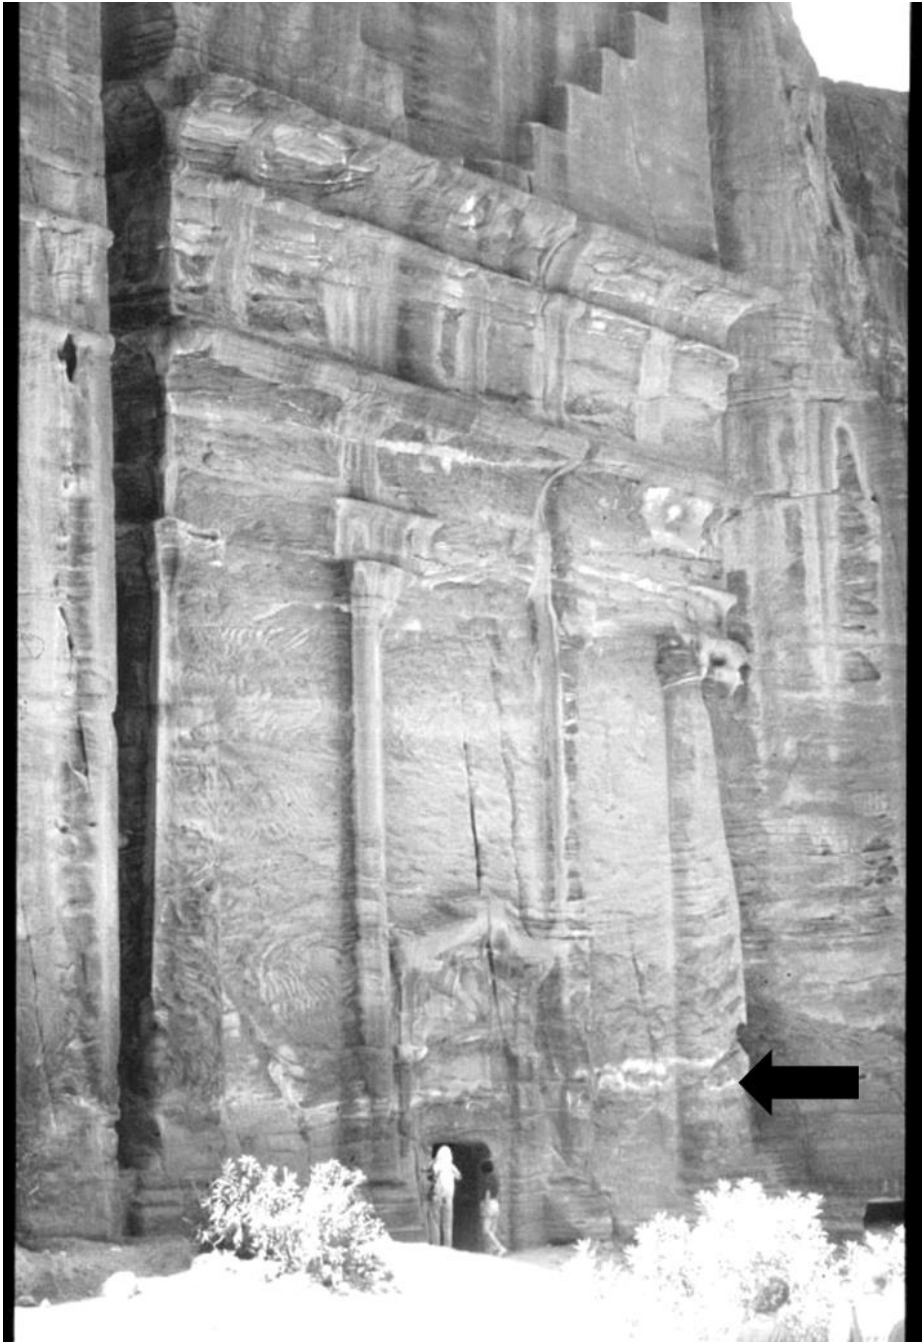
Figure 5: Weathering damage on the facade of the temples of Petra; the arrow indicates the capillary rise to above human height, illustrating the possibility of deterioration from soluble salts.

However, this continued attention also brings with it a large number of problems. Unfortunately as well as a World Heritage Listing, it also regularly features amongst the most endangered sites (World Monument Fund 2009) because of increased magnitudes of weathering (Akasheh, 2002; Paradise, 2005; Waltham, 1991). The continued stream of tourists brings with it sweat and laboured breath, increasing humidity and salt content in the air which precipitates onto the rock. Add to this touching of the walls with sweaty, sun block covered fingers and a toxic mix of chemicals is added to the natural deterioration processes which are already attacking the stone surfaces. Smith (1986) studied the problems of humidity and erosion and found that in particular tafoni formation has intensified, but that weathering rates on the stone surface of Petra are high in general and pose a substantial risk to the future of these structures (see figure 5). Paradise (2005) showed that in a relatively short time span, the walls had retreated significantly due to the chemical deterioration of the surface and the increased humidity, both of which can be directly linked to the increased stream of tourists.

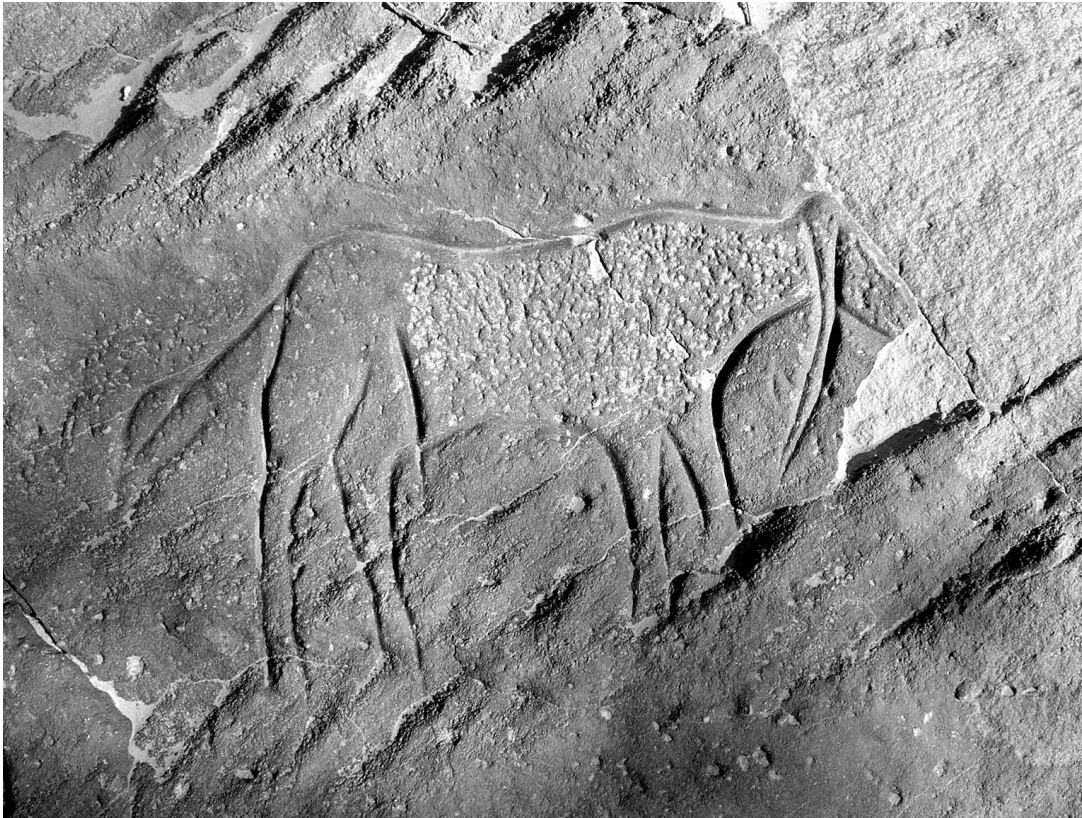
Figure 6: Engraving of a bull, MEssak Settafet plateau, Libya. Photo: Heather Viles

The rock art of the Tuareq, Libya, for example is under constant threat of weathering damage. The friable sandstone is prone to deterioration through crumbling, flaking and cracking of the surface. Figure 6 shows an engraving of presumably a bull which is surrounded by a flaking and cracking rock surface.

The Messak Settafet in SW Libya is a sandstone plateau within the Sahara Desert with plentiful and important engraved rock art. The climate today is hyperarid, but much evidence points to wetter conditions in the past, such as around the early to mid Holocene. The rock art probably dates back to about 3000 to 6000 years ago, when conditions started to dry out in the area. Much of the rock art is carved into sandstone surfaces which exhibit a dark brown patination, thought to be a desert varnish rich in iron and manganese oxides. Salt efflorescences are commonly found on the rocks within which the engravings are found, especially within cracks and shaded overhangs. Whilst the conditions today are generally too dry for much activation of the salts to occur, if future climate change caused any increase in precipitation the rock art could become seriously threatened. Already it is apparent that the rock surfaces flake easily around cracks and within sheltered areas where more moisture can accumulate.

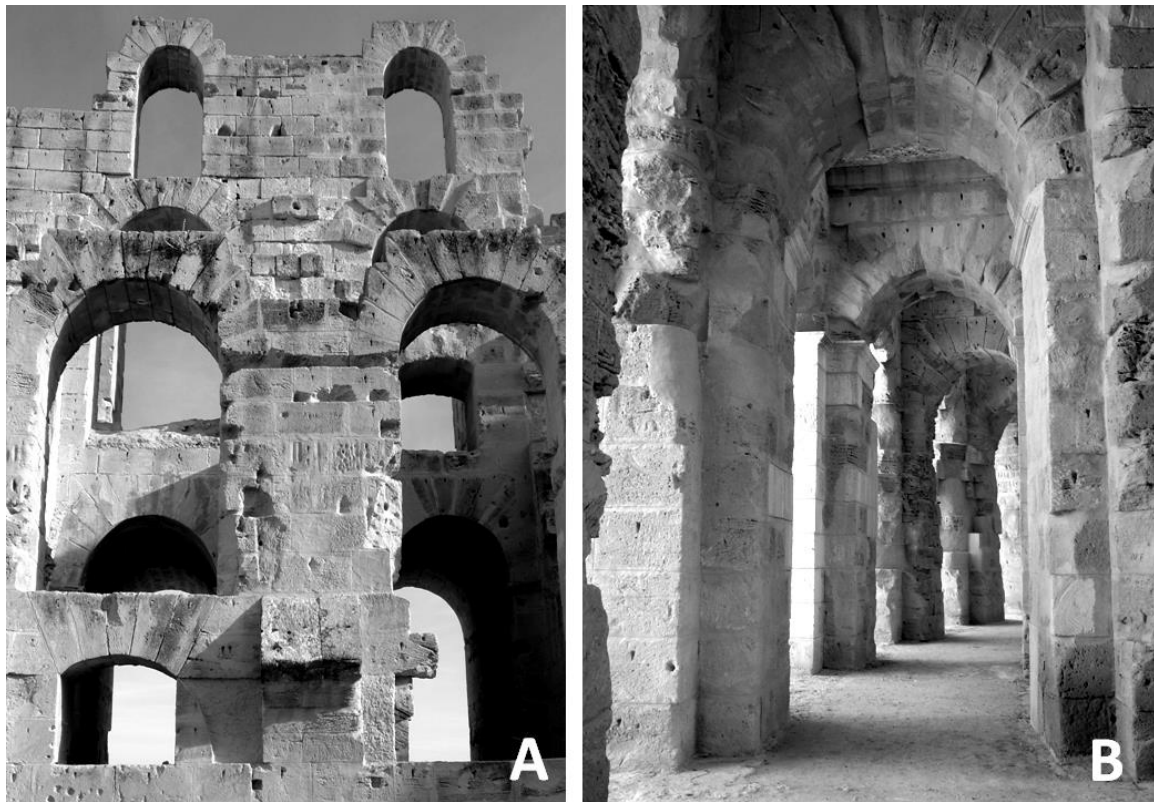
Figure 7 A and B: Walls of El Jem, Tunisia. which show much evidence of past restoration and deterioration and may be further affected by future climatic changes in the area

El Jem is a UNESCO World Heritage site, described as 'impressive ruins of the largest colosseum in North Africa, a huge amphitheatre which could hold up to 35,000 spectators (...). This 3rd-century monument illustrates the grandeur and extent of Imperial Rome' (UNESCO World Heritage List). Due to its location in an arid environment with close proximity to the Mediterranean Sea, and its high salt levels, as well as high levels tourism interest, this site could be at risk of rapid decay within a relatively short time span. It faces the same problems which Petra is currently dealing with, increased chemical weathering of the surface due to the proximity of large crowds of people, but in addition now faces increased thermal stress due to higher temperatures as well as potential salinization problems due to over-irrigation in the region. Figure 7 shows the deteriorating walls of El Jem which

have deteriorated heavily over the centuries. Rates of deterioration have been slowed down or accelerated by a number restoration projects over the past century.
