## Design, novel quality check and experimental test of an original variable length stepped scarf repair scheme

# Design, novel quality check and experimental test of an original variable length stepped scarf repair scheme

**Keywords:** Composite repair, stepped scarf joint, finite element analysis

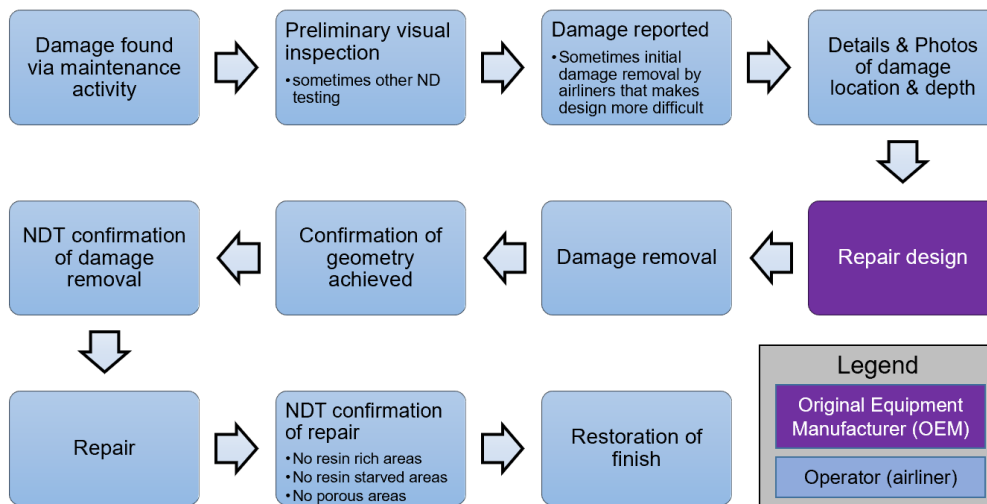
A typical repair process for composite structures is shown in Figure 1. It is worth noting that this figure is collated by the authors based on consultation from leading aerospace companies in the field. Thus, the figure is reflective of current industrial practices.

**Figure 1:** Current laminated composite repair process in industry

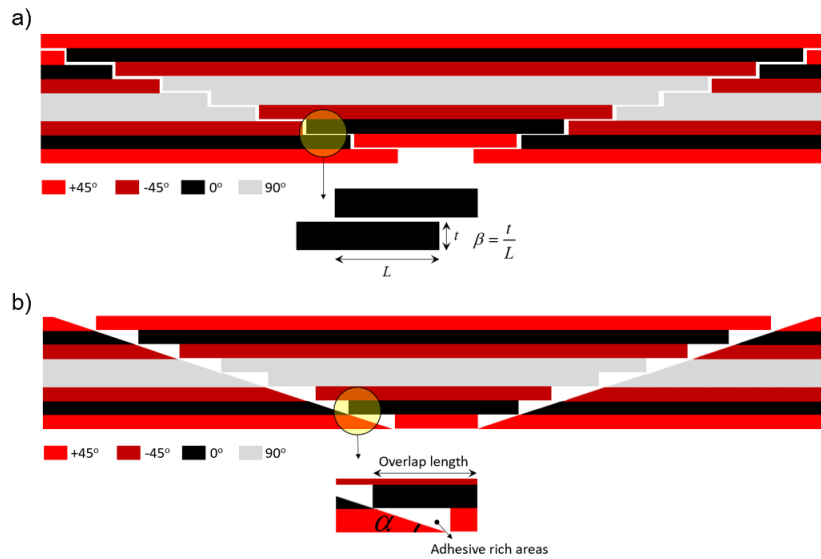
Typical bonded repairs on aerospace composites require a patch that is joined with scarfed joints to the parent material, as illustrated in Figure 2.

**Figure 2:** Examples of laminated composite repair schemes, a) stepped scarf repair and b) ramped scarf repair as seen in the literature

Such repairs are currently applied only to aircraft secondary structures and constrained to be near flush with any aerodynamic surface. In the case of a *stepped scarf repair* (see Figure 2a), the current practice requires scarf step parameter ( $\beta = t/L$ ) values of 1/45 (for Boeing) and 1/60 (for Airbus) [21]. These  $\beta$  values lead to prohibitively large repairs and considerable removal of healthy material. In the case of a *ramped scarf repair* (see Figure 2b), it has been shown in [22], [23] that a ramp of 50:1 is required to achieve maximum strength in the joints, although such ramps achieve slightly less than the full strength of the parent material. The lap length for each repair ply naturally becomes 50 times the ply thickness ( $50t$ ), while the peel load at the attachment of each repair ply is one fiftieth of the in-plane load. Furthermore, the current design methodology for scarf repairs recommends that the scarf angle be determined by analysing a scarf joint representing the most highly loaded section in a three-dimensional scarf repair. Such an idealisation approach is conservative and the beneficial effect of load bypass by the parent structure around the patch is neglected [23].

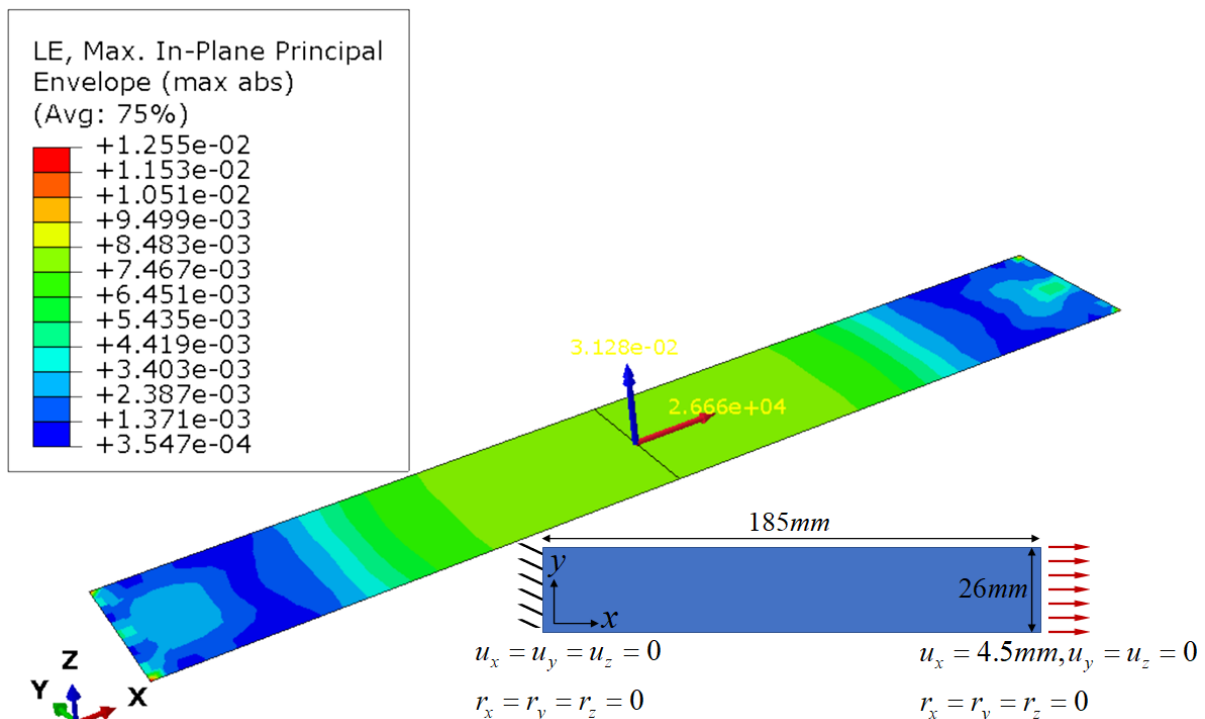
similar orientation such as three plies of  $0/90^\circ$  and three plies of  $\pm 45^\circ$ ) was employed as it reflects the use of such stacks in the manufacture of future aircraft. The laminate was discretised using three dimensional 4-noded conventional shell elements with reduced integration scheme, i.e. S4R elements. The material damage model and damage parameters used in this study are comprehensively detailed in [24]. The purpose of progressive damage failure was to obtain the failure displacement, strain and load of the pristine laminate under pure tensile loading. Boundary conditions, loading and principal strain contour plots of the laminate are shown in Figure 6. The failure displacement, strain and force are predicted as  $1.26\text{ mm}$ ,  $0.0125$  and  $26.67\text{ kN}$ , respectively.

**Figure 6:** Predicted failure strain ( $0.0125$ ) and failure force ( $26.67\text{ kN}$ ) of pristine laminate. (LE is logarithmic strain)

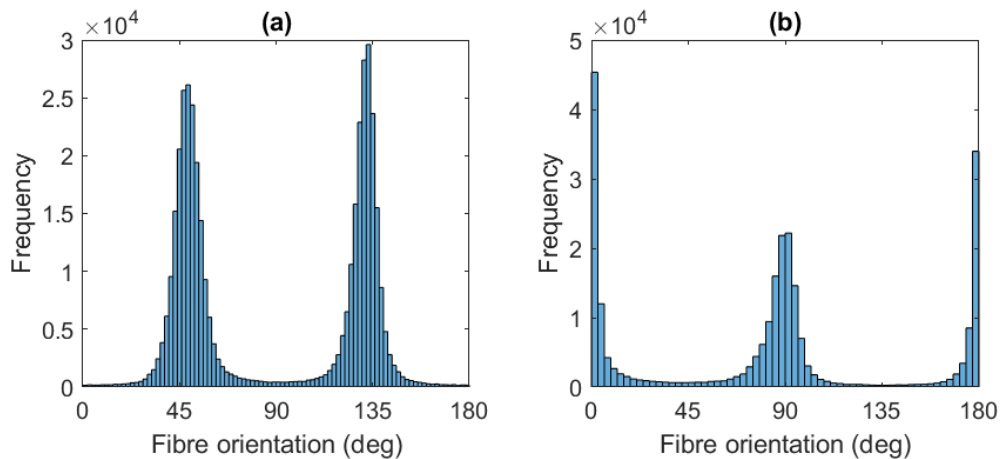
The final step of the machine vision part of the paper is to extract numerical data from Figure 10. To do this, the histograms of orientations are plotted for each step in the scarf. By way of example, the histograms for a region to the far left of Figure 10d and the central area of Figure 10d are plotted in Figure 11. This shows the capability of machine vision in obtaining ply orientation of scarfed plies. This is a potentially crucial step since it is often difficult to verify whether a full layer has been removed by other means – especially in the less controlled cases of grinding out scarfs. The combination of AoLP images and histograms give evidence of the underlying integrity of the component before testing or patch repair.

**Figure 11:** Histograms of ply orientation, a) far left and b) central steps from Figure 10d

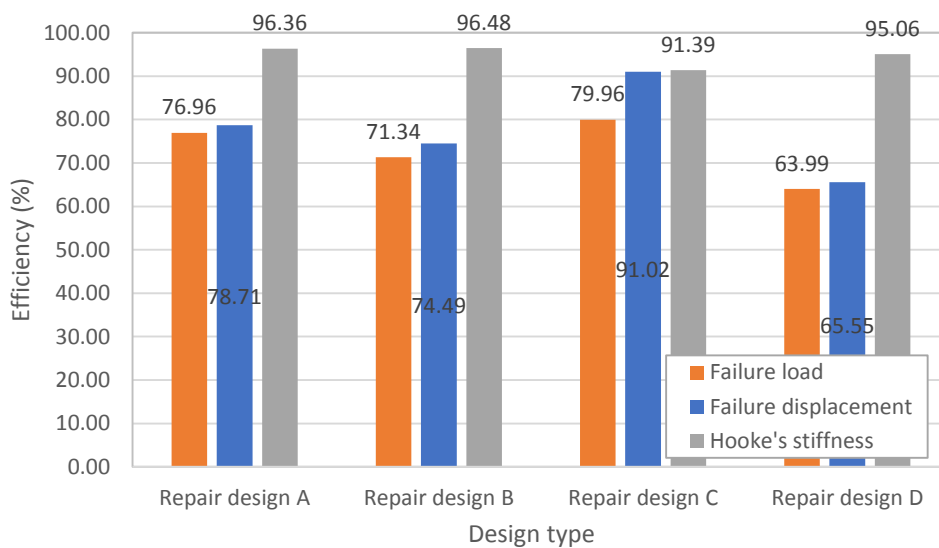
**Figure 16:** Average repair efficiency parameters normalised to those of pristine coupons (see Figure A5 for scattered data)

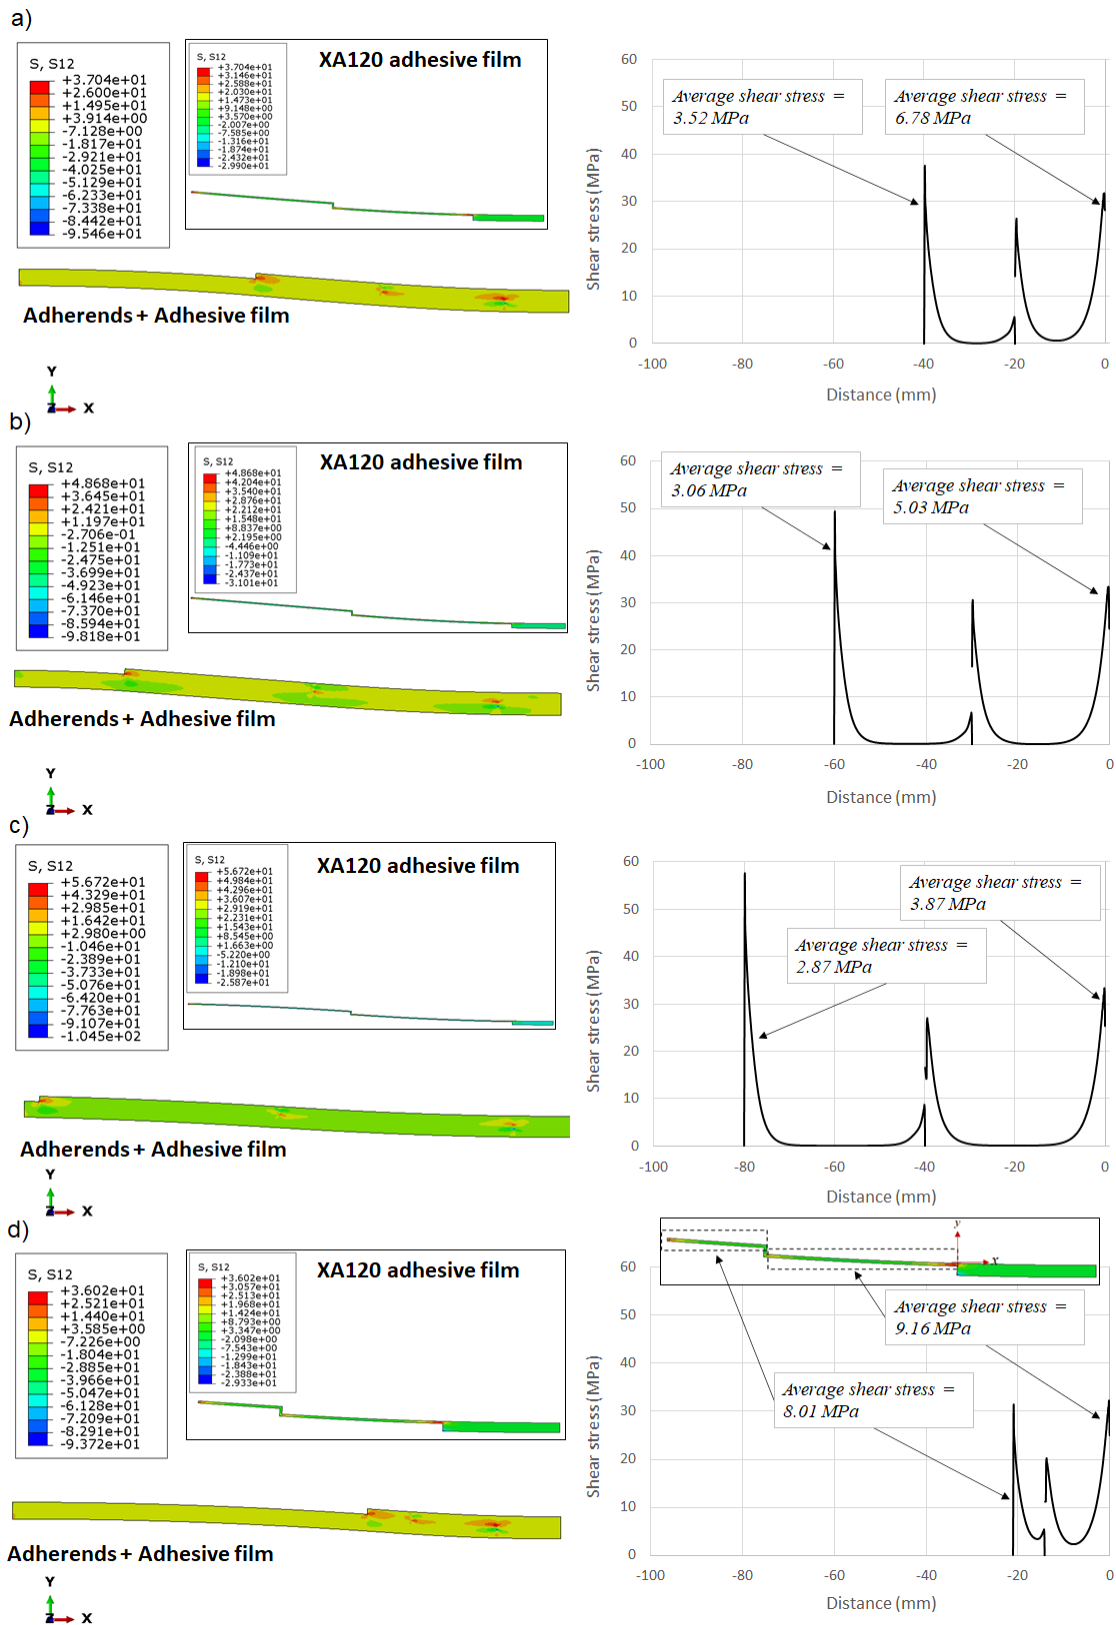
**Figure A2:** Shear stress ( $S_{12}$ ) contour plots (left) and shear stress distribution at mid-plane of adhesive (right) for 2D plane strain model of various repair designs at 0.63 mm enforced end displacement, a) repair design A, b) repair design B, c) repair design C and d) repair design D (VLSS). (All units are in MPa)

shown in Figure 17. This observation is in agreement with the findings in the work of Truong et al. [36], where interlaminar shear stresses led to delamination of the repair patch in a stepped scarf repair. Referring to contour plots of interlaminar shear stresses of Figure A2.a and Figure A2. **Error! Reference source not found.**d, the repair patch experiences elevated interlaminar shear stresses (orange contours at the step location of point 4) within the  $0/90_3^0$  repair plies and the interface between the  $\pm 45_3^0$  and the  $0/90_3^0$  repair plies. This stress state will have contributed to the formation of the delamination and progression via fracture mode I and II, due to the elevated peel ( $S_{22}$ ) and interlaminar shear stresses ( $S_{12}$ ), respectively. No delamination within the  $\pm 45_3^0$  repair ply group took place. It should be noted that, during the failure process the cohesive failure of the adhesive was not observed in these repairs (see Figure 17). Generally, the free edge locations (point 4 and point 1- yellow line of Figure 17) experience higher shear and peel stresses as shown in the numerical study of section 3.1 - which leads to the formation of cracks and failure of the adhesive-adherend interface through crack propagation in fracture mode I and II [37]. After the debond, overall failure of the test laminates for these designs took place immediately in the form of fibre failure (adherend cohesive failure) of the parent laminate in the middle of the test coupon.

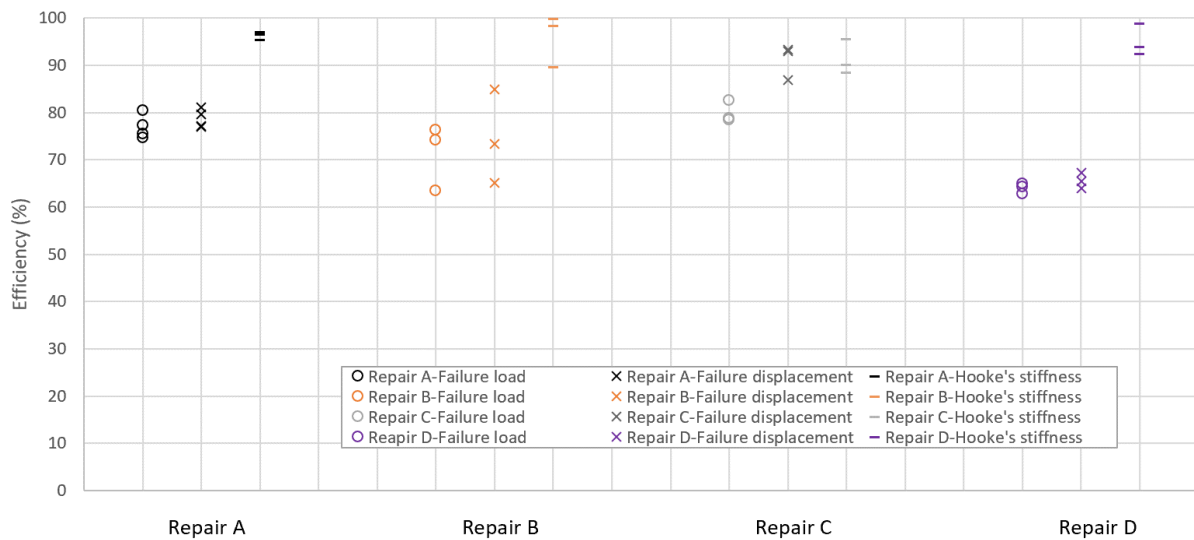
**Figure A5:** Efficiency scattered data of repair tests
