Experimental investigation of buckling and post-buckling behaviour of repaired composite laminates under in-plane shear loading

M. Damghani^{*}, A. Bugaje, G.A. Atkinson, D. Cole

School of Engineering, University of the West of England (UWE), Bristol, BS16 1QY, UK

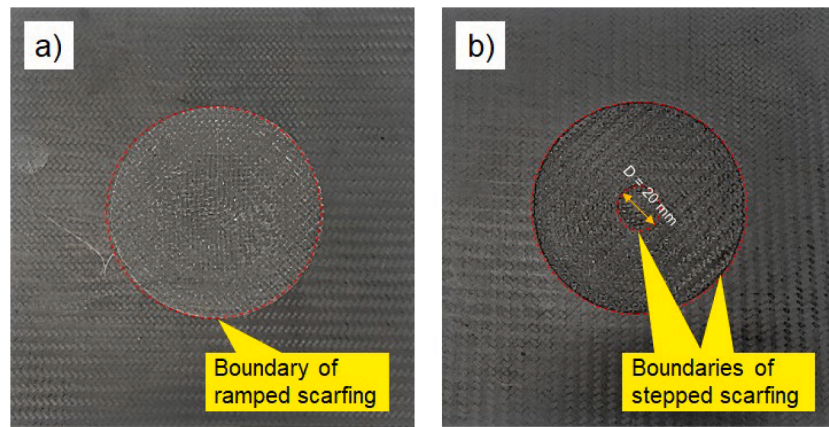
Fig. 2. Prepared laminates, a) ramped scarf, b) stepped scarf.

To manufacture RS and SS laminates, the pristine laminates were prepared/scarfed in ramps and steps, respectively, as illustrated in Fig. 2. This process assumed a circular damage size $D = 20 \text{ mm}$ located 6 plies below the top surface which is typical for low velocity impact events [39].

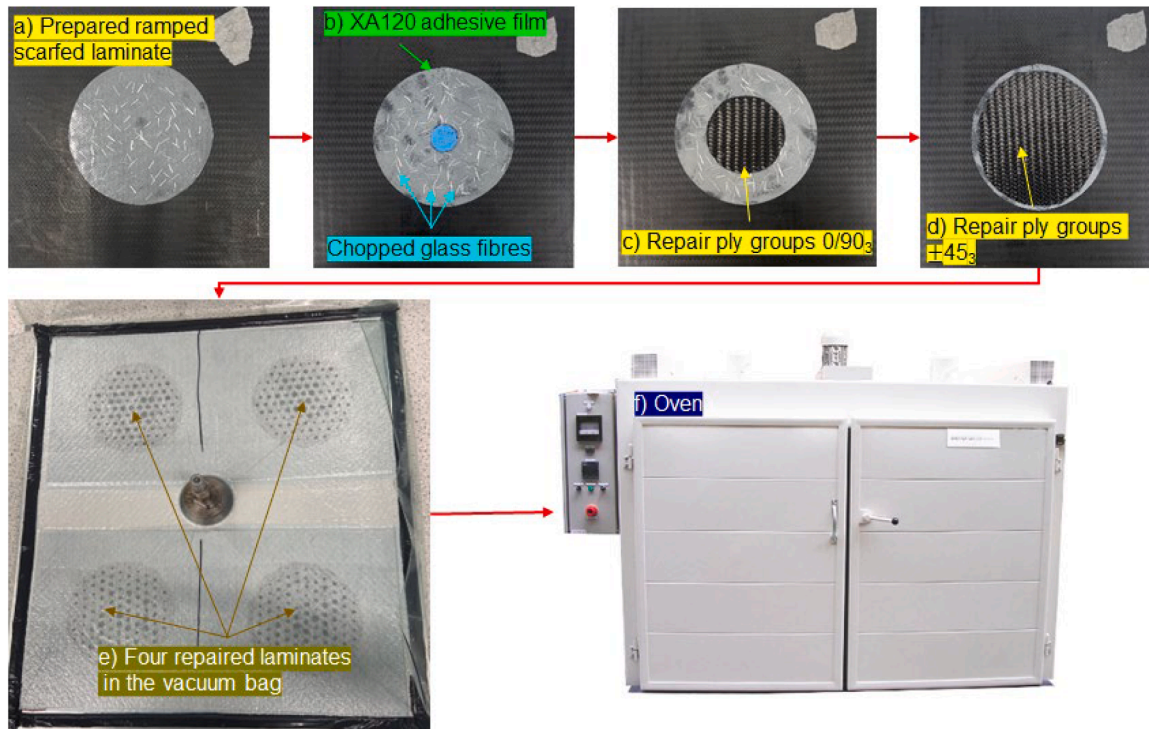
Fig. 4. Sequence of repair process for ramped scarf repair.

For the manufacture of RS laminates, a similar procedure to that of SS laminates was followed. The sequence of repair activities for RS samples is illustrated in Fig. 4.

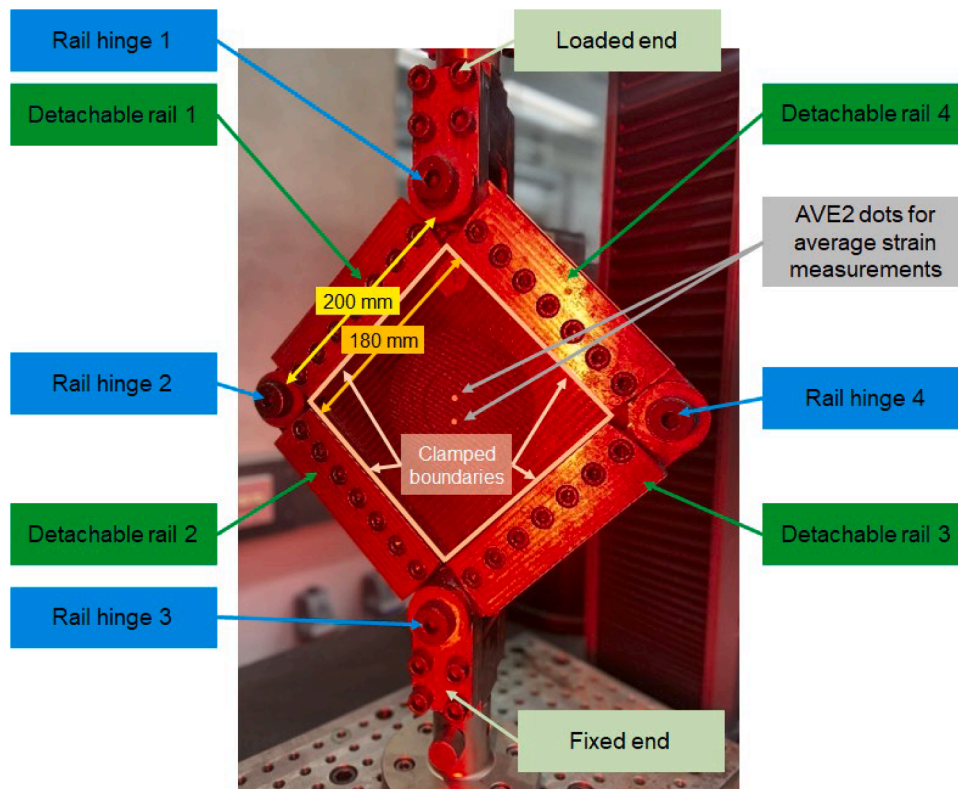
Fig. 5. In-plane shear test set-up.

The shear test was conducted using a 100 kN capacity INSTRON tensile machine equipped with a picture frame test fixture. The specimens were first clamped into the test fixture via grip plates of 10 mm width, resulting in gauge dimensions of 180 mm × 180 mm. The specimens were held in position and loaded by constant static friction via the clamping force of the bolts. The specimens, along with in-house manufactured test fixture, were then positioned in the tensile test machine (see Fig. 5). A tensile load was applied under displacement control at a speed of 2 mm/min, inducing shear deformation in the test laminate.

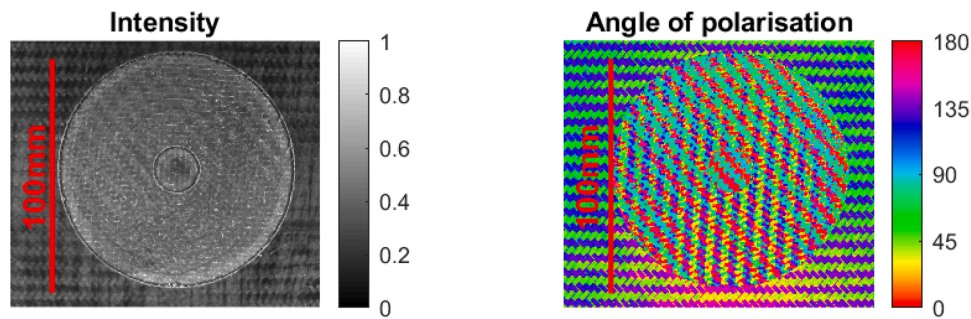
Fig. 7. Polarisation image for a stepped scarf.

Fig. 7 presents a polarisation image of a stepped scarf. The image clearly shows $\pm 45^\circ$ fibres outside the scarf and successful material removal down to the $0/90^\circ$ layer in the centre. The intermediate regions display a mixture of each layer, indicating that the machining process

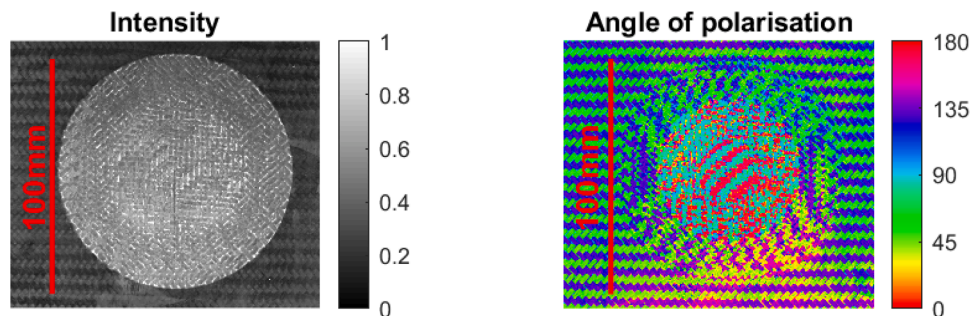
Fig. 8. Polarisation image for a ramped scarf.

was successful in reaching the required interface. A comparable example for the ramped scarf is shown in Fig. 8. For this study, all specimens were qualitatively assessed to be adequately machined within the possible tolerances of the adopted manufacturing method.

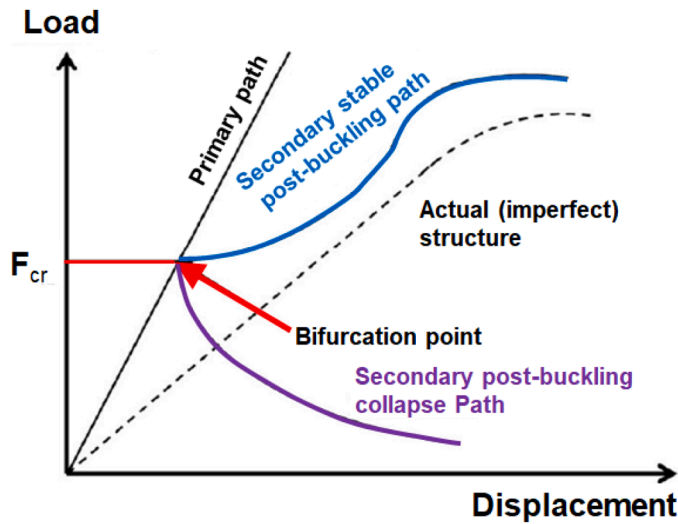
Fig. 9. Typical buckling and post-buckling behaviour of structures.

Fig. 9 illustrates typical instability behaviour of structures. Generally, the load-displacement of structures follows a linear primary path. However, upon reaching the buckling load (bifurcation point at F_{cr}), the structure can follow one of two possible secondary paths:

- **Secondary Post-Buckling Collapse Path:** In this scenario, the slope of the load-displacement graph becomes negative, indicating negative stiffness, which leads to the collapse of the structure.

- Secondary Stable Post-Buckling Path:** Here, the structure continues to endure higher loads as displacement increases, exhibiting positive stiffness and stable behaviour.

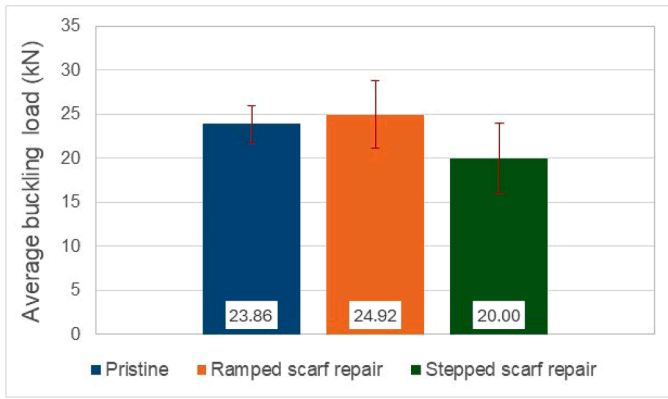
Fig. 12. Comparison of average buckling load.

Based on Fig. 11, the pristine (P), Ramped Scarf (RS), and Stepped Scarf (SS) repairs exhibit a linear load-displacement behaviour up to displacements of approximately 1.5 mm to 1.7 mm, where buckling occurs. Fig. 12 presents the average buckling loads for the test specimens, with pertinent Standard Deviations (SD) represented as error bars. RS repairs demonstrate the highest average buckling load, indicating superior buckling performance compared to pristine and SS repair. However, it is important to consider the variability captured by the SDs. The overlap of the error bars indicates that the range of buckling loads for the RS and pristine samples might significantly overlap, suggesting that their buckling performance could be statistically similar. This implies that the apparent superiority of RS repairs, as inferred from the average buckling load values, might not be as pronounced when accounting for the variability in the data. Therefore, while RS repairs may show a trend towards higher buckling loads, the standard deviations suggest caution in definitively concluding that their performance is significantly better than that of pristine samples. Conversely, SS repairs perform poorly compared to pristine laminates in terms of buckling load. The observed reduction in performance can be attributed to load eccentricities present in Stepped Scarf (SS) repairs, where the overlapping repair plies are misaligned relative to their corresponding parent plies through the laminate thickness. Specifically, as shown in Fig. 10, an offset e exists between the mid-plane of the unrepaired section of the laminate and that of the repaired section. Consequently, the application of a shear force S brings about bending moment of $S.e$. These load eccentricities function as imperfections within the laminate, promoting premature buckling under shear loading conditions. SS repairs generally exhibit a less discernible transition between primary and secondary load path (see Fig. 11c). This is particularly evident in specimen 4, where the laminate behaves similarly to an imperfect structure, with a less distinct transition between primary and secondary load paths (see Fig. 9). It should be mentioned that, in such cases, the buckling load of an imperfect structure is generally expected to be lower than that of a perfect one. However, this is not observed with specimen 4, where the buckling load is unexpectedly higher. This discrepancy could be attributed to variability in the manufacturing of the repair specimens, particularly concerning the cured ply thickness of the repair patch, which directly affects the bending stiffness of the repaired laminate. Variations in the thickness of the cured plies may have led to increased bending stiffness, thereby influencing the buckling performance observed in specimen 4. A comparison of SDs suggests that repaired specimens, particularly SS repairs, show higher deviations from average values. This outcome is expected within the scope of the current study, as bonded repairs inherit vulnerabilities associated with bonded joints. The greater the number and length of bonded joints, the higher the vulnerabilities and data scatter, as observed in SS specimens. It is well established in the literature [40] that bonded joints are susceptible to various parameters, including variations in the manufacturing bonding process, geometric parameters (bond line thickness, joint configuration, overlap length), material parameters (adhesive properties, adherend material), and environmental factors (pre-bond moisture, post-bond moisture, temperature, combined moisture, and temperature). These factors lead to less reliable joints, often resulting in higher SDs, as demonstrated in earlier work by the authors [41].

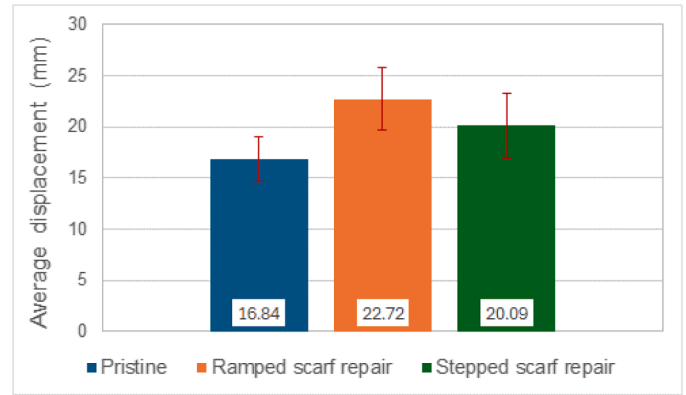
Fig. 14. Comparison of average values maximum displacement.

Figs. 14 and Fig. 15 provide a comparison of maximum displacements and failure loads for all test specimens, respectively. It is evident that both repair types exhibit superior performance compared to pristine laminates. For instance, RS repairs demonstrate an average of 35 % higher maximum displacement and 12 % higher failure load than the pristine laminates. Similarly, SS repairs show 19 % higher maximum displacement, and 5 % higher failure load compared to the pristine laminates. As detailed in Section 4.2, the stepwise addition of material at varying depths in SS repairs leads to an increase in effective thickness, which in turn enhances the bending stiffness compared to pristine laminates. This increased stiffness improves the failure load capacity of the laminate. However, due to load eccentricity, the improvement in failure load observed with SS repairs does not reach the level achieved by RS repairs.

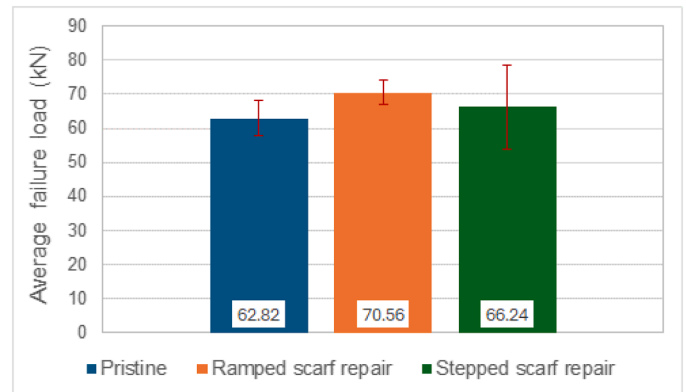
Fig. 15. Comparison of average failure load.

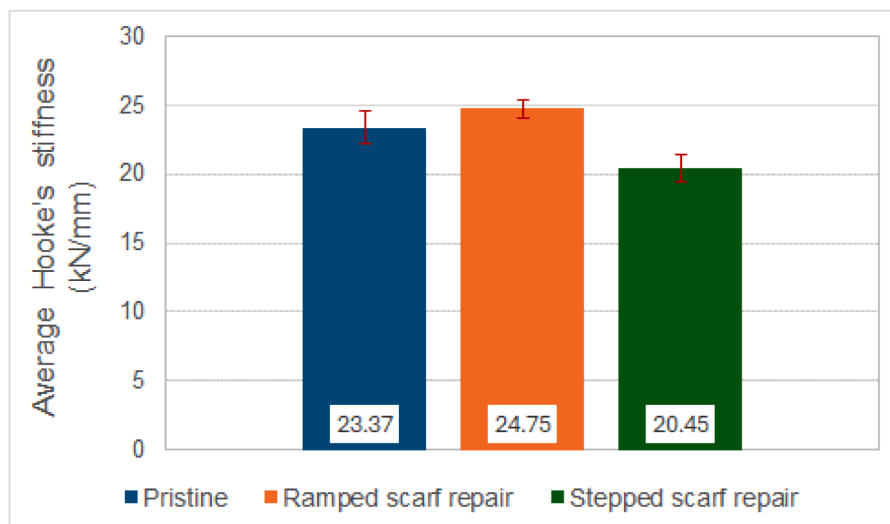
Fig. 13. Comparison of average Hooke's stiffness.

Hooke's stiffness is defined as the slope of linear portion of the load-displacement response shown in Fig. 11. As depicted in Fig. 13, the stiffness of RS and pristine laminates are similar, with RS laminates showing a slightly higher stiffness, though this difference is negligible considering the standard deviation (SD). In contrast, SS repairs exhibit the least stiffness. This reduced stiffness is attributed to the offset

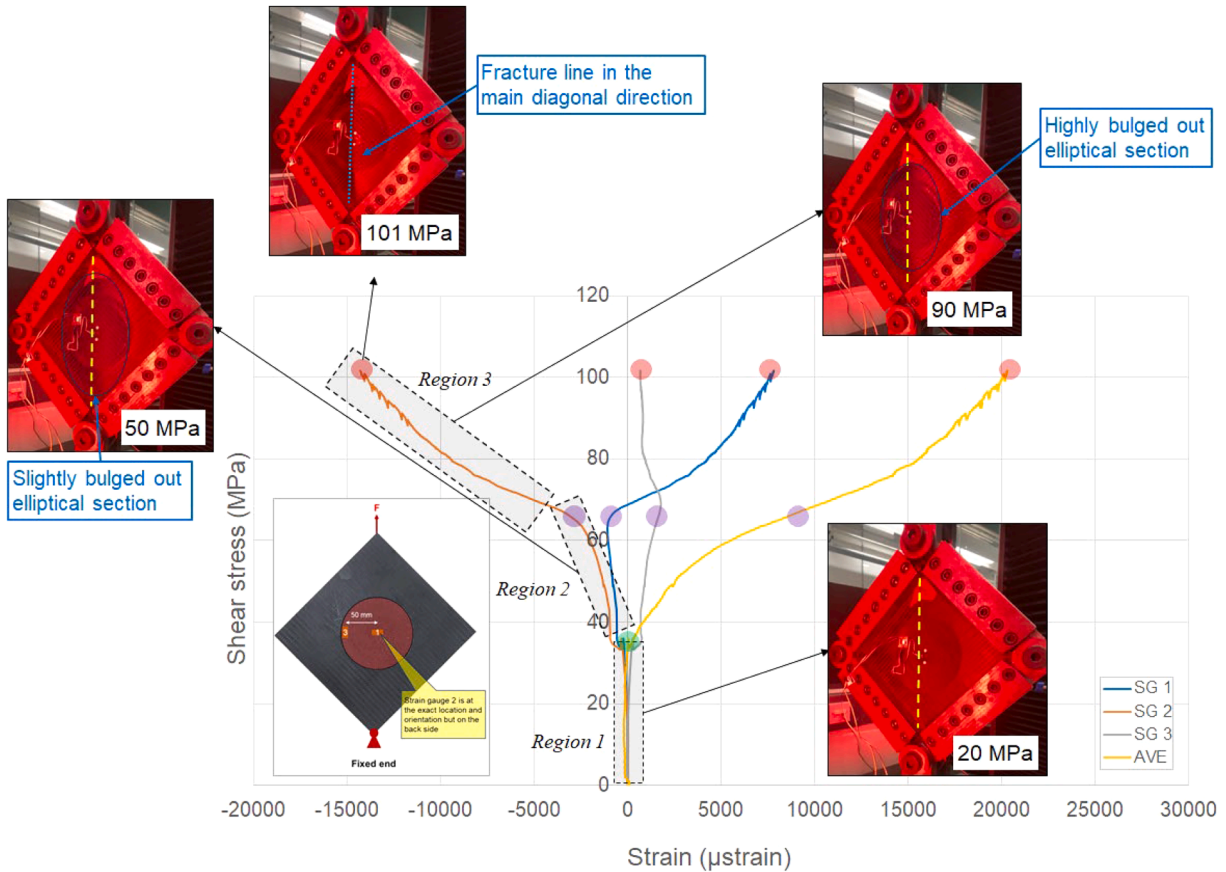
Fig. 17. Shear stress vs. strain of RS laminates.

Based on Figs. 16-Fig. 18, stress-strain responses of P, RS and SS laminates respectively, show similar qualitative behaviour, characterised by three distinct regions:

Finally, at the end of the test (red point), the laminates begin to fracture mostly symmetrically for both P and RS specimens, as indicated by the blue dotted lines in Figs. 16 and Fig. 17. Notably, for RS specimens, the ramped repair patch detaches precisely at the point of failure (red point), demonstrating an excellent bond with the parent laminate. Throughout the test, the average strain readings from the INSTRON AVE2 Non-contacting Video Extensometer consistently show tensile strains in the loading direction, in agreement with the findings of [32]. Full details of failure modes are provided in Section 4.3.

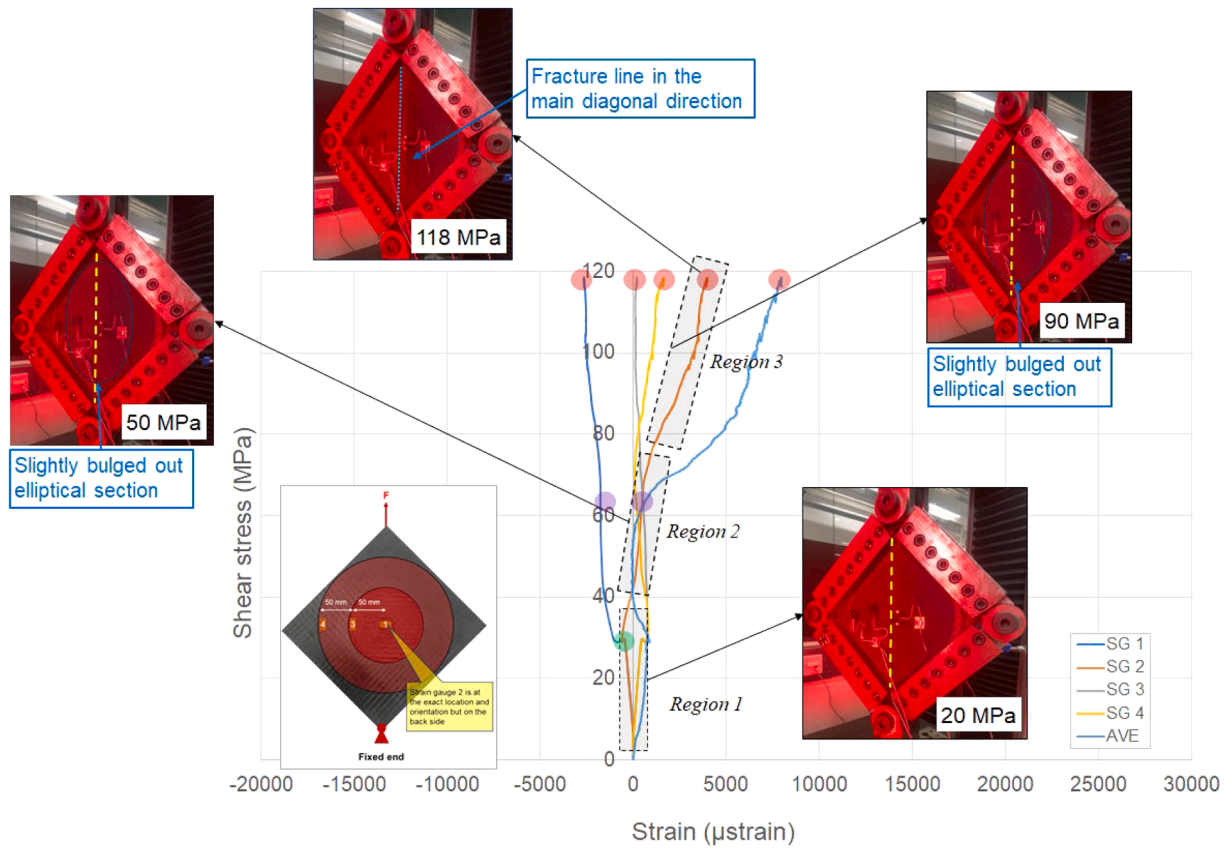
Fig. 18. Shear stress vs. strain of SS laminates.

It is important to note that for SS laminates, the behaviour in regions 2 and 3 differs from that of P and RS laminates. This difference arises from the inherent load eccentricities and imperfections in SS repairs, which affect their post-buckling performance and overall stability. This phenomenon is detailed in the previous work of Damghani et al. [1]. The SS laminates show a less consistent and more variable stress-strain response in these regions compared to P and RS laminates.
