The Role of Broken Fibres on Crack Migration into 0° Surface Plies in Adhesively Bonded Carbon Fibre Composite Joints

Aakash Paul¹, Xiaodong Xu^{1,2*}, Takayuki Shimizu³, Michael R. Wisnom¹

¹ Bristol Composites Institute (ACCIS), University of Bristol, University Walk, Bristol BS8 1TR, UK

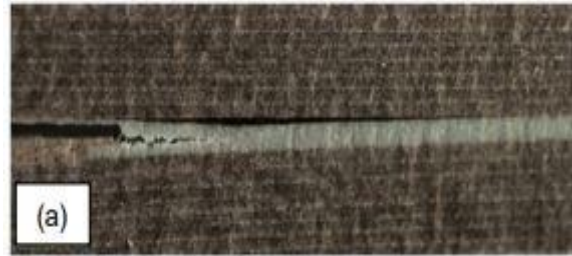
Figure 1 - Example of double delamination [9].

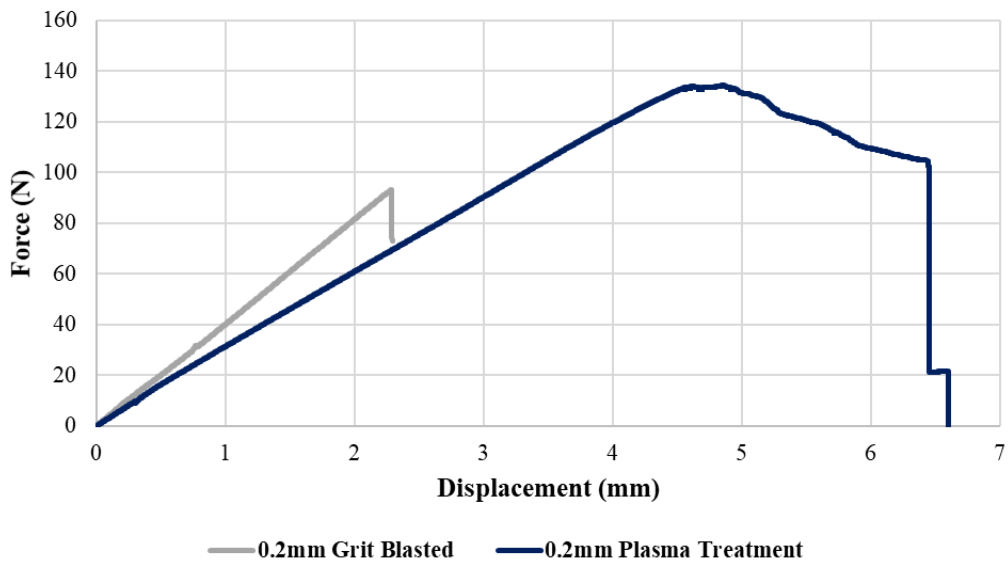
Figure 6 - Typical load displacement curves for the 0.2 mm nominal adhesive thickness DCB cases.

Analysing the force-displacement curves for both cases for the 0.2 mm nominal adhesive thickness case in Figure 6 shows a significant increase in maximum load. A discrepancy in the stiffness was observed due to the difference in a_0 length before the DCB test for the two batches as discussed in Section 2.3.1. Comparing the G_{IC} and fracture surfaces for the different surface treatments for the 0.2 mm nominal adhesive thickness cases shows a large increase of 149% in G_{IC} and a clear change in failure mode. As discussed in Section 2.2.1, the grit blasting surface treatment creates microscopic regions of broken fibres. These broken fibres can potentially introduce local high stress concentrations which could create a path for crack migration into the adherend surface 0° ply before the adhesive could yield and allow propagation in the adhesive. A sudden load drop was seen on the force-displacement curve (Figure 10) for the grit blasted tests as the crack migrated into the less tough composite before any non-linear adhesive behaviour could occur, as shown in Figure 6. The crack stayed within the adherend during propagation. For the plasma treated cases, a cohesive failure was observed. As no fibres were broken on the adherend surface during the surface preparation stage, the failure initiated from the adhesive/adherend interface into the adhesive as this was the weakest path. The failure was now controlled by the higher adhesive G_{IC} properties, giving a much higher G_{IC} than for the grit blasted surface for the 0.2 mm nominal adhesive thickness case. During propagation, it can be seen on the fracture surface in Figure 8b that some crack migration still occurred, initiating from the specimen edges. Although no broken fibres were present on the plasma treated surfaces, they do occur at the edges where the specimens were cut since the fibres are not perfectly parallel. The appearance of the fracture surface suggests that these broken

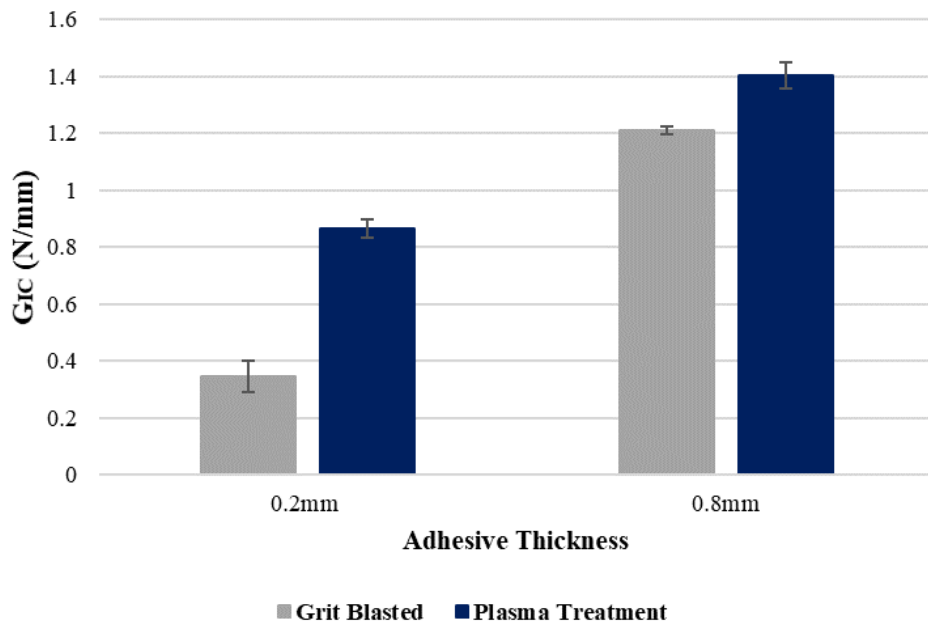
Figure 9 - Comparison of grit blasted and plasma treated G_{IC} .

Increasing the adhesive thickness increases the G_{IC} for both surface preparation methods as shown in Figure 9. A greater increase was found comparing the grit blasted case to the plasma treatment case, due to the change in failure mode for the grit blasted case. The 0.2 mm nominal adhesive thickness case was controlled by the adherend properties, whereas the 0.8 mm case was controlled by the adhesive properties. For the plasma treated specimens, the failure for both 0.2 and 0.8 mm cases were cohesive, i.e. controlled by the adhesive properties. The increase in G_{IC} with adhesive thickness may be attributed to the increased energy dissipation in the process zone through increased plastic straining [24].

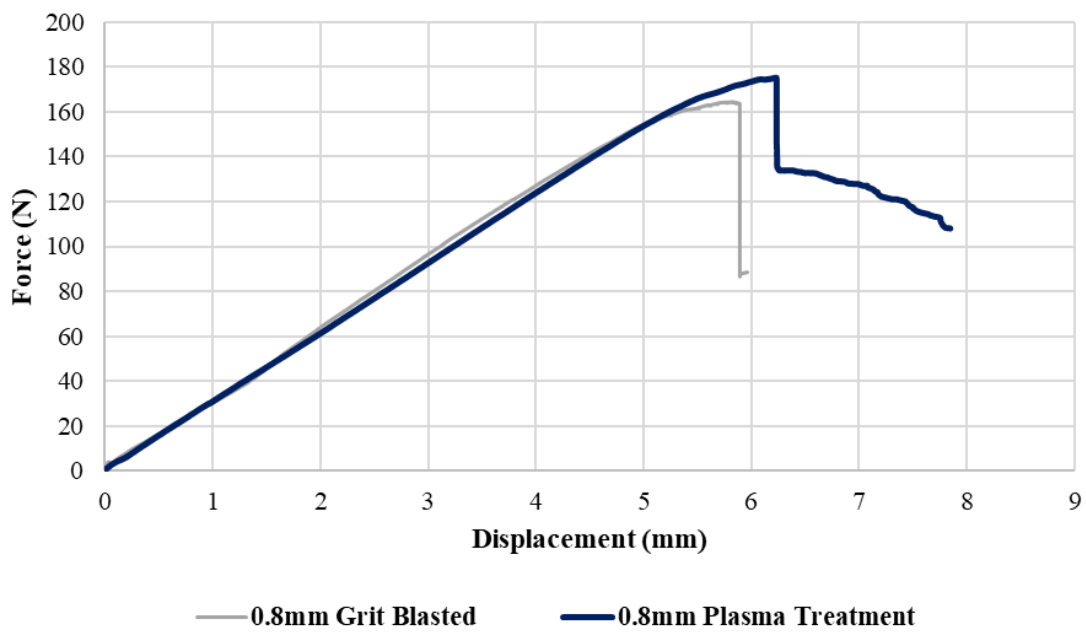
Figure 10 - Typical load displacement curves for the 0.8 mm nominal adhesive thickness DCB cases.

Figure 10. The experimental results for the 0.8 mm nominal adhesive thickness grit blasted case are summarised in Table 1.

Like the grit blasted 0.8 mm adhesive thickness the P5% load was used to calculate the G_{IC} as non-linearity was present during loading as seen in Figure 10. During curing of some 0.8 mm adhesive thickness specimens, wrinkles in the PTFE film were present as shown in Figure 12. These were formed due to movement of the insert film placed in between the adhesive layers as a result of the low adhesive viscosity at higher temperatures. These wrinkles were not believed to be critical as they were away from the crack tip. Table 2 summarises the plasma treated G_{IC} results for the 0.8 mm nominal adhesive thickness.

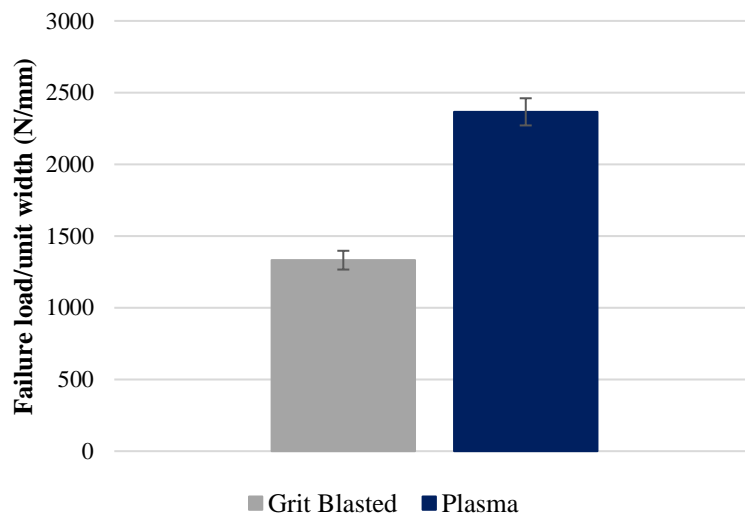
Figure 18 - Comparison of the plasma treated and grit blasted surface treatment for the DLJ strength.

A 78% increase in DLJ strength for the plasma treated specimens was observed compared to the grit blasted specimens, as shown in Figure 18. Comparing the failure mechanisms shows that the grit blasted case was controlled by the adherend properties as there were broken fibres present from the surface preparation stage facilitating crack migration into the adherend at failure. For the plasma treatment, patches of adhesive were visible on the fracture surface, which indicates that the adhesive had a significant influence on the failure. The 0° fibres visible on the fracture surface are believed to be a post failure effect, i.e. after the failure within the adhesive. The change in failure mechanism explains the significantly higher strength observed for the plasma treatment case compared to the grit blasted case. The failure is mixed mode, nevertheless it is interesting to note that the 78% increase in failure load is of similar order to the DCB tests, where the 149% increase in G_{IC} is consistent with a 58% increase in load since energy release rate is proportional to load squared.
