RESEARCH ARTICLE

Subsurface fracturing of sedimentary stones caused by bullet impacts

Oliver Campbell^{1*}, Tom Blenkinsop¹, Lisa Mol², Oscar Gilbert²

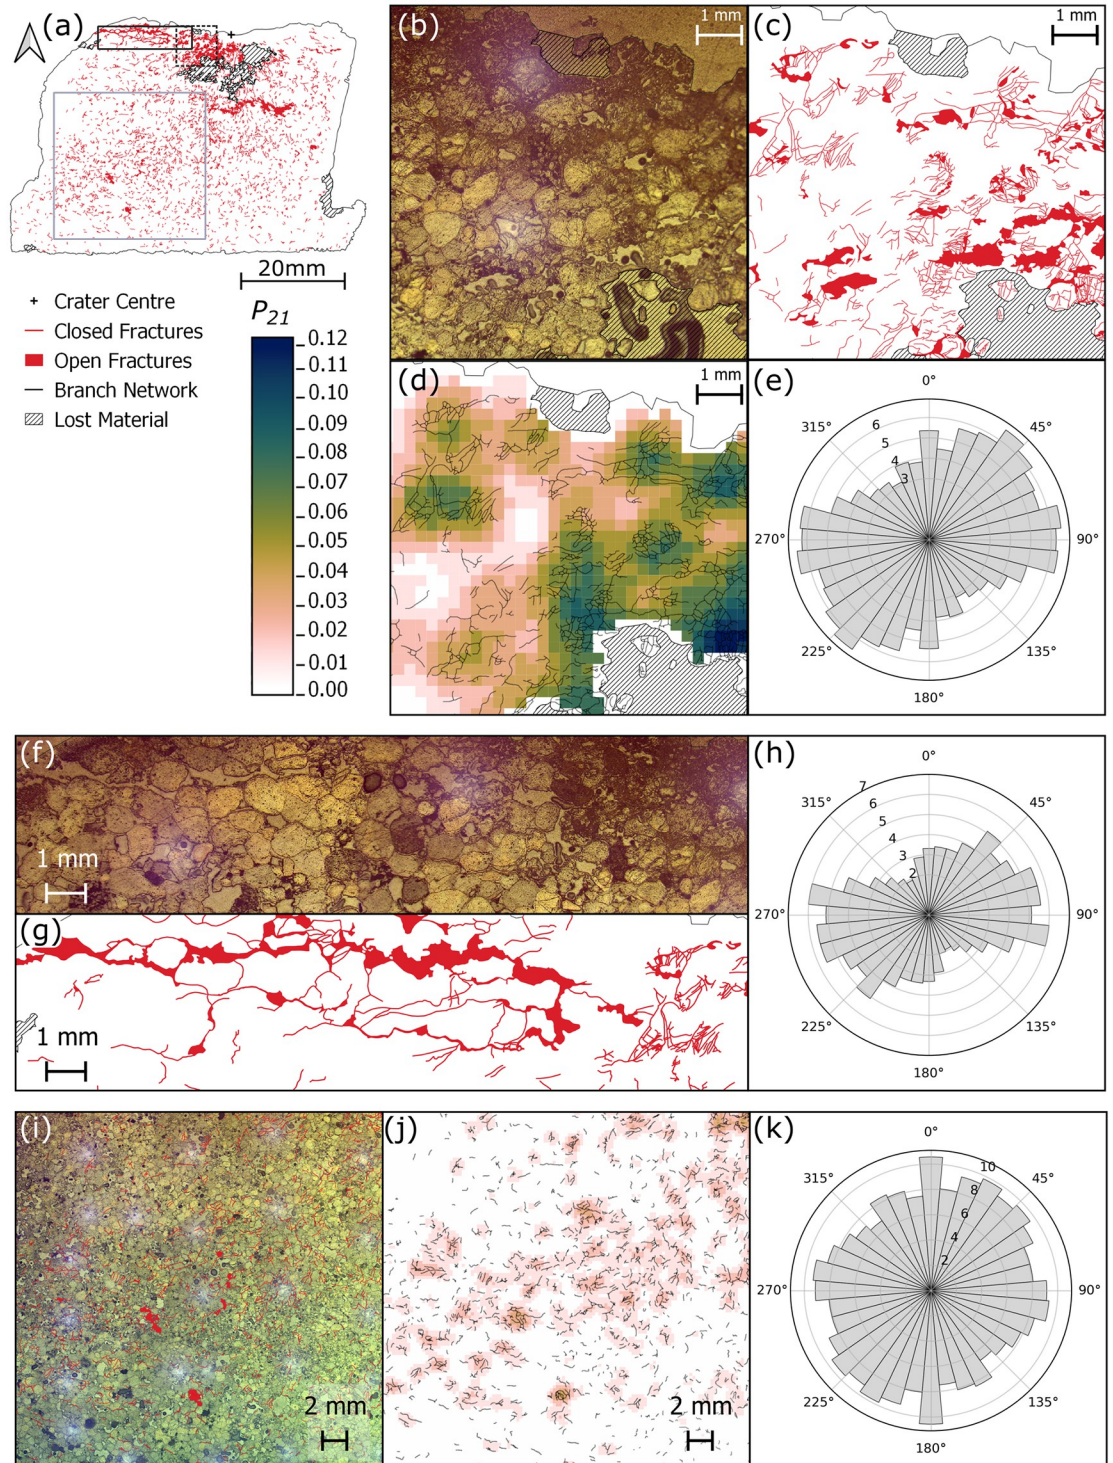
Fig 4. (a) Fracture map of the thin section through the impact crater in Stoneraise Red Sandstone (SRS_09), showing closed and open fractures (red). Dashed box shows the location of panels (b-e). Solid black box outlines the location of panels (f-h). Grey box shows the location of panels (i-k). (b) Reflected light photomicrograph showing substantial grain crushing (top of frame) at the crater floor and a high number of trans- and intergranular fractures in the region beneath. Interconnected fracture pathways are seen in the fracture map in panel (c). The highest fracture intensity value (0.124) is observed in the lower right of the P_{21} intensity map (d), 5.9 mm from the crater centre (out of frame towards the top right). Topology parameters were calculated using the branch network (black lines) interpreted by the NetworkGT plugin based on a threshold image of the digitised fractures (red lines). The orientations of the digitised fracture network show a slight predominance in orientation around $45^{\circ}/225^{\circ}$ and $90^{\circ}/270^{\circ}$. (f-g)

Reflected light micrograph and corresponding fracture map of open, extensional fractures directly below the crater edges. Fractures are oriented sub-parallel to the target face as seen in the rose diagram for the region (h). (i) Reflected light photo micrograph and fracture network showing a region of fracturing from below the crater to the SW corner of the central section. (j) P_{21} fracture intensities and NetworkGT branch map for the same region. There appears to be a slight trend of fracture orientations from $45^\circ / 225^\circ$ (k), though the dominant orientation for the region is perpendicular to the target face. All rose diagrams (e, h, k) are plotted as equal area diagrams, orientation frequency is weighted for fracture length, and the radial scale is the square root of the weighted frequency.

Directly below the crater centre is a zone of primarily closed intra- and trans-granular fractures, forming a region of intense fracturing that extends to a depth of ~7 mm below the crater floor (Fig 4a–4e). The highest P_{21} fracture intensity value calculated (0.124) is in this region, 5.9 mm away from the crater centre (Figs 3b and 5b). Many grains exhibit multiple closed fractures that originate at contact points with adjacent grains, forming connected networks across multiple grains. Open extensional fractures are visible just beneath the crater floor traversing from the crater centre towards the rim (Fig 4f and 4g). These fractures have both inter- and trans-granular pathways, with no measurable lateral displacement between fracture walls. They are primarily sub-parallel to the target face of the samples (Fig 4h). In the top central section there appears to be a band of damage stretching from the SW corner of the section to an area of material loss directly below the crater centre (Fig 4a and 4i–4k). The band has an approximate orientation of $35^\circ/215^\circ$.

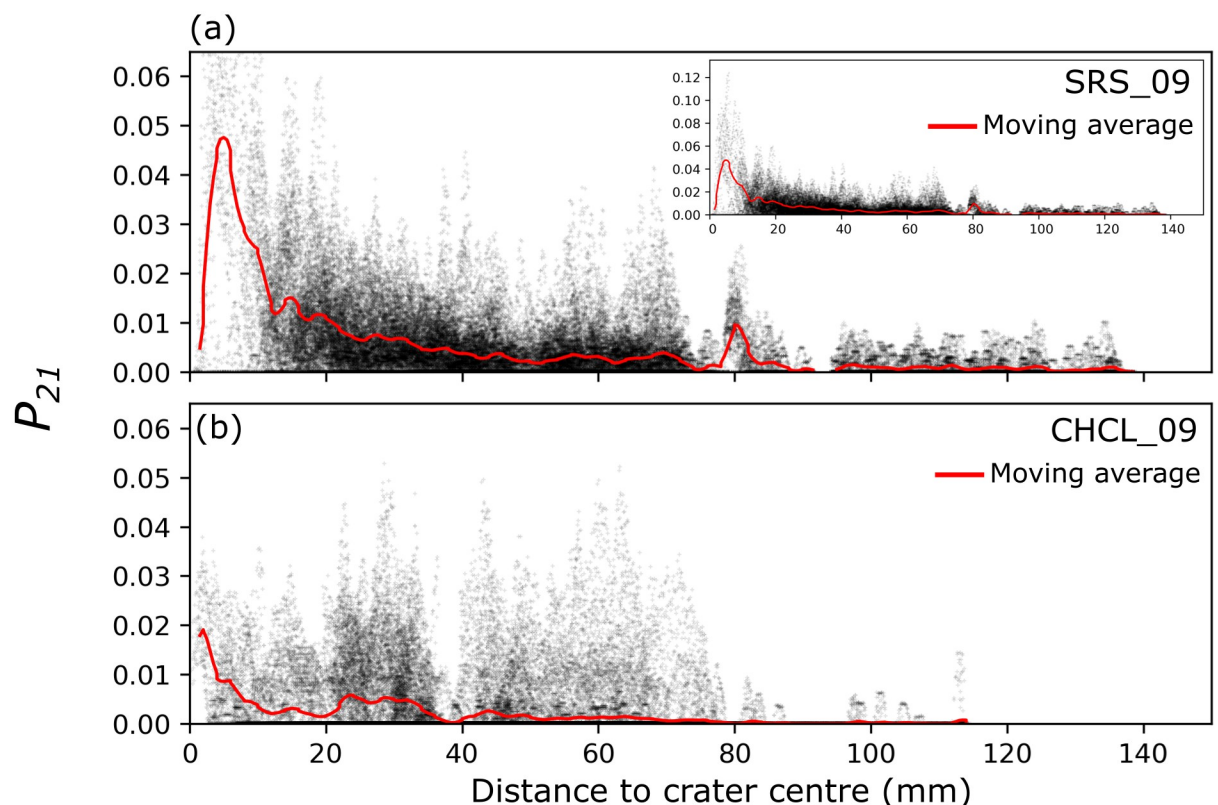
Fig 5. P_{21} fracture intensity with increasing distance from the crater centre for the sandstone (a) and limestone (b) target blocks. Red line is a 2 mm moving average of P_{21} intensity with distance from crater centre. Inset shows the full extent of P_{21} values in the sandstone target.

There are few fractures in the thin sections further than 80 mm below the crater floor, and those present are short, intra-granular fractures, typically confined to a single grain. This is visible in the small peak in P_{21} intensity at 80 mm below the crater centre (the large open fracture), followed by very low intensity values with increasing distance from the crater centre (Fig 5a).

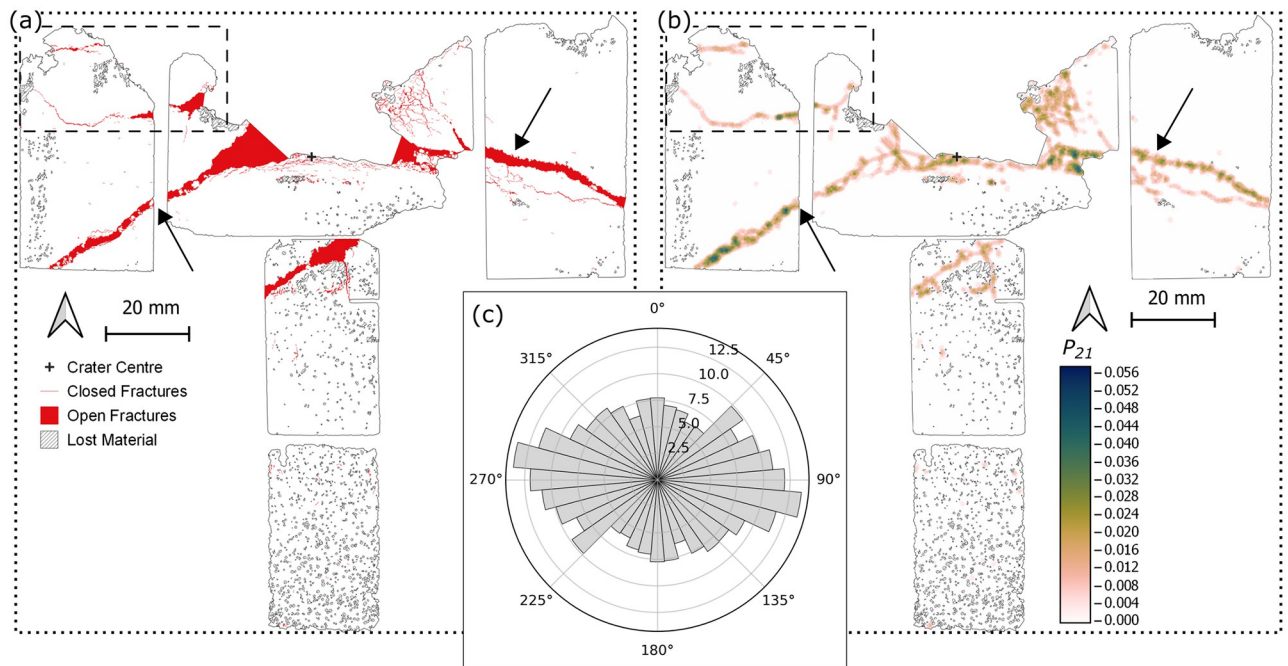
Fig 6. Fracture map (a) through the centre plane (XZ) of the Cotswold Hill Cream Limestone (CHCL) sample (CHCL_09). An open fracture (black arrows) is present across multiple thin sections, intersecting the edges of the target block and the crater. Open fractures are visible sub-parallel to the target face and forming incipient spall fragments (dashed rectangle). There are crater floor parallel, closed fractures (red line) directly below the crater centre. (b) Map of P_{21} fracture intensity values across the thin sections. The highest values (dark blue) are localised along the wide open fracture (black arrows) and around the crater centre. For both maps impact direction is top to bottom and the original block outline is shown with a dotted line. (c) Equal area rose diagram showing the orientation of all fractures, weighted for fracture length, mapped within the limestone sample. The fractures are predominantly sub-parallel to the target face. Radial scale is the square root of frequency.

Fractures throughout the sample are generally sub-parallel to the target face (Fig 6c), although there is another group of fractures with an orientation of 50°/230°. Material below the spall zone surface is highly fractured, with grain sizes beyond the scale of observation in optical sections (Fig 7a–7c). The top surface of the incipient wedge is the floor of the spall zone surrounding the central excavation and has an orientation of approximately 45°/225°. Some fractures within the wedge, particularly those close to the spall surface, are oriented parallel to the spall surface, while other fractures throughout the wedge are perpendicular to this surface (Fig 7c). Higher P_{21} values reflect the higher fracture intensity in these regions (Fig 7d). This orthogonal pair of fractures is bisected by a third group, with orientations of approximately 100°/280° (Fig 7e.)
